February 12, 2019

Porcupine Wood Products Ltd.
Box 850
Salmo, BC
V0G 1Z0

**RE: TERRAIN STABILITY ASSESSMENT
BALFOUR FACE, CP 409, BLOCKS 7, 8 and 9**

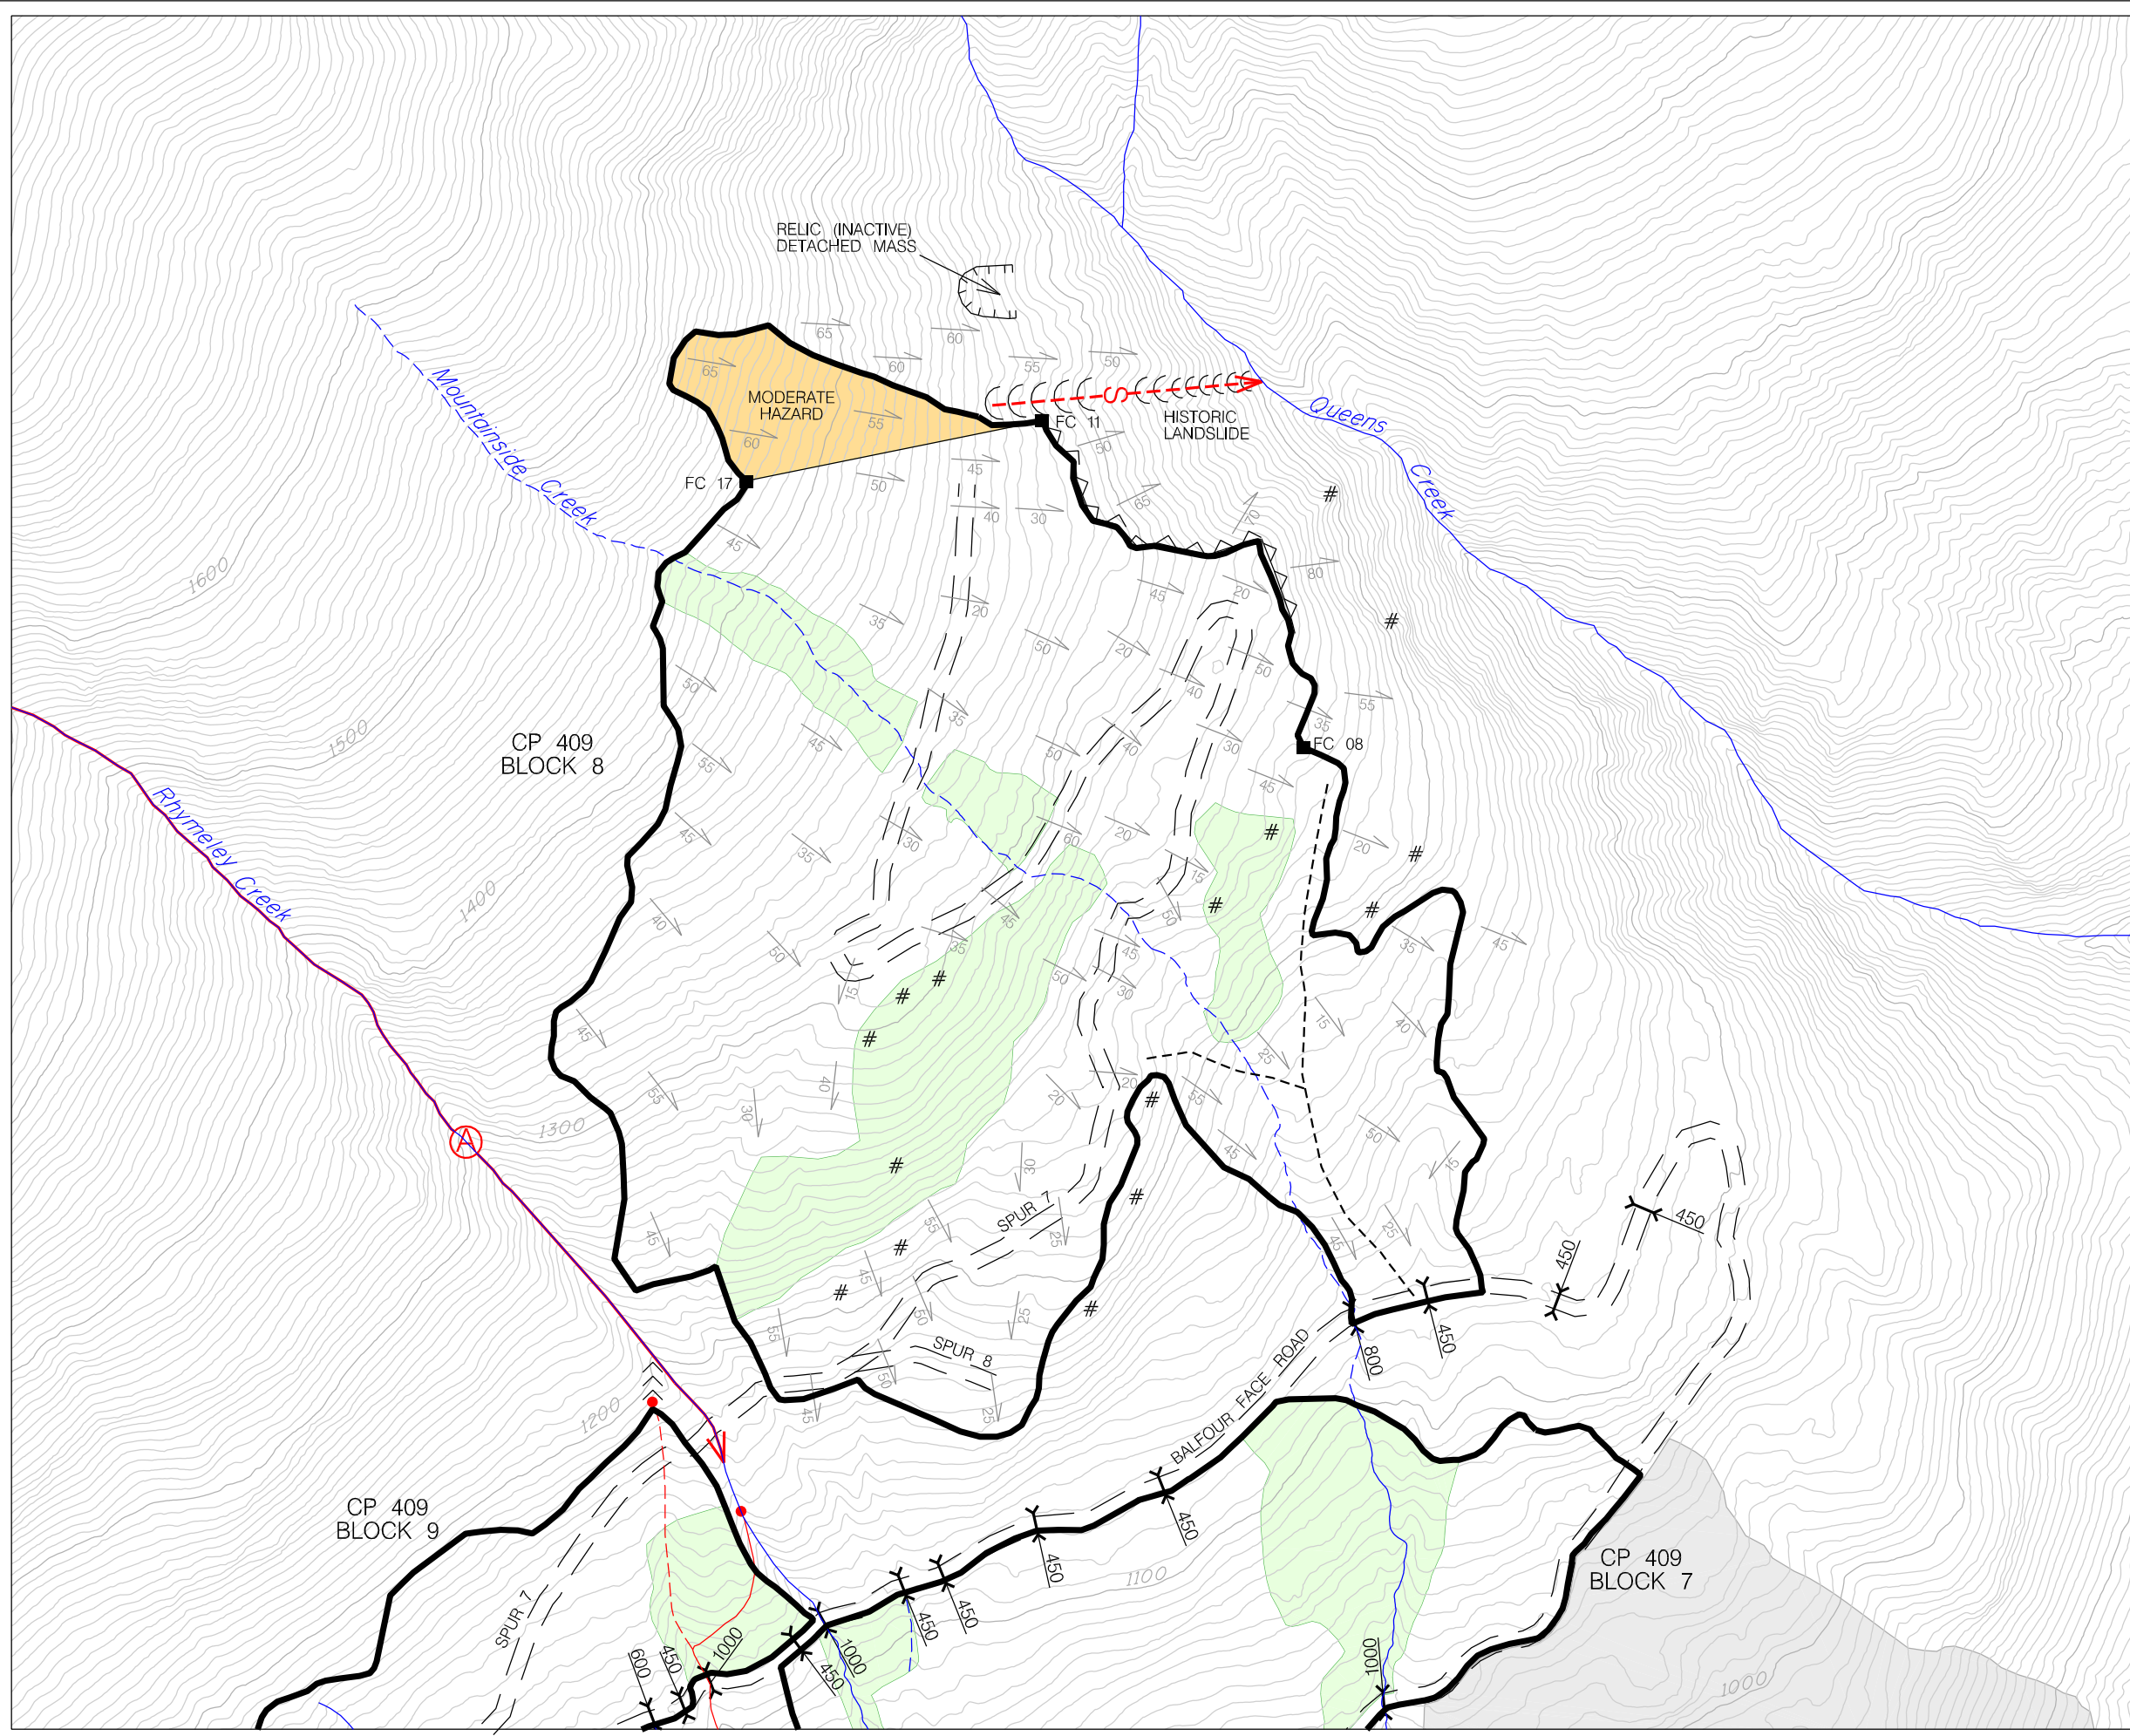
FL: A30171	MAP REF: 82F066
DISTRICT: SELKIRK	PROJECT: 18006-002
DATE: FEBRUARY 2019	
DRAWN: TRIPWIRE	
CHECKED: CP	
SITE PLAN	FIGURE: 4

Block 8 is an elongated and approximate rectangular-shaped harvest area situated on the northwestern side of the Kootenay Lake valley. It encompasses the mid valley slopes and is partially bound by an existing cut block and the existing Balfour Face Road along its southwestern corner and southeastern boundary, respectively. Primary access will be provided by the existing Balfour Face Road and recently constructed Spur 7 and Spur 8 alignments.

According to previous terrain mapping, the majority of the block is rated as TSC IV with a small inclusion along the central-northeastern boundary rated as TSC V. The remainder of the block is rated TSC I and III. At the request of PWP, a geotechnical assessment was completed for the entire block. It is understood the proposed cut block will be harvested as a clear cut with reserves, while utilizing both ground-based and cable-based harvesting equipment. A site plan of Block 8 is shown in Figure 4.

Block 8 is characterized by variable terrain. The lower (southeastern) approximate two-thirds is irregular and broken that is predominantly governed by the near surface, underlying bedrock. By comparison, the upper (northwestern) remainder is more uniform with slight irregularities. Slopes throughout the block typically range from 20% to 45% with limited steeper slopes measuring up to 60%.

Soils consist predominantly of well-drained, mantled deposits of sandy silt till and lesser accumulations of silty rubbly residual soils derived from the underlying bedrock weathering in-situ. Discontinuous, overlying deposits of glaciofluvial silty sand and gravel were identified within the northeastern area of the block. Infrequent exposures of igneous bedrock were encountered, typically in association with steeper slopes.

Overall, site conditions throughout Block 8 are considered primarily dry. Mountainside Creek is a seasonal watercourse that bisects the block along a variably-incised drainage feature. Localized moist sites were identified in close proximity to Mountainside Creek and within the northern corner of the block, which transitions to moist site conditions approximately 40 m south of Falling Corner (FC) 11.

The northeastern boundary discontinuously extends along a distinct, convex slope break, between FCs 08 and 11, that defines the Queens Creek gully. Slopes are relatively uniform below this boundary section, typically measuring 60% to 110%. Soils consist of well-drained, shallow accumulations of sandy silty rubbly colluvium and lesser residual deposits of sandy silt till amongst occasional exposures of igneous bedrock.

Slopes are less steep below the northern corner of Block 8 (north of FC 11), measuring 50% to 65% with evidence of historic slope instability and wetter site conditions. The headwall of an historic landslide was encountered immediately north of FC 11 and below the proposed harvest boundary. The dimensions of initiation zone measured 12 m wide, 25 m long and 2 m deep (on average). Evidence of seasonal groundwater emergence was observed within the head scarp region, which is presumed to be a primary contributing factor of slope instability. The age of the failure is estimated to be 100 to 150 years old, and may correlate with the most recent wildfire activity to affect the area.

A relic (inactive) detached mass was identified approximately 150 m below the northern limit of the block, across the lower sidewall of the Queens Creek gully. The dimensions of the initiation zone measured 40 m wide, 40 m long and more than 4 m deep. Slopes adjacent to the initiation zone measured 55% to 60%. The detached mass appears to have traveled 40 m to 50 m (slope distance) and terminated approximately 50 m above Queens Creek. Slopes below the residual deposition mass measured 90% to 110%. Site conditions are considered moist, although no indication of seasonal groundwater emergence was observed at the time of the field review. The relic feature predates the existing stand of timber and is presumed to have occurred several hundred or thousands of years ago. The cause of instability was not conclusively determined.

No evidence of recent slope instability was identified within the proposed harvest area or the immediate adjacent terrain during the field review.

Based on the results of the assessment, the northern corner of Block 8 is rated as **Moderate**. Due to the presence of moist site conditions and historic, seepage-induced mass wasting immediately below the proposed harvest area, timber harvesting will increase seasonal groundwater levels and increase the likelihood of further slope instability. The potentially hazardous area of Block 8 measures approximately 4.4 hectares (ha) in size and is defined as the area north of a linear line connecting Falling Corners 11 and 17, as illustrated on Figure 4. The hazard rating for this area of the block and the potential downslope / downstream effects were conveyed to Mr. Mike Kit (pers. comm., September 17, 2018).

A landslide originating within or below the northern area of Block 8 would directly impact Queens Creek and expected to initiate a debris torrent along the creek channel. According to LiDAR-derived contour mapping and field observations, channel gradients along Queens Creek (downslope of the northern area

of Block 8) measure an average of 35% for approximately 1,950 m (stream length) to Highway 31. VanDine (1996)² concluded that transportation and erosion of channelized debris torrent occurs on slopes greater than 27% (15°), and deposition of material typically occurs once the gradient decreases below 18% (10°). Channel gradients along Queens Creek are considerably greater than the documented transportation and deposition angles for debris torrents and debris flows.

Potential resources at risk from a debris torrent include multiple licensed water intakes, Highway 31, and a private, residential building on the Queens Creek alluvial fan, immediately below the highway. The spatial effect of a debris torrent along Queens Creek on each of the aforementioned resources is High.

Using the partial risk matrix in Appendix A (Table 3), the resultant partial risk associated with timber harvesting the northern area of Block 8 is rated as High.

The northern, 4.4 ha area of Block 8 has been identified as having a Moderate likelihood of post-harvest landslide initiation. The proposed harvest area should be amended to exclude this area of the block.
