Detailed Terrain Stability Field Review

Proposed Harvesting and Road Construction
in the Salisbury Face Area (Blocks 405-1, 2,
4, 5, 6 and 7: Spurs 1-3, 4-1, 4-2, 6-1 and 6-
3)
for
Cooper Creek Cedar Ltd.

W. Halleran P. Geo, L.Eng.

13/02/2020

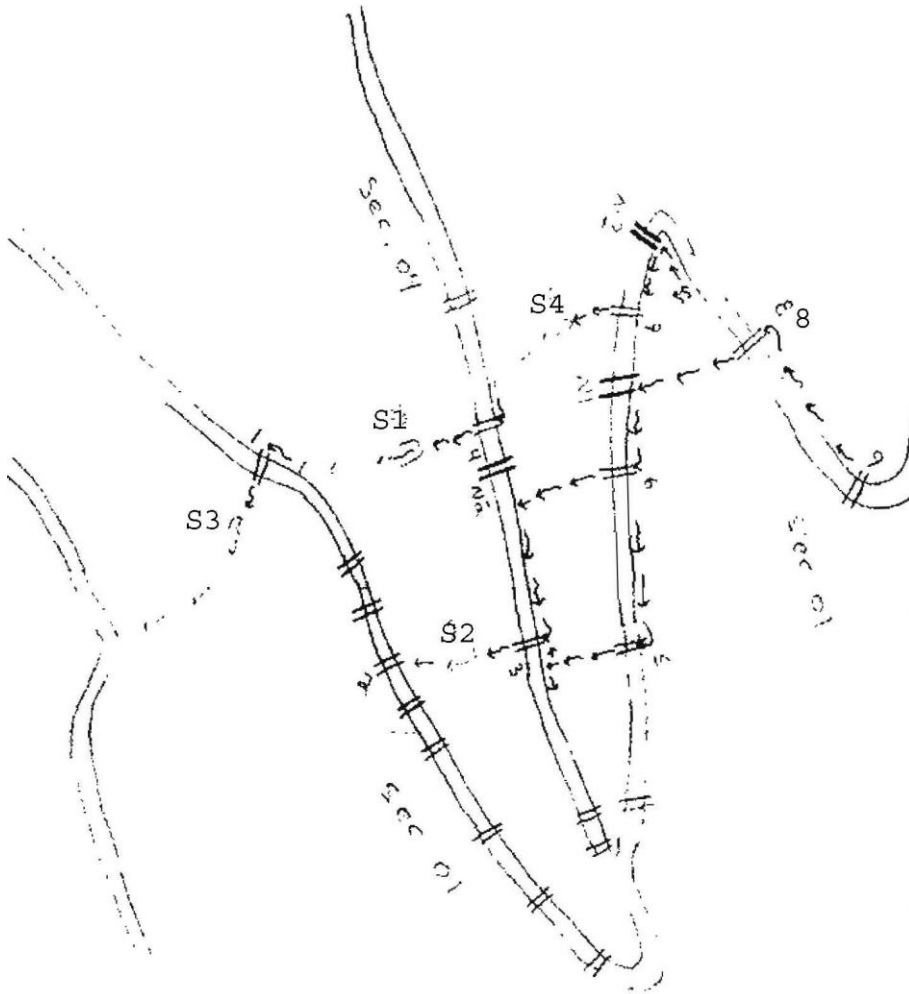
Sketch 1

slides occurred because of the road concentrating the runoff flows from a rain event (with some snowmelt) of May 21st. Mr. Nicol further describes the chain of events that contributed to the four slides and recommended removal of two culverts and the addition of culverts to reduce the volume of water flowing to slide scarps. Mr. Nicol commented that the rain event did not appear to be extreme and culvert placing was within the norms for FSR's. It is unclear from the report and included sketch, if the recommendations were designed to restore natural drainage and/or reduce the likelihood of additional slides.

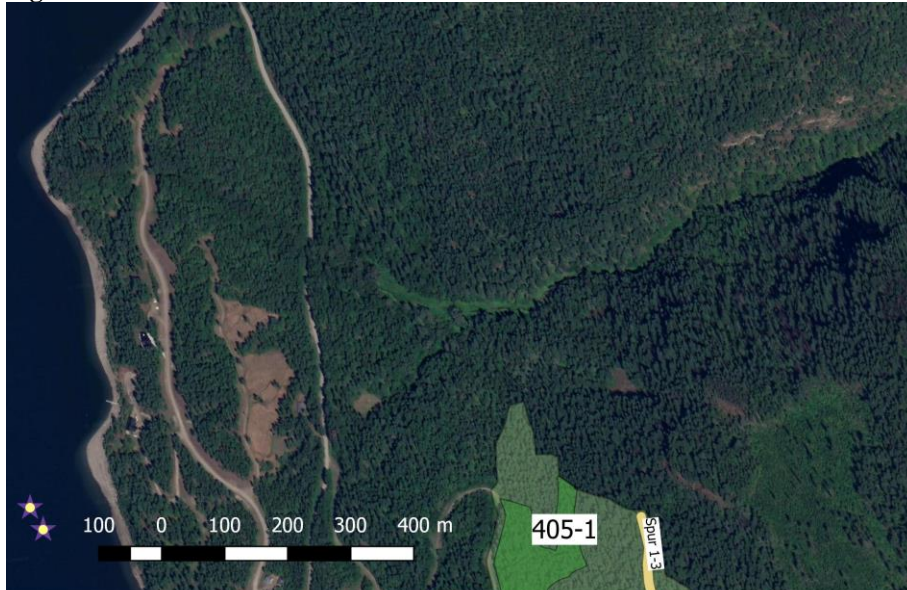
Figure 5

Although the fans were not investigated in the field, disturbed vegetation along Bulmer Creek, visible on google earth imagery, suggests that there has been a recent flood or debris flood in Bulmer Creek that terminated along the upper portions of the paleo fan.

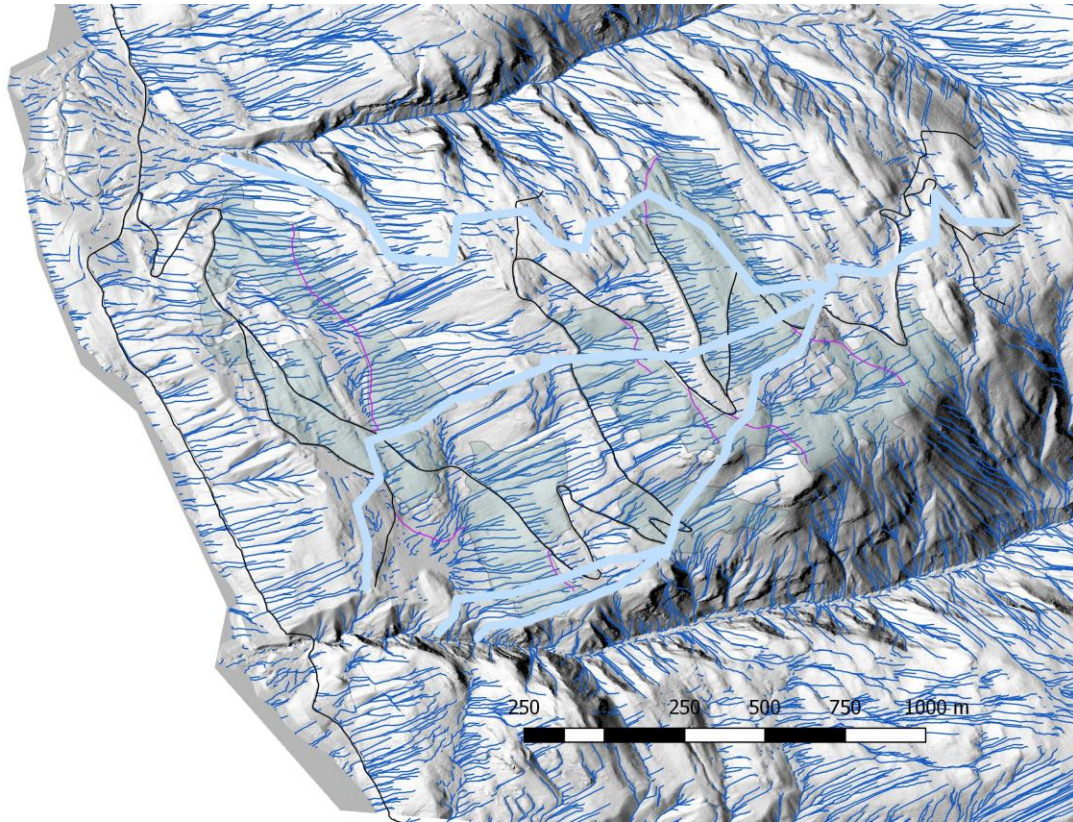
Figure 7

There are possible interception and diversions of slope drainage along the FSR between blocks 6 and 7. The field review of the existing roads failed to locate any other significant diversions or interceptions of slope drainage.

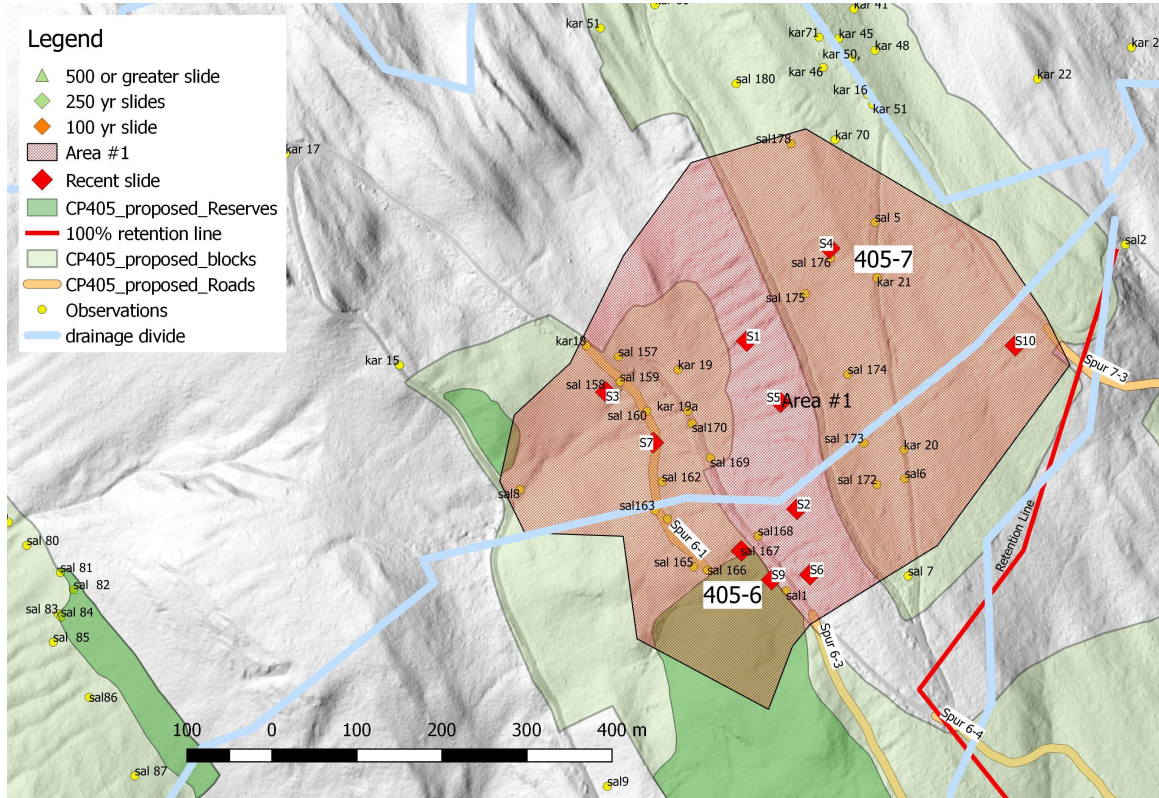
Figure 9

4.4.1 Area #1: As can be seen in the figure 9 (and map at the back of report), blocks 405-6 and 405-7 impinge on Area #1, Spur 6-1 is within the zone. This area is near the top junction of 4 sub-basins, the divides, minor ridges and or shallow flutes are easily breached by the existing roads. There are at least 10 recent debris slides in this area, tabulated in table 4.1 below. All the slides are related to road drainage associated with the stacked road system. This area corresponds to Mr. Well's (2002) High Hazard Zone, which he indicated was sensitive to concentrated road drainage. Slides 1-4 are the slides reviewed by D. Nicol (2002), (these slides are numbered consistent with Nicol's numbering). As recommended by Mr. Nicol's, road drainage was altered by culvert removal and installation of additional culverts. It appears that slides 5-9 correspond with the new road drainage patterns. Slide 10 was not investigated in the field (not noted until after field season) but is indicated by the lidar.

Slides 1-5 occur within older slide features (250 to 500 yr.), are relatively small and runout on the slope or on benches just below the scarps. Slide 6 is a relatively wide slide that includes part of the cutslope of the FSR, this slide appears to have blocked the ditch

directing water onto the fillslope which failed as slide S9. Slide S9 is the largest slide (156m x 10m x 2m), it is just to the south of slide S8 which is 156m x 2m x 2m, both these slides terminate upslope of the FSR. Slide S8 is downslope of a culvert and likely is associated with the same diversion as slide S9.

Although there is a low hazard, there is a very high likelihood of landslides. Construction of Spur 6-1 will likely result in additional slides, it is recommended that Spur 6-1 not be constructed as proposed. Spur 6-1 can be constructed as a forwarding trail and recontoured within 1 year.

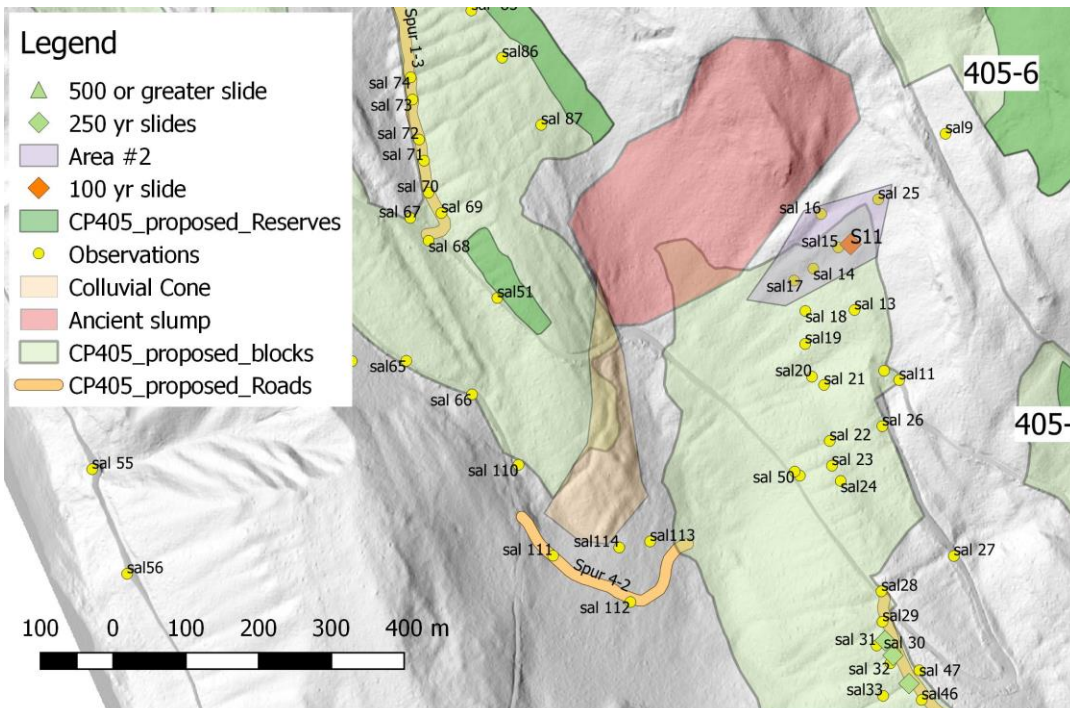
Figure 10

4.4.2 Area #2: This area encompasses a 100-year-old slide (S11), likely triggered after the last large forest fire in the area (figure #10). Just to the north is a large ancient failed slump and associated “colluvial cone”.

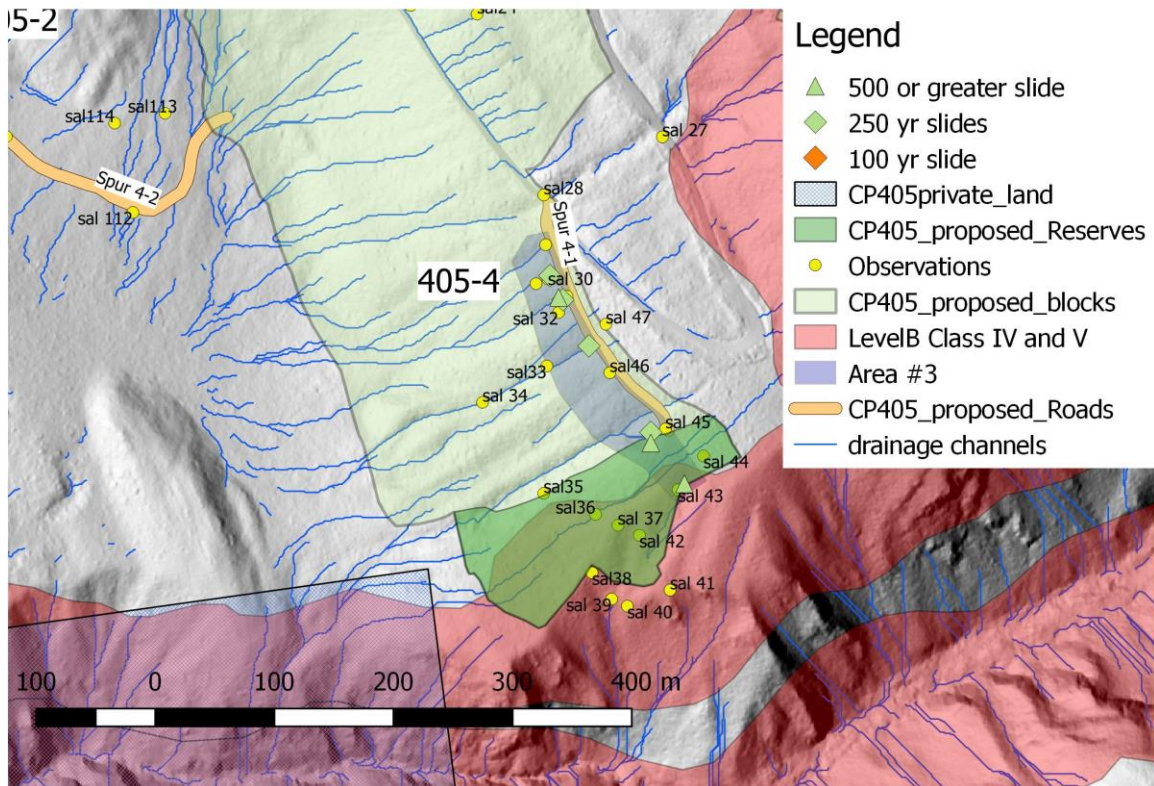
Figure 11

4.4.3 Area #3: Area #3 (figure #11) is within proposed block 405-4 and partially along Spur 4-1. The delineated area encloses the initiation zone of the slides. The crown of the slides are on ~ 40/60% slope break developed in slightly dense silty sandy gravel. The slide at station sal 43 is ancient and terminates at small rock bluffs downslope. There has been some timber harvesting through the debris slide swales as indicated by old cut stumps (30 yrs.?). It is possible that some of the logs were skidded up or down the swales causing soil disturbance. The deposition zone of the slides is along the lower slope and on the bench below the proposed block.

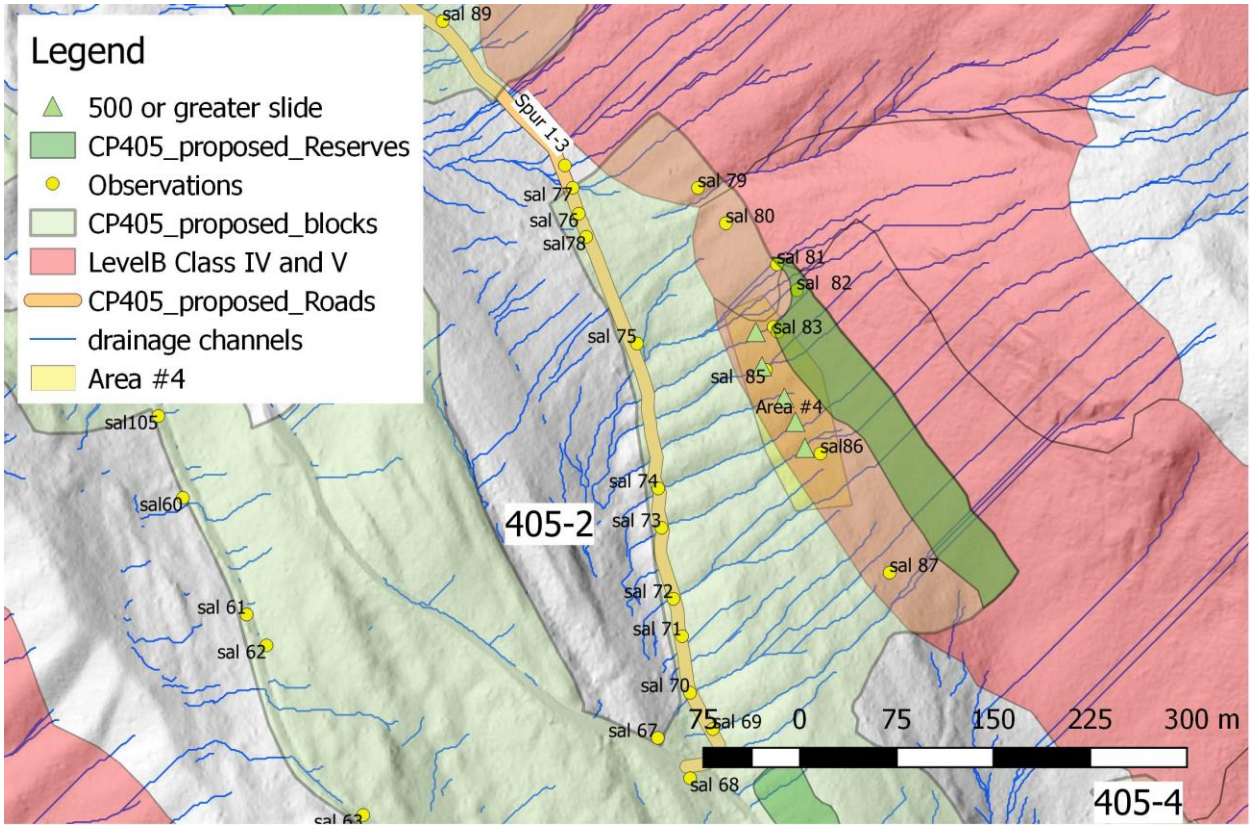
Figure 12

4.4.4 Area #4: Between stations sal 85 and sal86 there are a series of headscarp zone of swales all filled with rubble, the swales mostly in silty sandy angular to sub angular gravel. The crown/headscarps on a small bench (35 to 45% gradient) between steep rocky slopes with angular colluvium (upslope) and a moderately steep swaled slope underlain by sandy silty angular to sub angular gravel (downslope). It is likely that these features are ancient (>500 yrs), forming soon after deglaciation, under a much wetter condition. The slope gradient isn't steep enough to initiate a slide under current conditions.

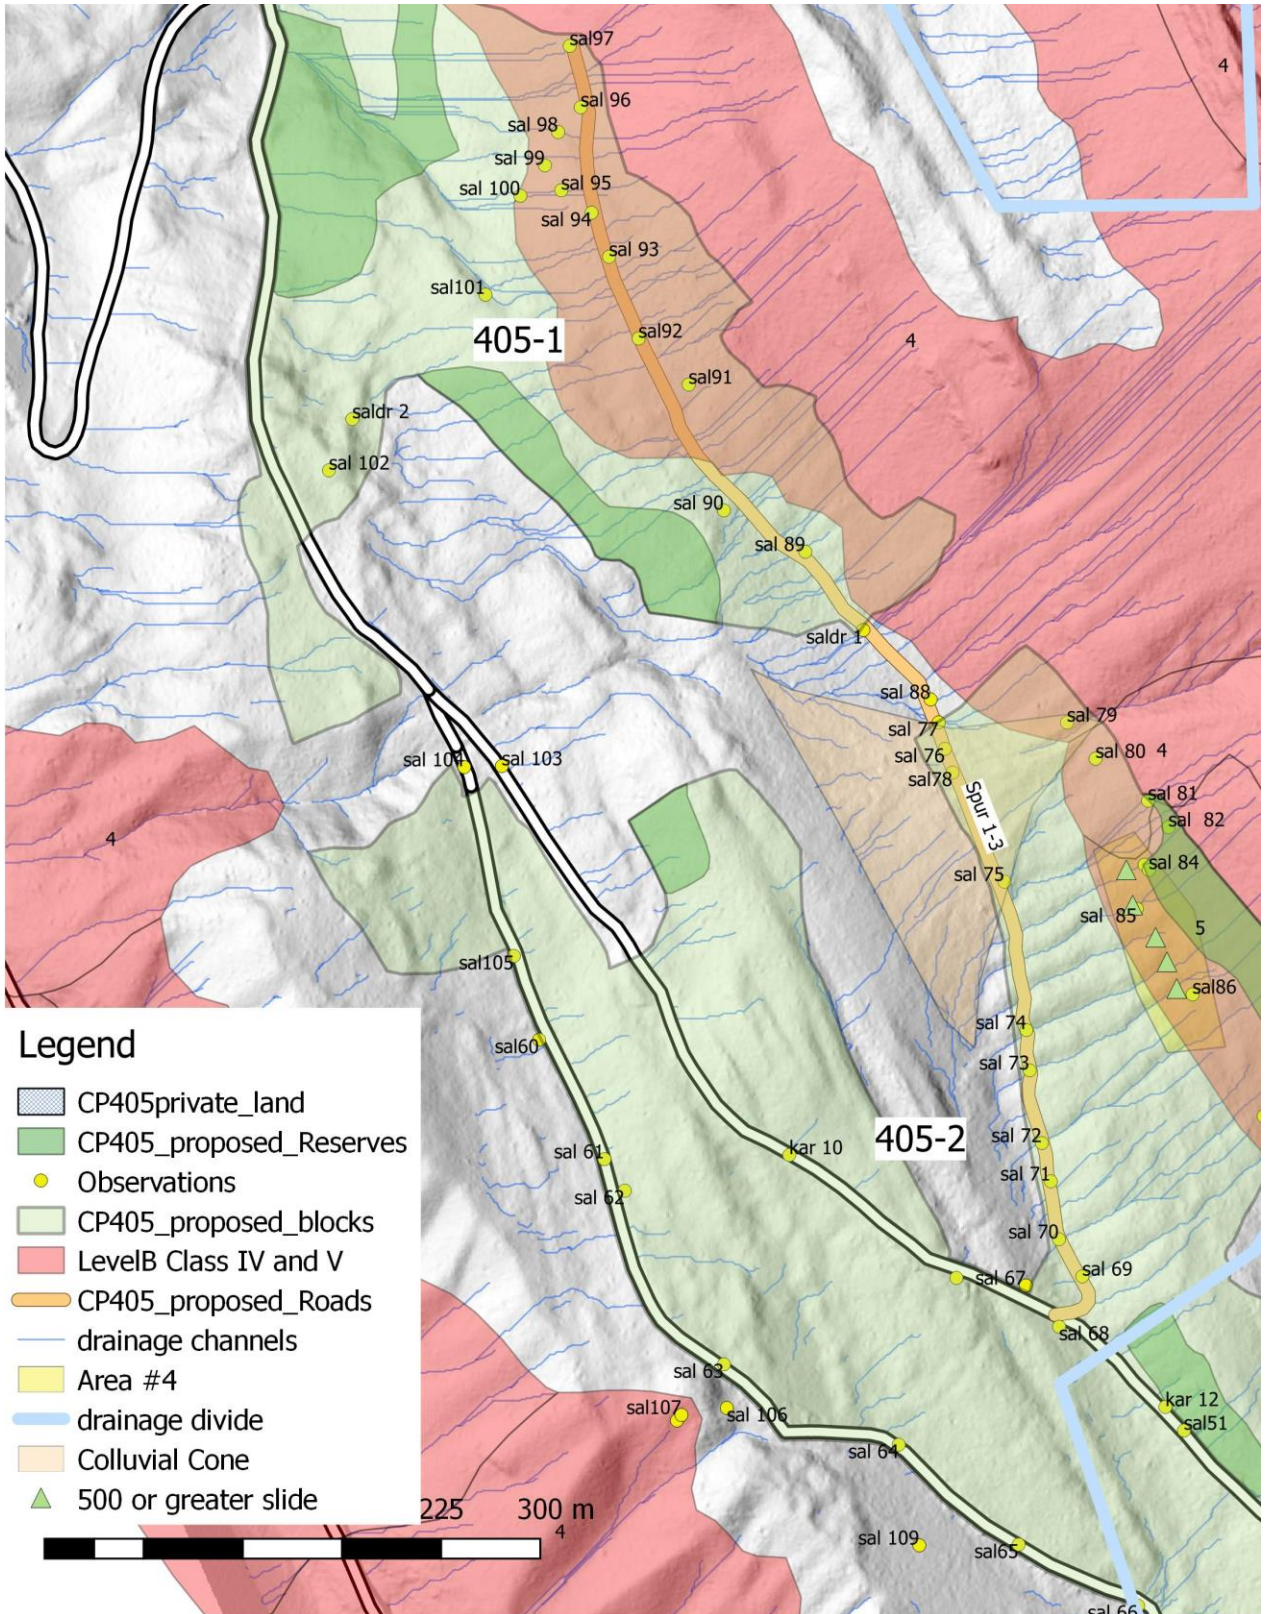
Figure 13

From sal 95 to the end of the road at sal 97 (110m) the road is on or just above 80% gradient slope underlain by coarse blocky sandy rubble. At sal 96 the road is just upslope of a 90% gradient headscarp of a swale.

Proposed additional culverts are tabulated below. The last ~ 100 meters of the proposed road is on steep terrain. Construction recommendations for ~ last 100 meters of the road are:

1. For a permanent road, construct the pilot trail below grade, use the pilot trail to support a portion of the fillslope. The fillslope of placed blocky schist keyed into the pilot trail can be 1:1, the cut slope in rock can be 0.5:1, in colluvium it should not exceed 1:1.
2. For a temporary road, leave high stumps on the fill side, place large woody debris in the fill to span the stumps. Reclaim within 5 years.
3. Construct as a forwarding trail, reclaim after harvesting.

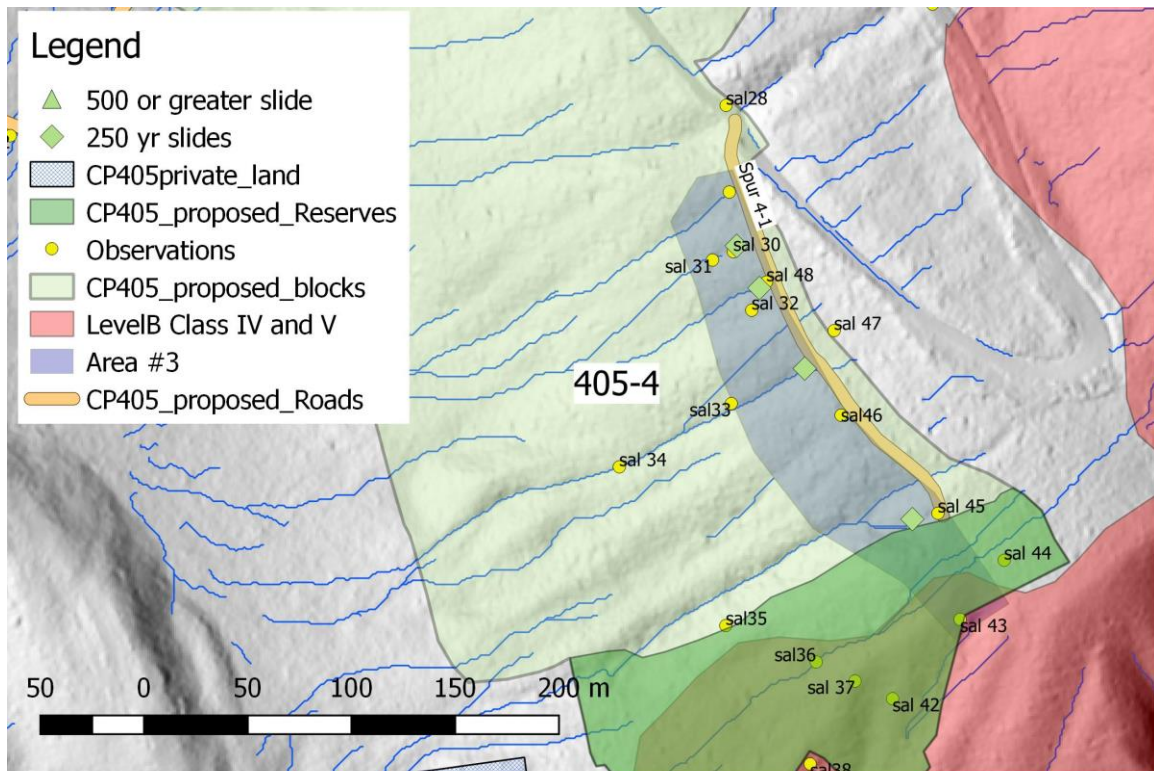
Figure 14

This spur is positioned to access the upper southern portion of block 405-4 (Figure #14), the spur is just upslope of and slightly impinges on Area #3 (section 4.4.3). Debris slides (250 yrs.) initiate on the slope below the proposed road. The proposed road is predominately on ~45% gradient slope underlain by slightly cohesive silty gravel (GW), just set back from -55 to 65% slope. The proposed culverts are located at natural drainage locations. The road terminates just past a “stream” swale upslope of an old scarp. At sal 48 (just north of rd. sta. 50) the proposed road crosses the upper scarp of a swale (likely a wet area), 3 pink flags were hung to mark a suggested culvert location.

Spur4-1 is positioned to access the upper southern portion of block 405-4, the spur is just upslope of and slightly impinges on some historic instability (Area #3). If the recommendations to build the spur as a 5-year temporary road are implemented, construction of the road will not significantly increase the low likelihood of landslide initiation. An additional culvert is proposed just north of road station 5.

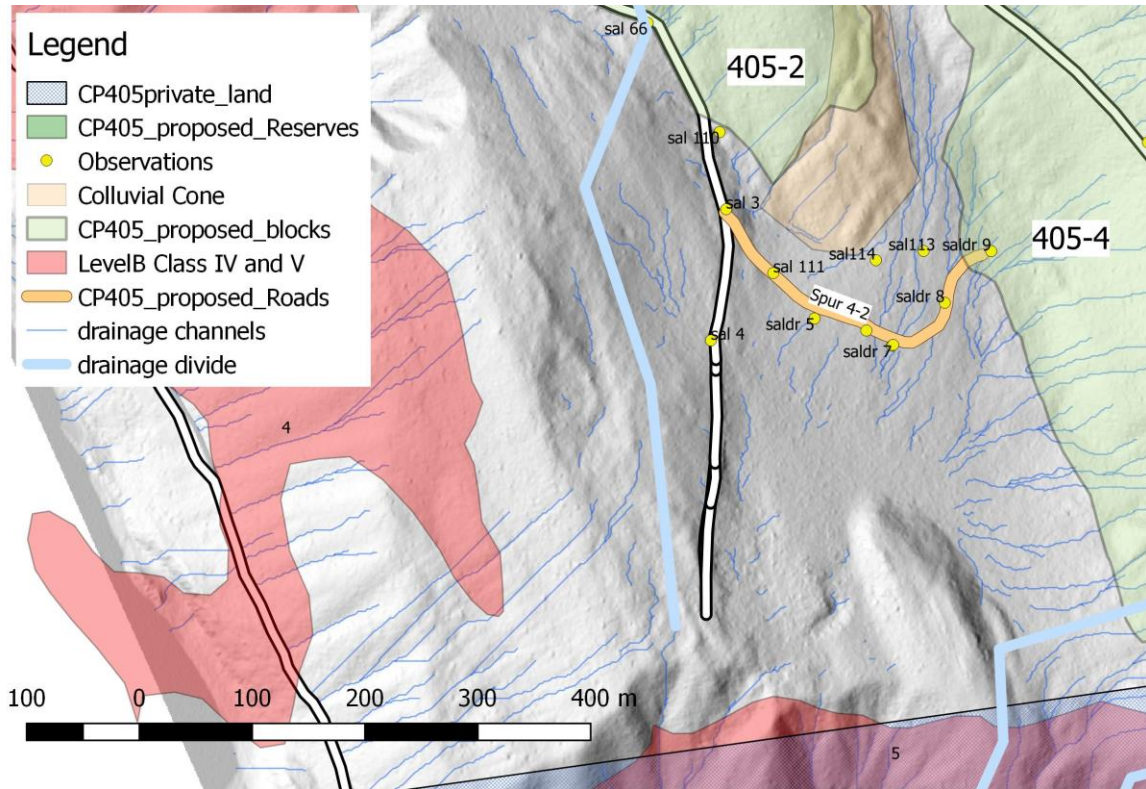
Figure 15

Spur 4-2 is located to access the lower portion of Block 405-4 (Figure #15). The spur crosses an ancient fan just downslope of ancient colluvial cone. Road culverts are well located.

proposed road crossing at sal 111, the “draw” terminates at a broad flat. Although there is no channel a road culvert was marked here. The proposed road continues across an ancient fan, a road culvert is marked at sal 112 (Sta. 10), which is downslope of a shallow swale (sal 113). At saldr 8 the road angles up a swale (old channel).

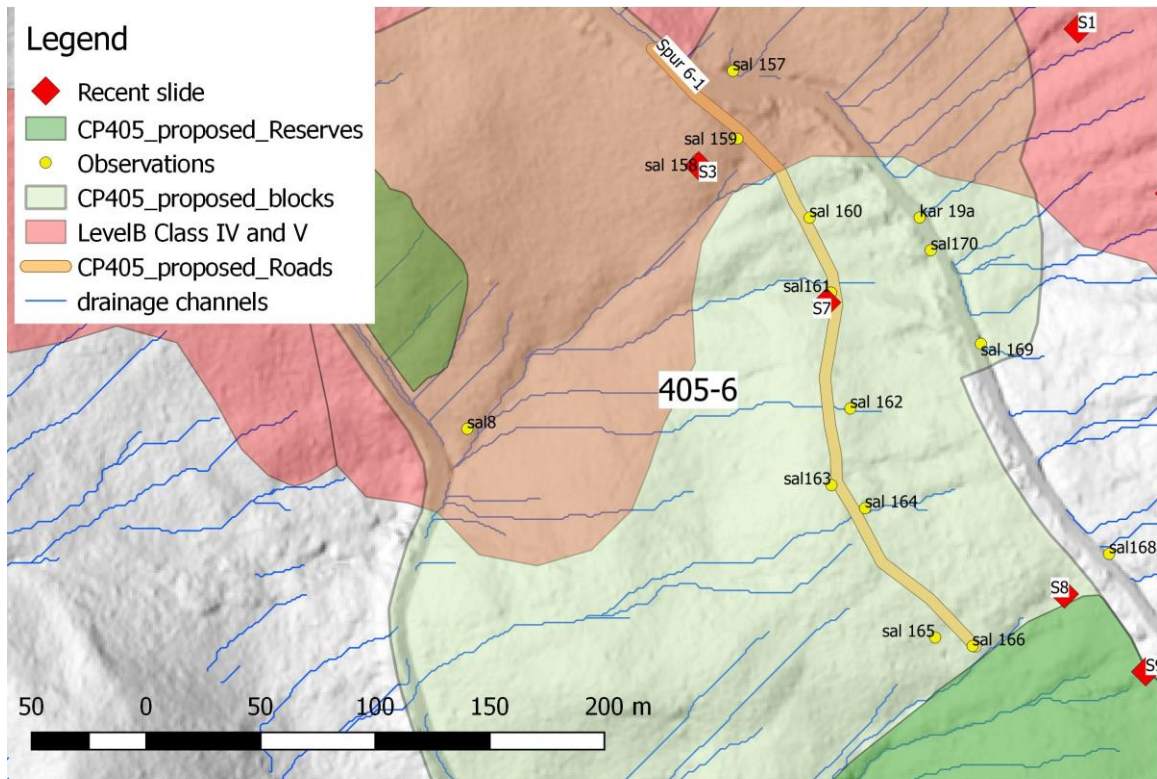
Figure 16

This Spur is within Area #1 (section 4.4.1), directly below the existing FSR (figure #16).

a broad bowl which is likely the head scarp of an ancient failed slump. The soil is a poorly graded silty sandy gravel (50% cf). There is good soil development across the slump scarp. A recent (15yrs) small debris scar (S7) is located within the larger older scarp. The gully downslope is still treed indicating relatively short runoff. The slide scar is 2m wide, 0.25m deep, and 15m long.

A culvert (sal 168) on the existing road discharges onto the headscarps of S8, the culvert at 169 does not currently appear to carry much flow. The culvert at sal 170 discharges onto slide S3.

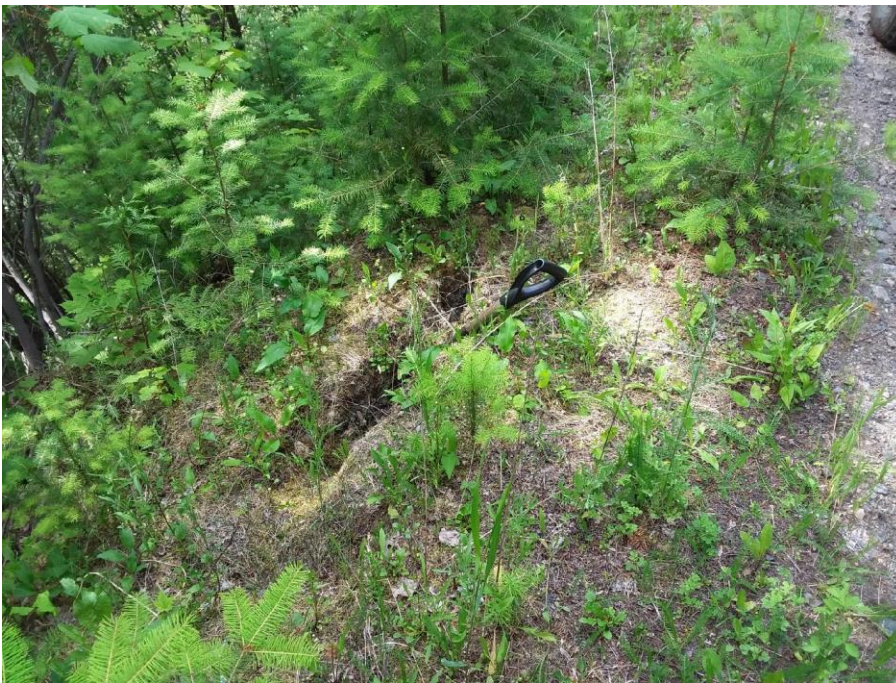
Photo 1

Downslope on the existing FSR (sal 49) the 130% cutslope is excavated into phyllite and silty gravel. The ditch is blocked and there is minor scour down road from here, possibly causing the cracked fill at sal 50 (photo 1). The slope below is -80%, the cutslope is sub vertical rock cut. The next culvert up road gradient is at sal 28 (fed by a culvert at sal 27).

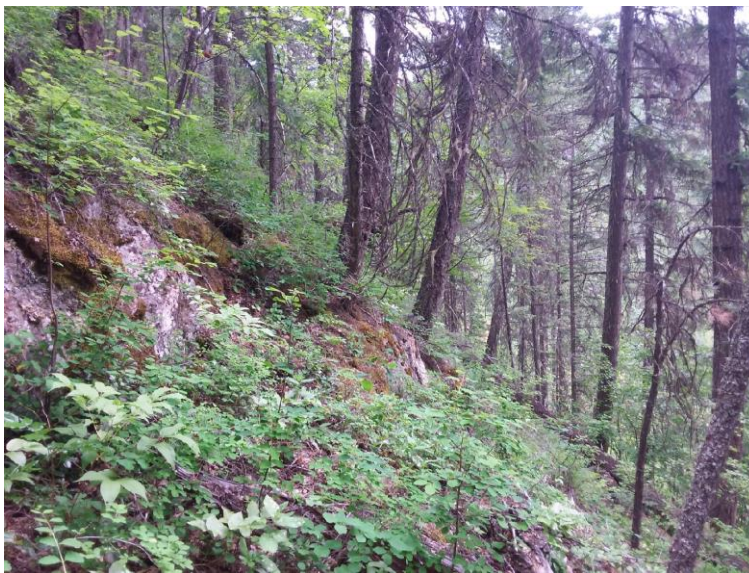
Photo 2

The steep slope to the creek is a series of rock steps (photo 2).
