Detailed Terrain Stability Field Review

Proposed Harvesting and Road Construction
in the Salisbury Face Area (Blocks 405-1, 2,
4, 5, 6 and 7: Spurs 1-3, 4-1, 4-2, 6-1 and 6-
3)
for
Cooper Creek Cedar Ltd.

13/02/2020

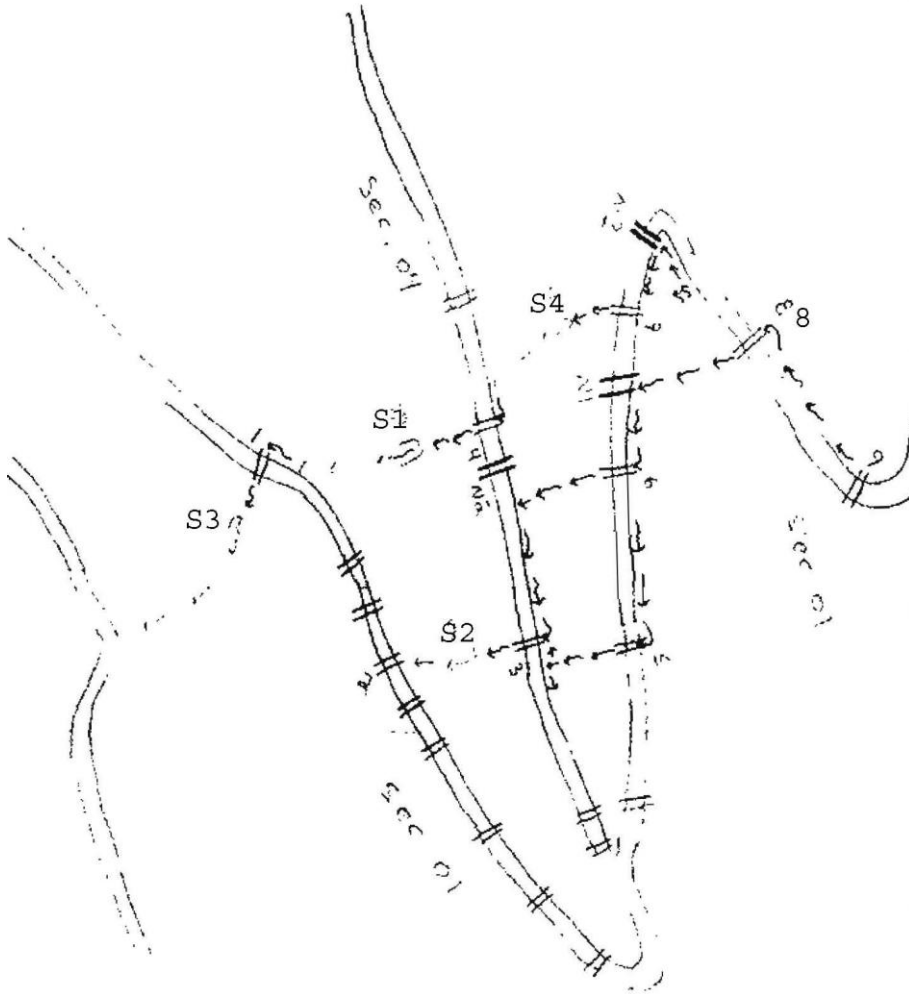
Sketch 1

Salisbury Creek FSR Field Review by Doug Nicol P. Eng: On June 7th, 2002 Doug Nicol and Della Peterson of MoF investigated 4 slides that occurred on May 21st between 6.4 km and 7.5 km on of the Salisbury FSR. Mr. Nicole is of the opinion that two initial drainage diversions were responsible for all the slides. Mr. Nicol concluded that “all the slides occurred because of the road concentrating the runoff flows from a rain event (with some snowmelt) of May 21st. Mr. Nicol further describes the chain of events that contributed to the four slides and recommended removal of two culverts and the addition of culverts to reduce the volume of water flowing to slide scarps. Mr. Nicol commented that the rain event did not appear to be extreme and culvert placing was within the norms for FSR’s. It is unclear from the report and included sketch, if the recommendations were designed to restore natural drainage and/or reduce the likelihood of additional slides.

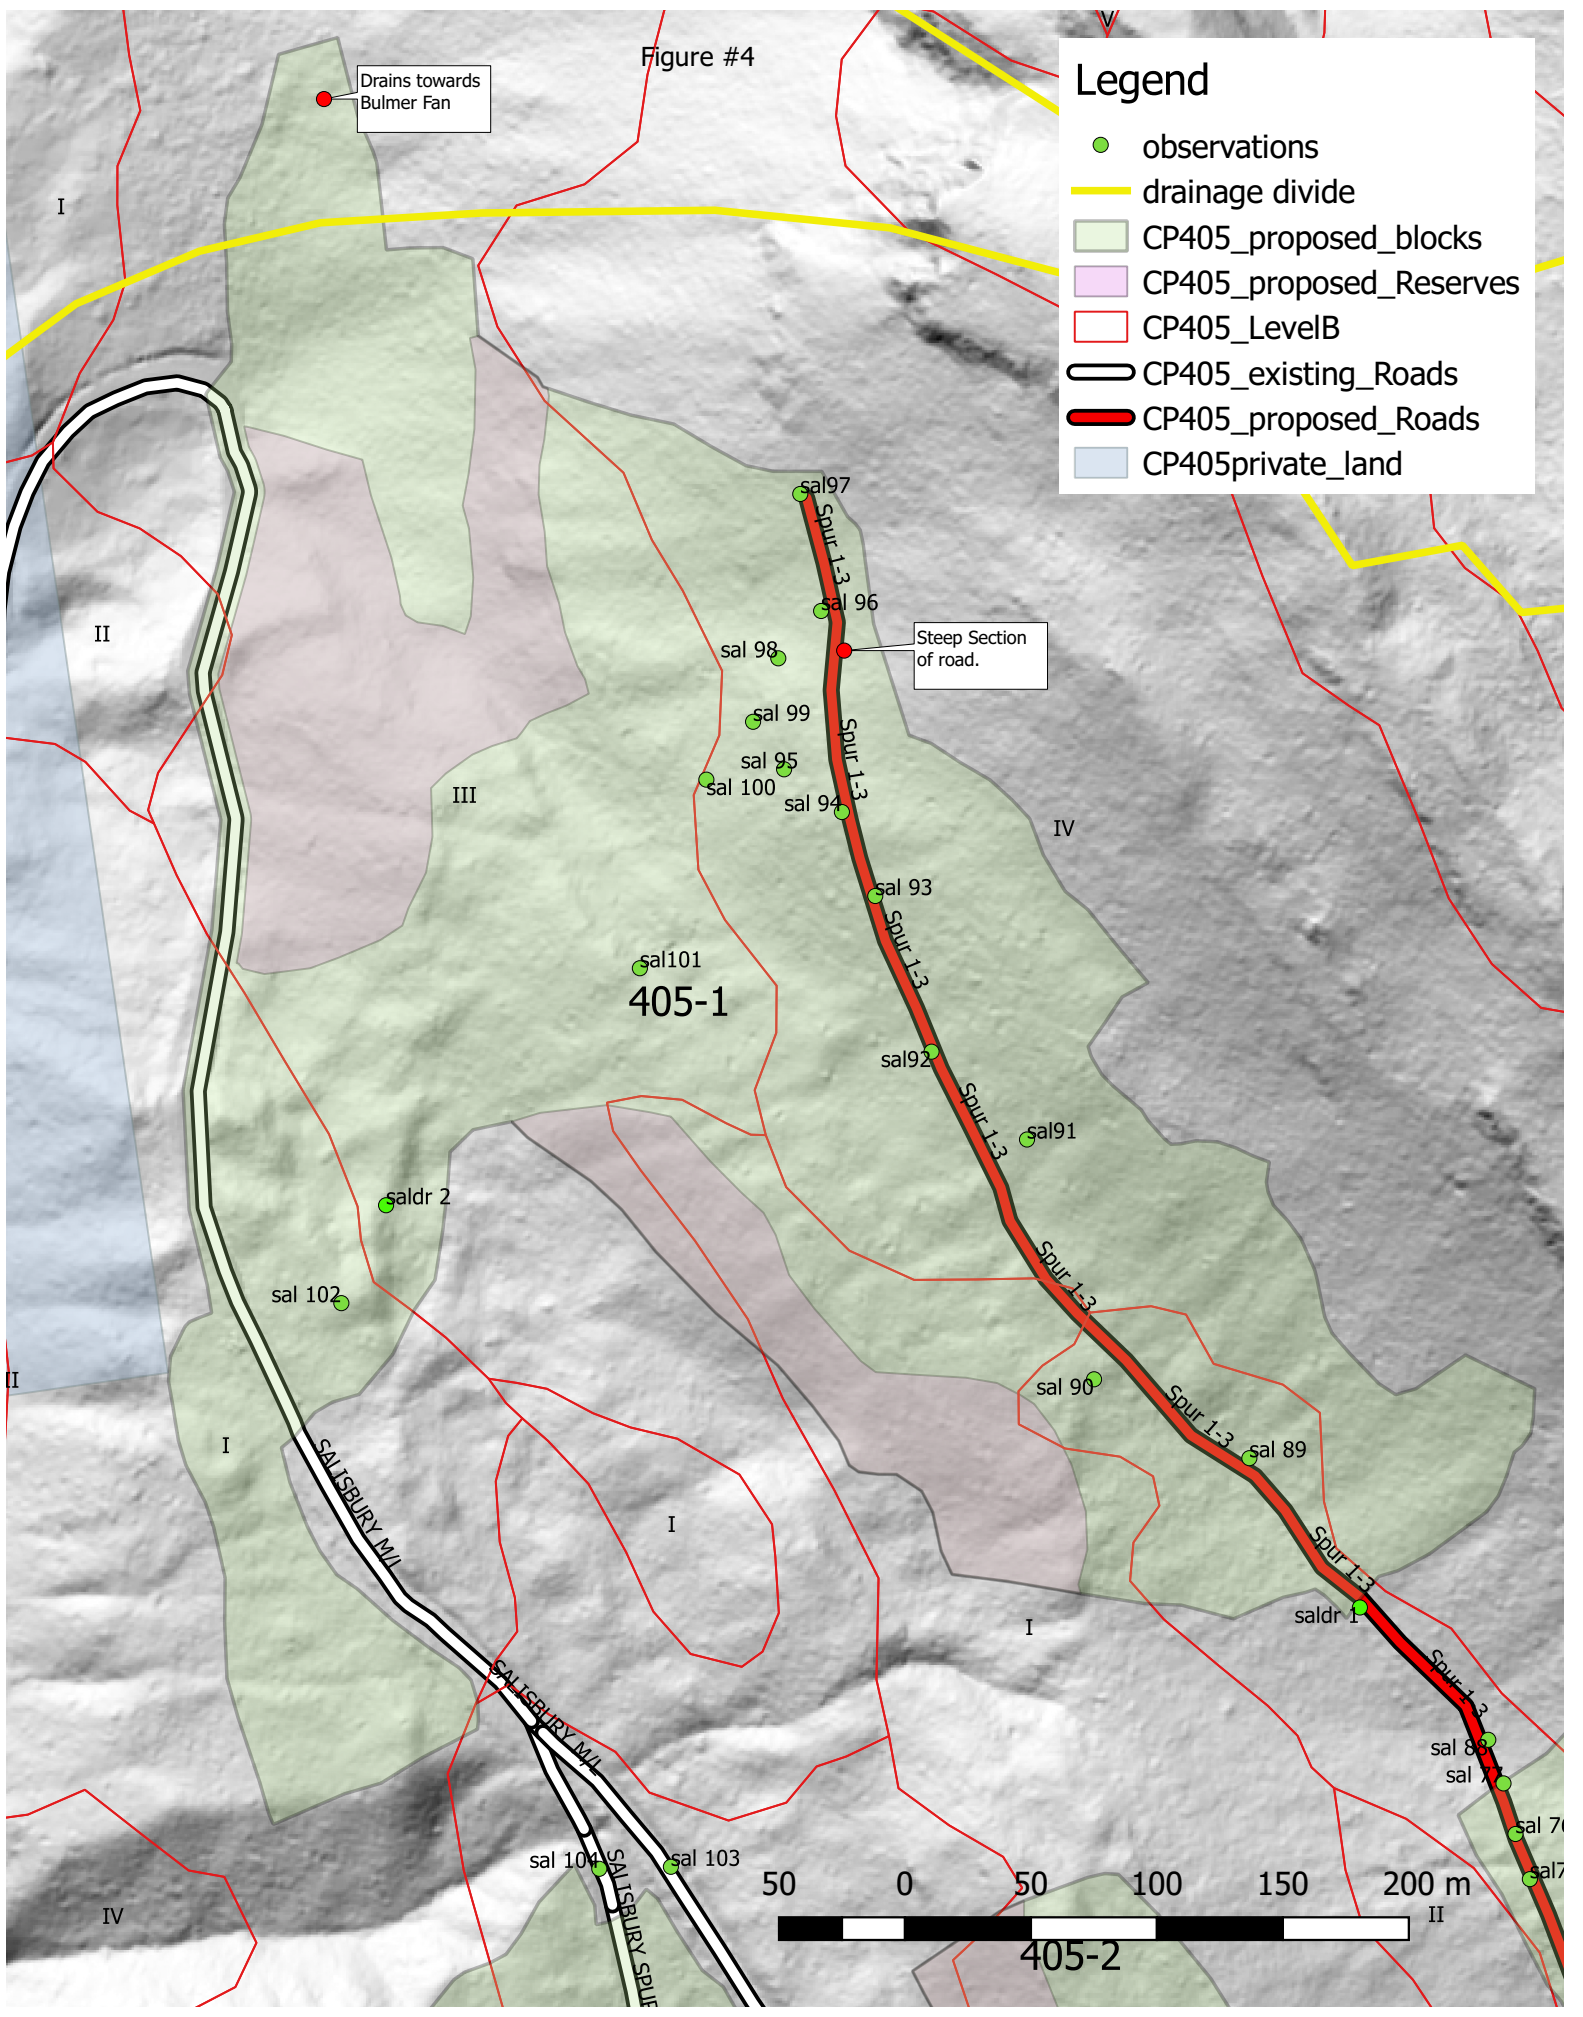
4.5.1 Block 405-1 and the north section of Spur 1-3, Figure #4:

The upper portion of the proposed block is within a Class IV polygon. The Class IV polygon is mostly benched terrain underlain by sandy gravel (sand 25%, rounded to subrounded, loose, well graded coarse fragment 75%) to silty sandy angular gravel. There is a steep step (65% to 100%) underlain by phyllite and quartzite capped with silty rubble that angles down from sal96 to sal101. The slope terminates at a small north west pitching draw. The southwest side of the draw is a ridge of well-rounded sandy gravel (esker?). The lower slopes (sal 102) is underlain by kettled sandy gravel.

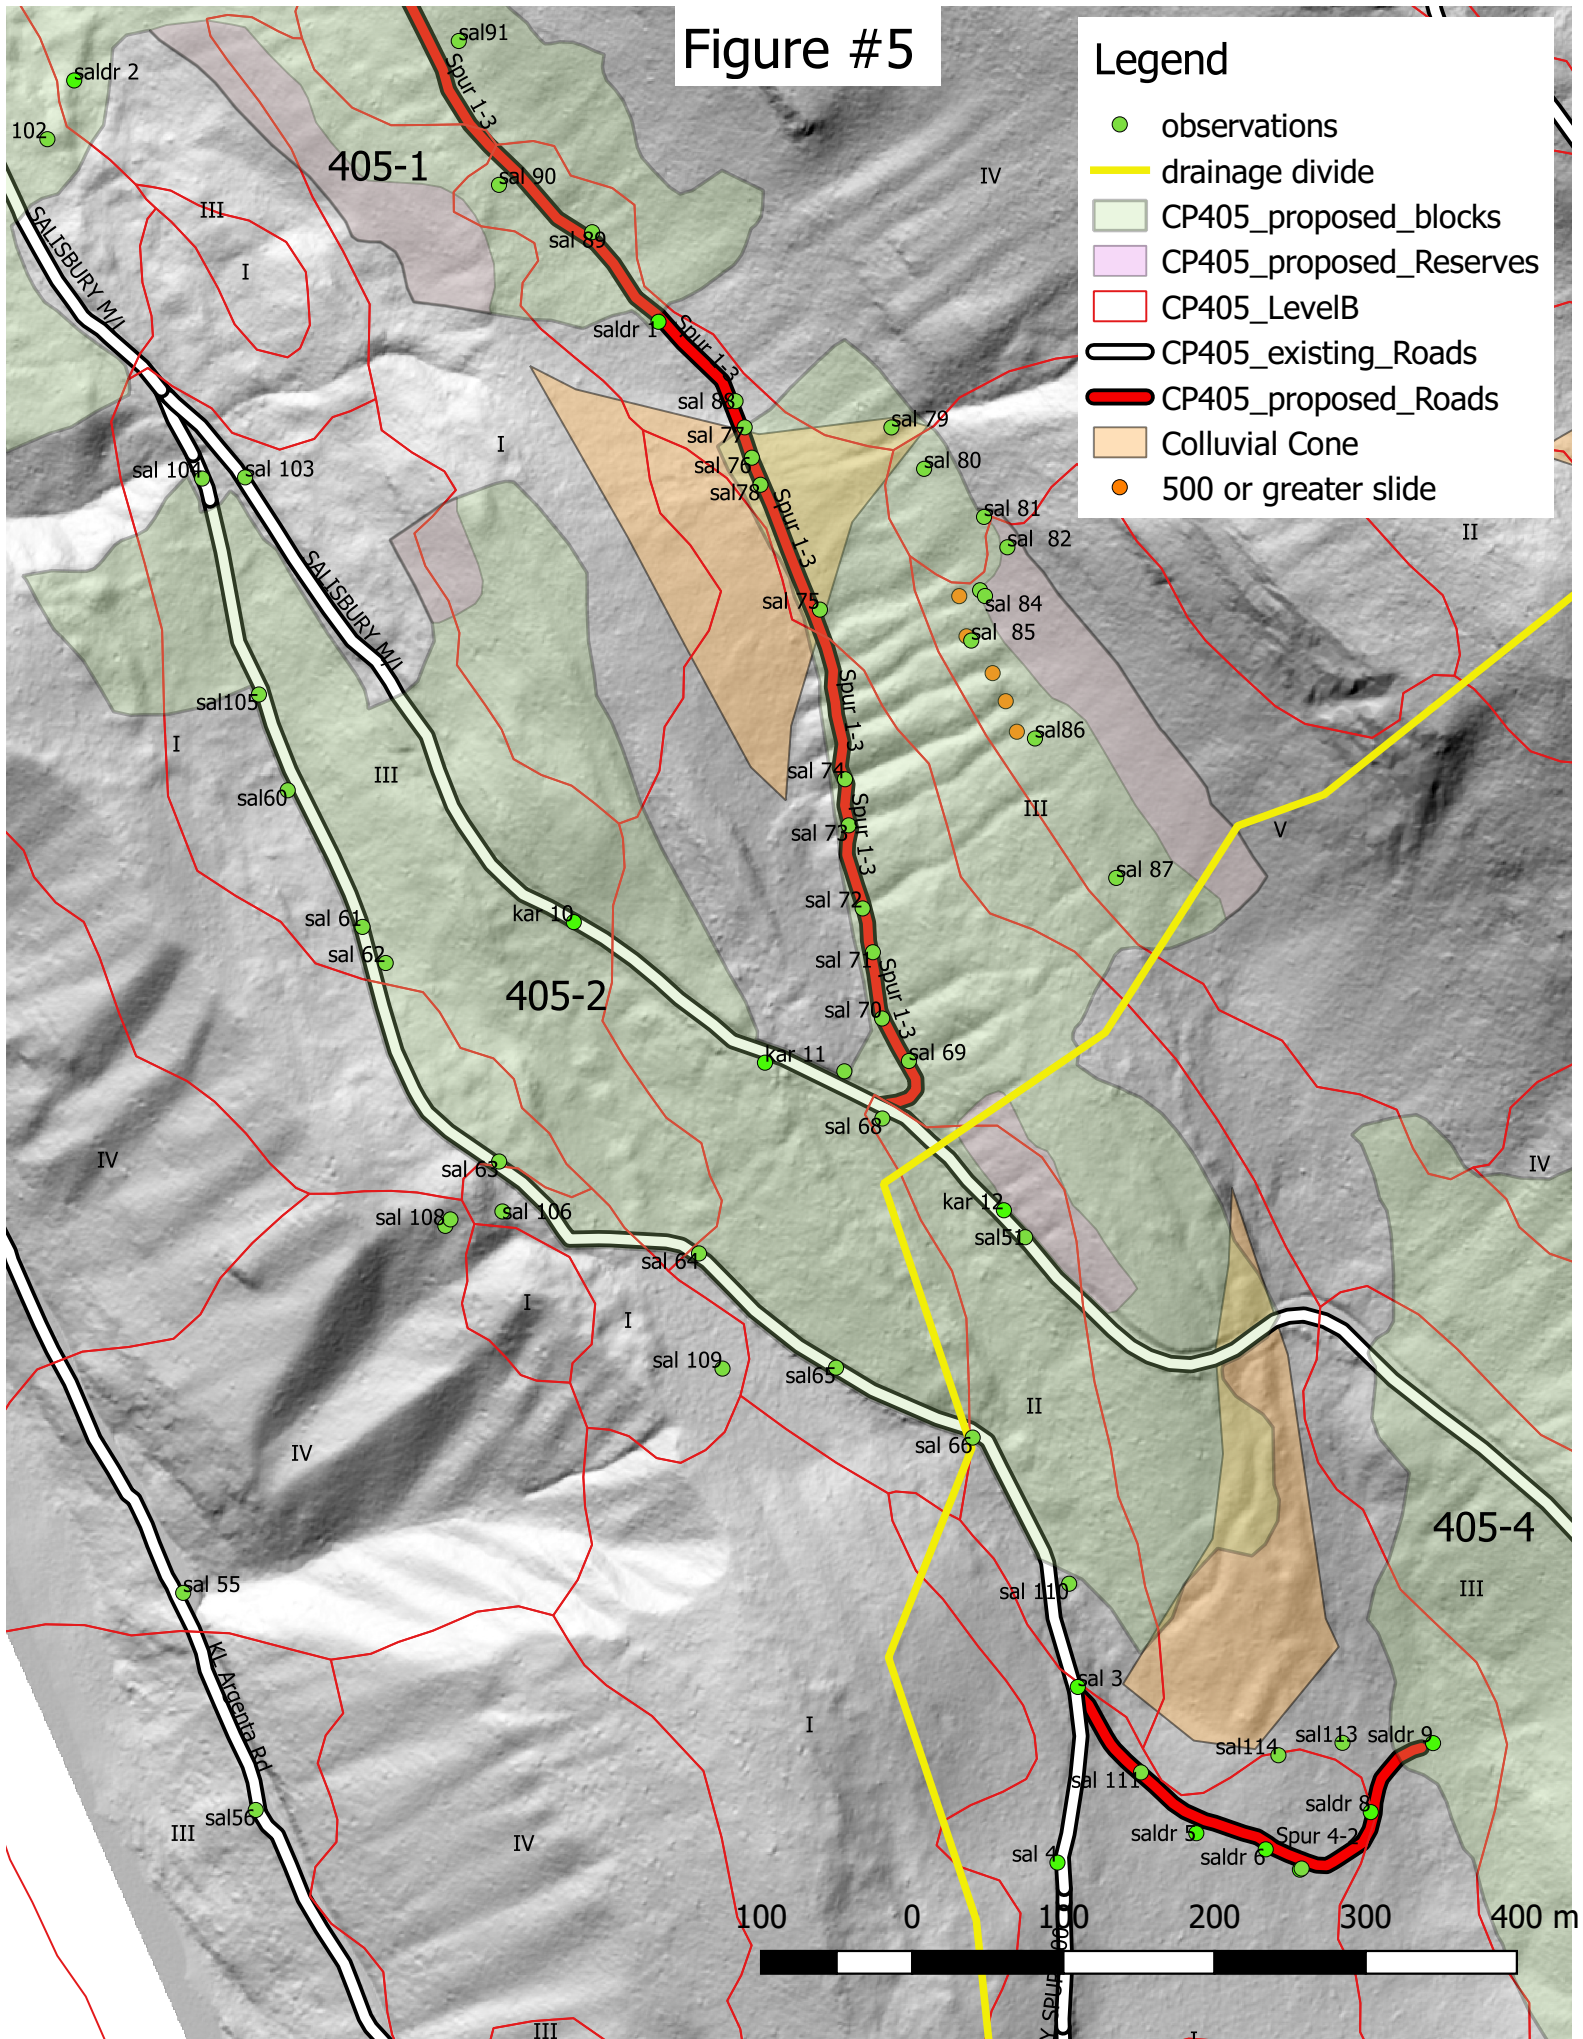
4.5.2 Block 405-2 and south section of Spur 1-3 (Figure #5).

The proposed block is Y shaped with a northeastern, northwestern, and southern lobe. The proposed block is located along the lower slopes mostly on Salisbury Face and a small portion of the southern lobe is partially within a secondary catchment to Salisbury Creek.

Salisbury FSR cuts through the middle of the northwestern and southern portions of the block. North of sal 68, the road is excavated into loose sandy gravel, south of sal 68, the cutslope is predominately in silty gravel with occasional Phyllite exposed in the cut.

Except for the very old slides noted in the northeast portion, there is no evidence of instability within the proposed block.

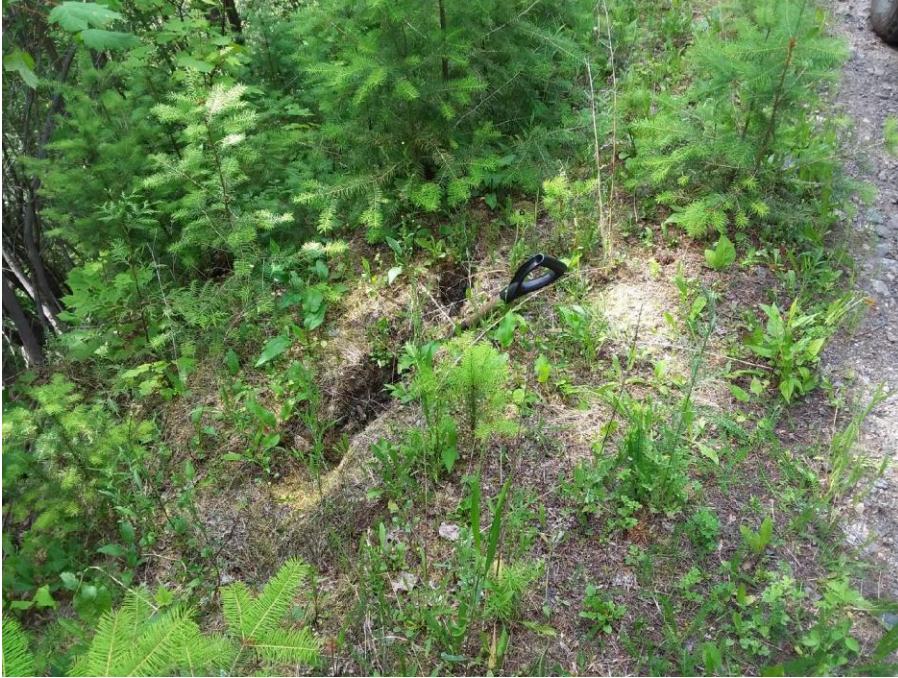
Downslope of the block, on the existing FSR (sal 49), the 130% cutslope is excavated into phyllite and silty gravel. The ditch is blocked and there is minor scour down road from here, possibly causing the cracked fill at sal 50 (photo 1). The slope below is -80%, the cutslope is sub vertical rock cut. The next culvert up road gradient is at sal 28 (fed by a culvert at sal 27).

Photo 1 Fillslope Tension Crack at Sal 50.

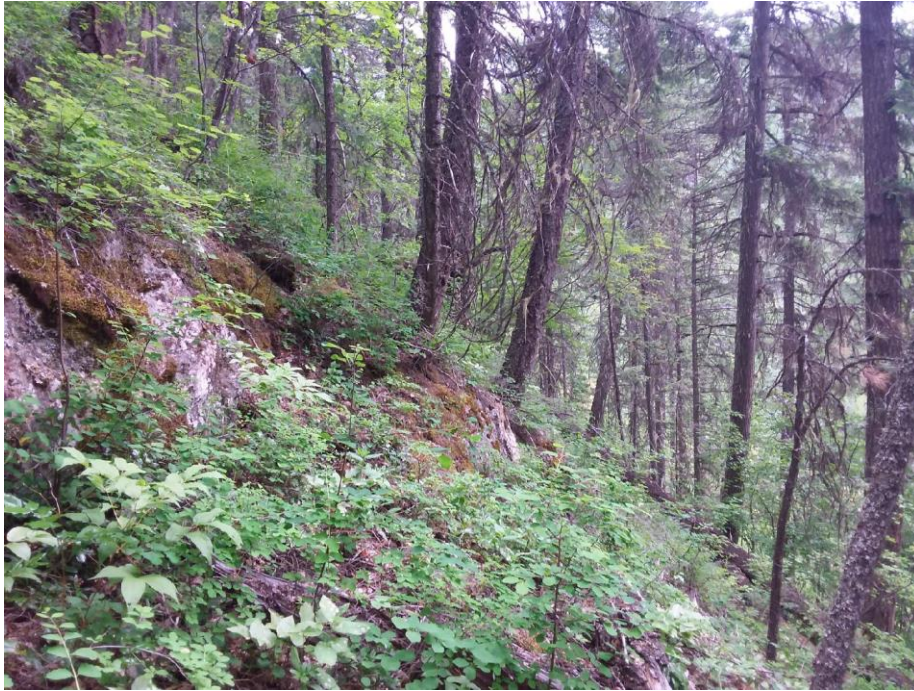
The steep slope (Class V polygon) to the creek is a series of rock steps (photo 2).

Photo 2 Slope to Salisbury Creek.

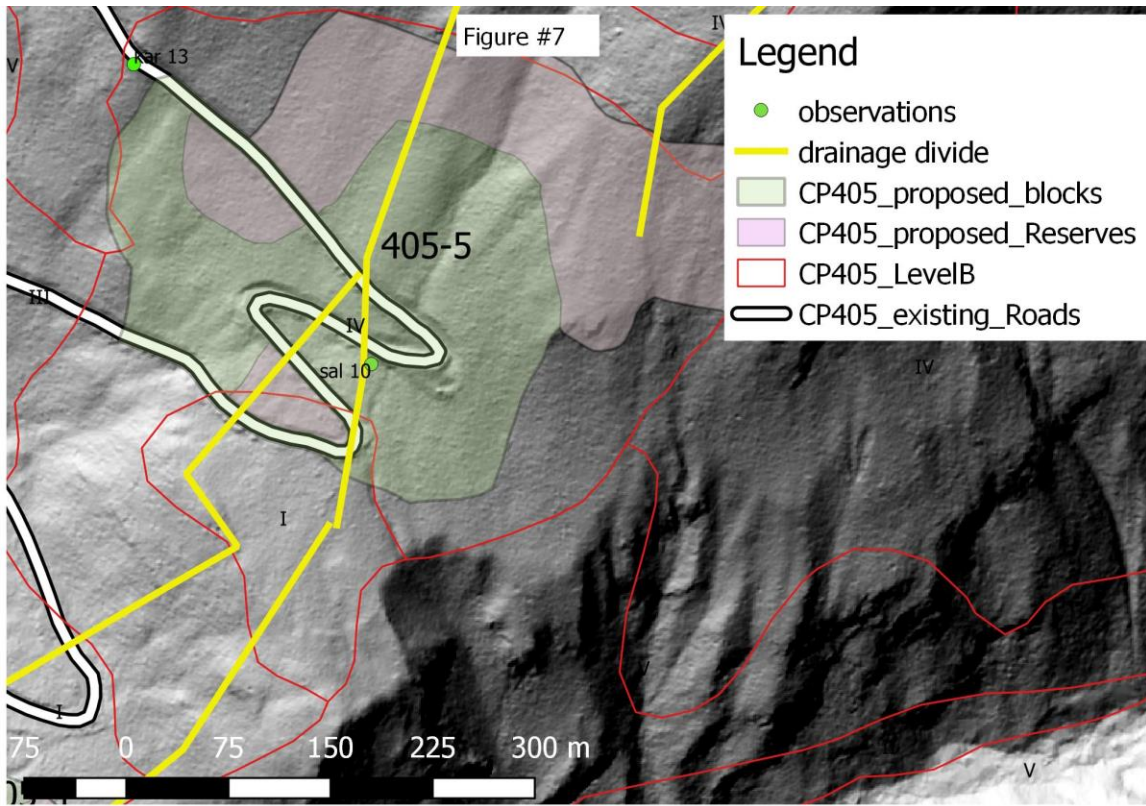
4.5.4 Block 405-5 (Figure #7)

Salisbury Mainline switches up through the proposed block. The block will be cable harvested using the existing road to set up. The block is within a Class IV terrain stability polygon, the slope is underlain by silty sandy gravel with small scattered outcrops of phyllite, quartzite and minor micritic limestone. There is no evidence of instability and no evidence of intercepted slope drainage along the existing road. No trails or bladed structures are planned within the block. The proposed block is upslope of steep rock slopes which delineated by a Class V terrain stability polygon.
