May 29, 2019

Porcupine Wood Products Ltd.
Box 850
Salmo, BC
V0G 1Z0

**RE: TERRAIN STABILITY ASSESSMENT
DECEPTION CREEK, CP 409, BLOCKS 13, 14 and 15**

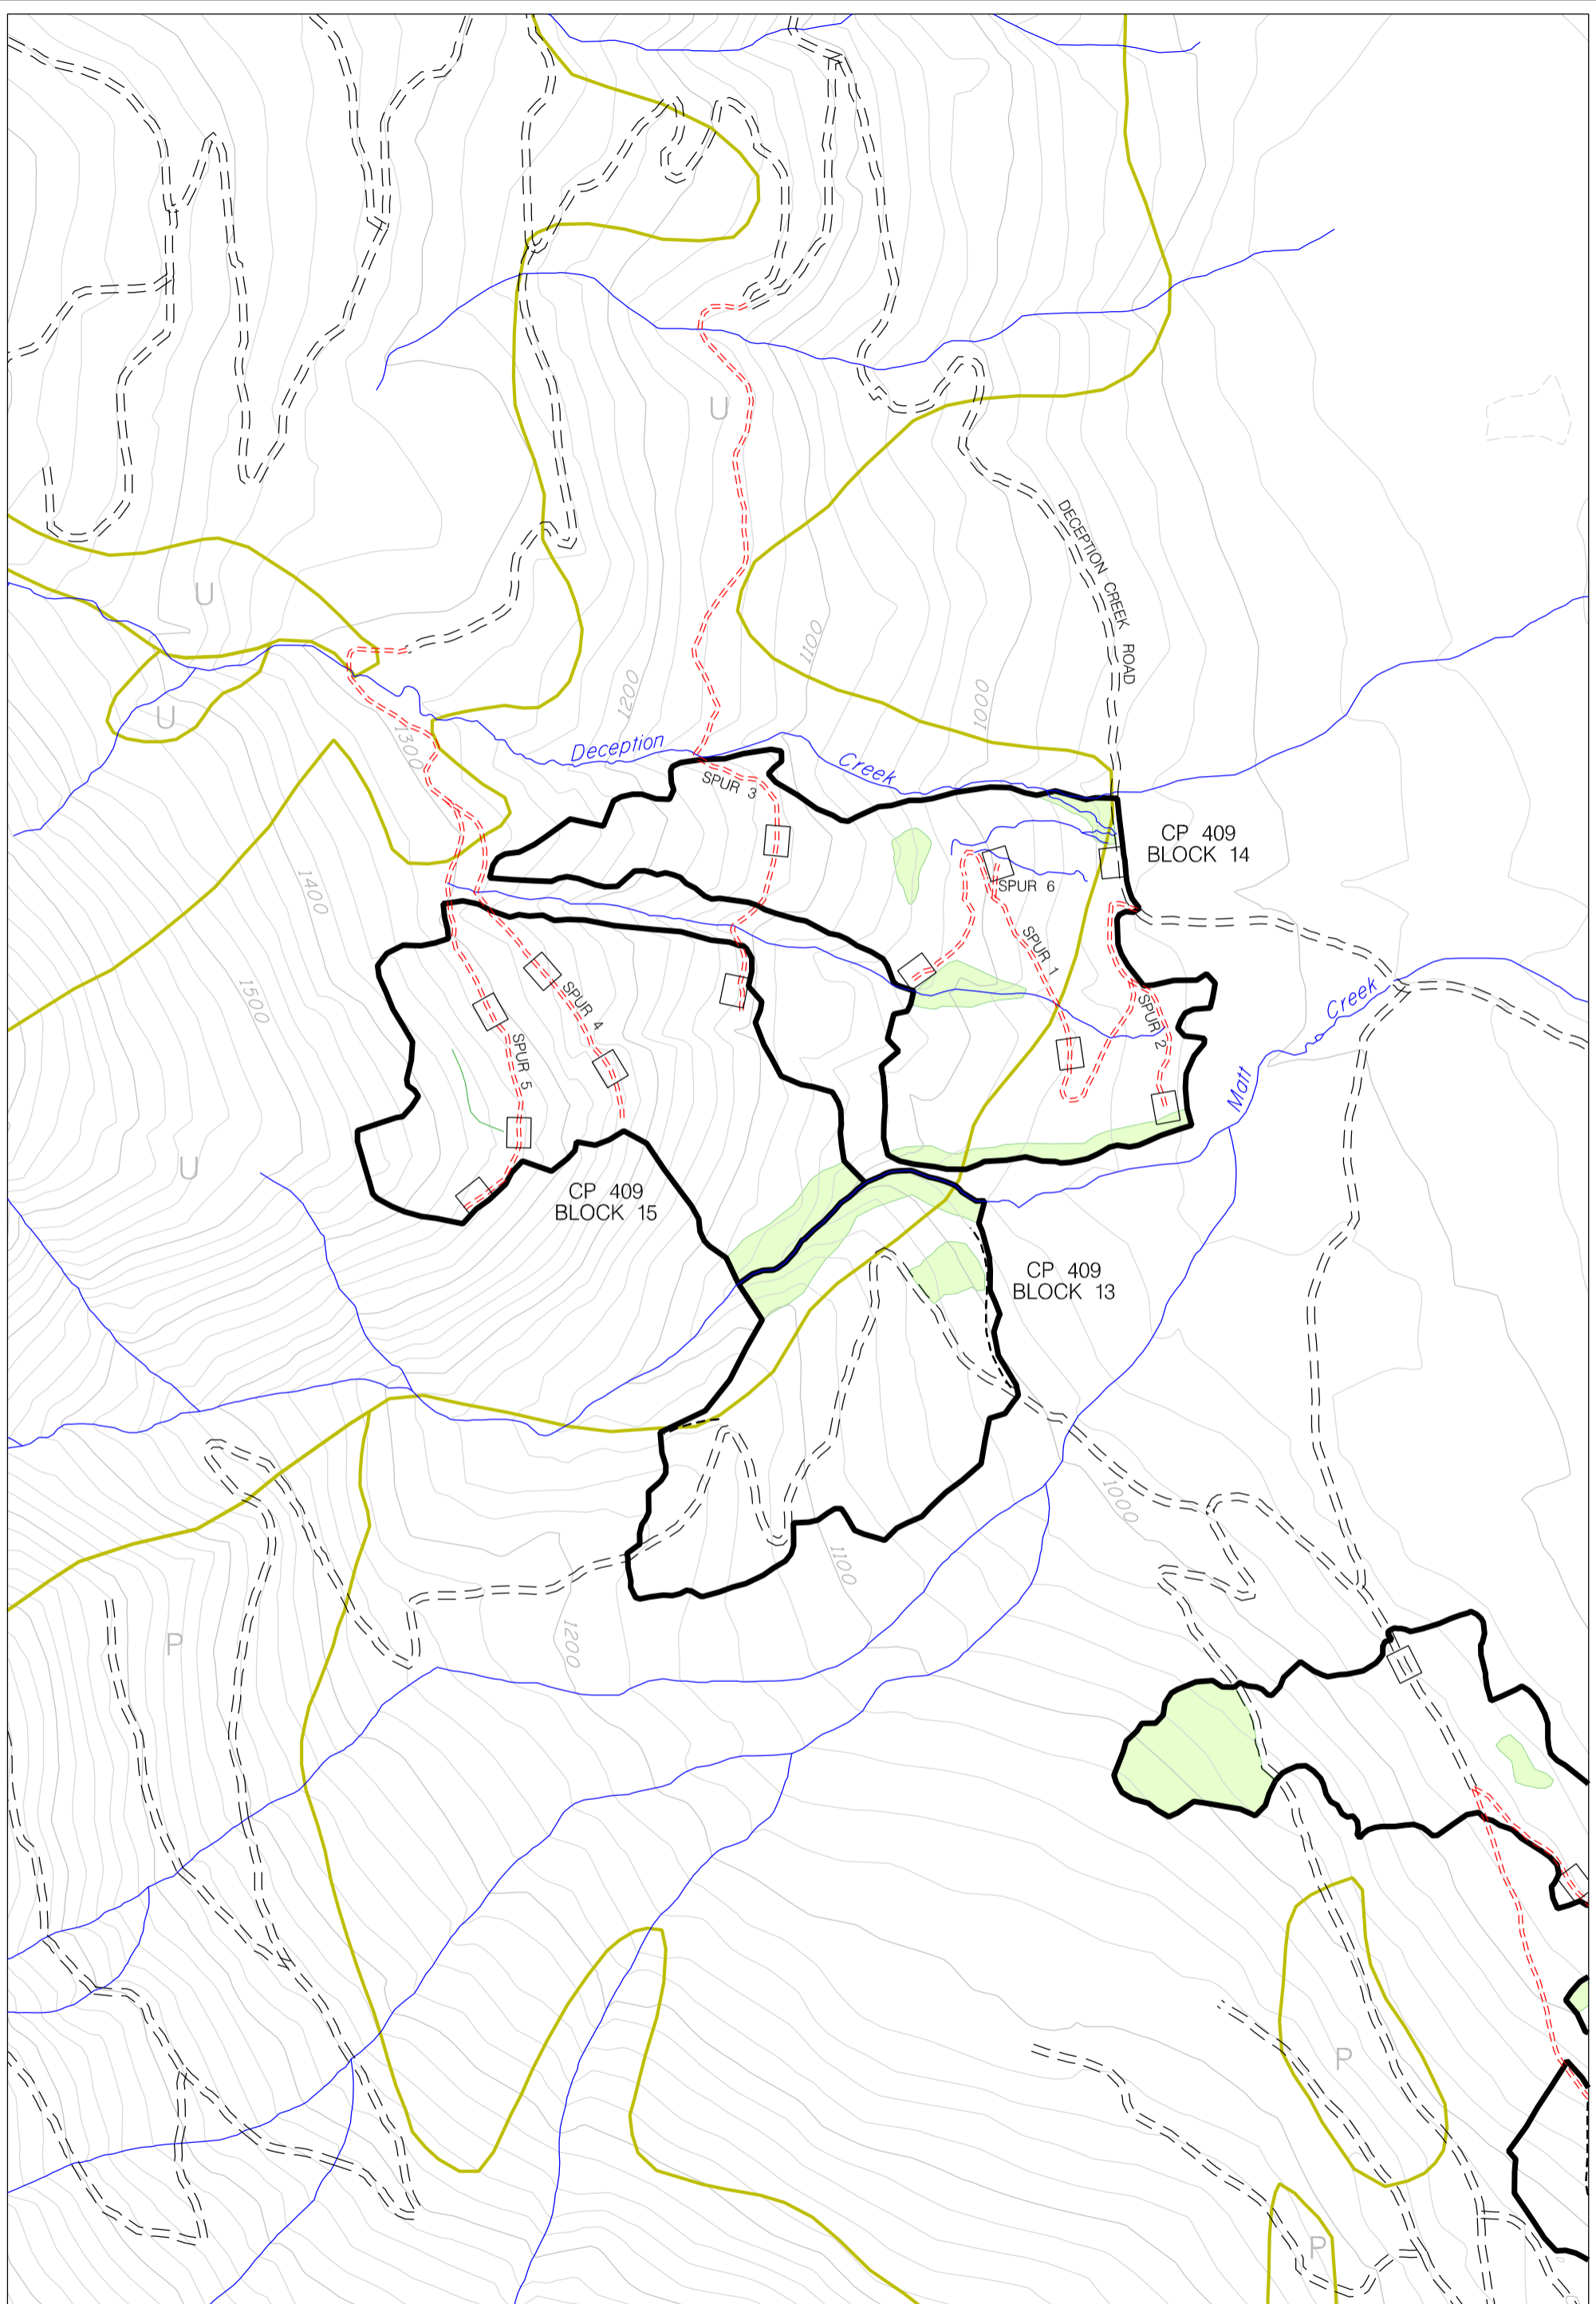
Mapsheet: 82K035
 UTM: 495110E 5575170N
 Scale: 1:10,000
 Figure: 2

Detailed terrain stability mapping for the proposed development area was provided by PWP. The terrain hazard polygons are shown on Figure 2.

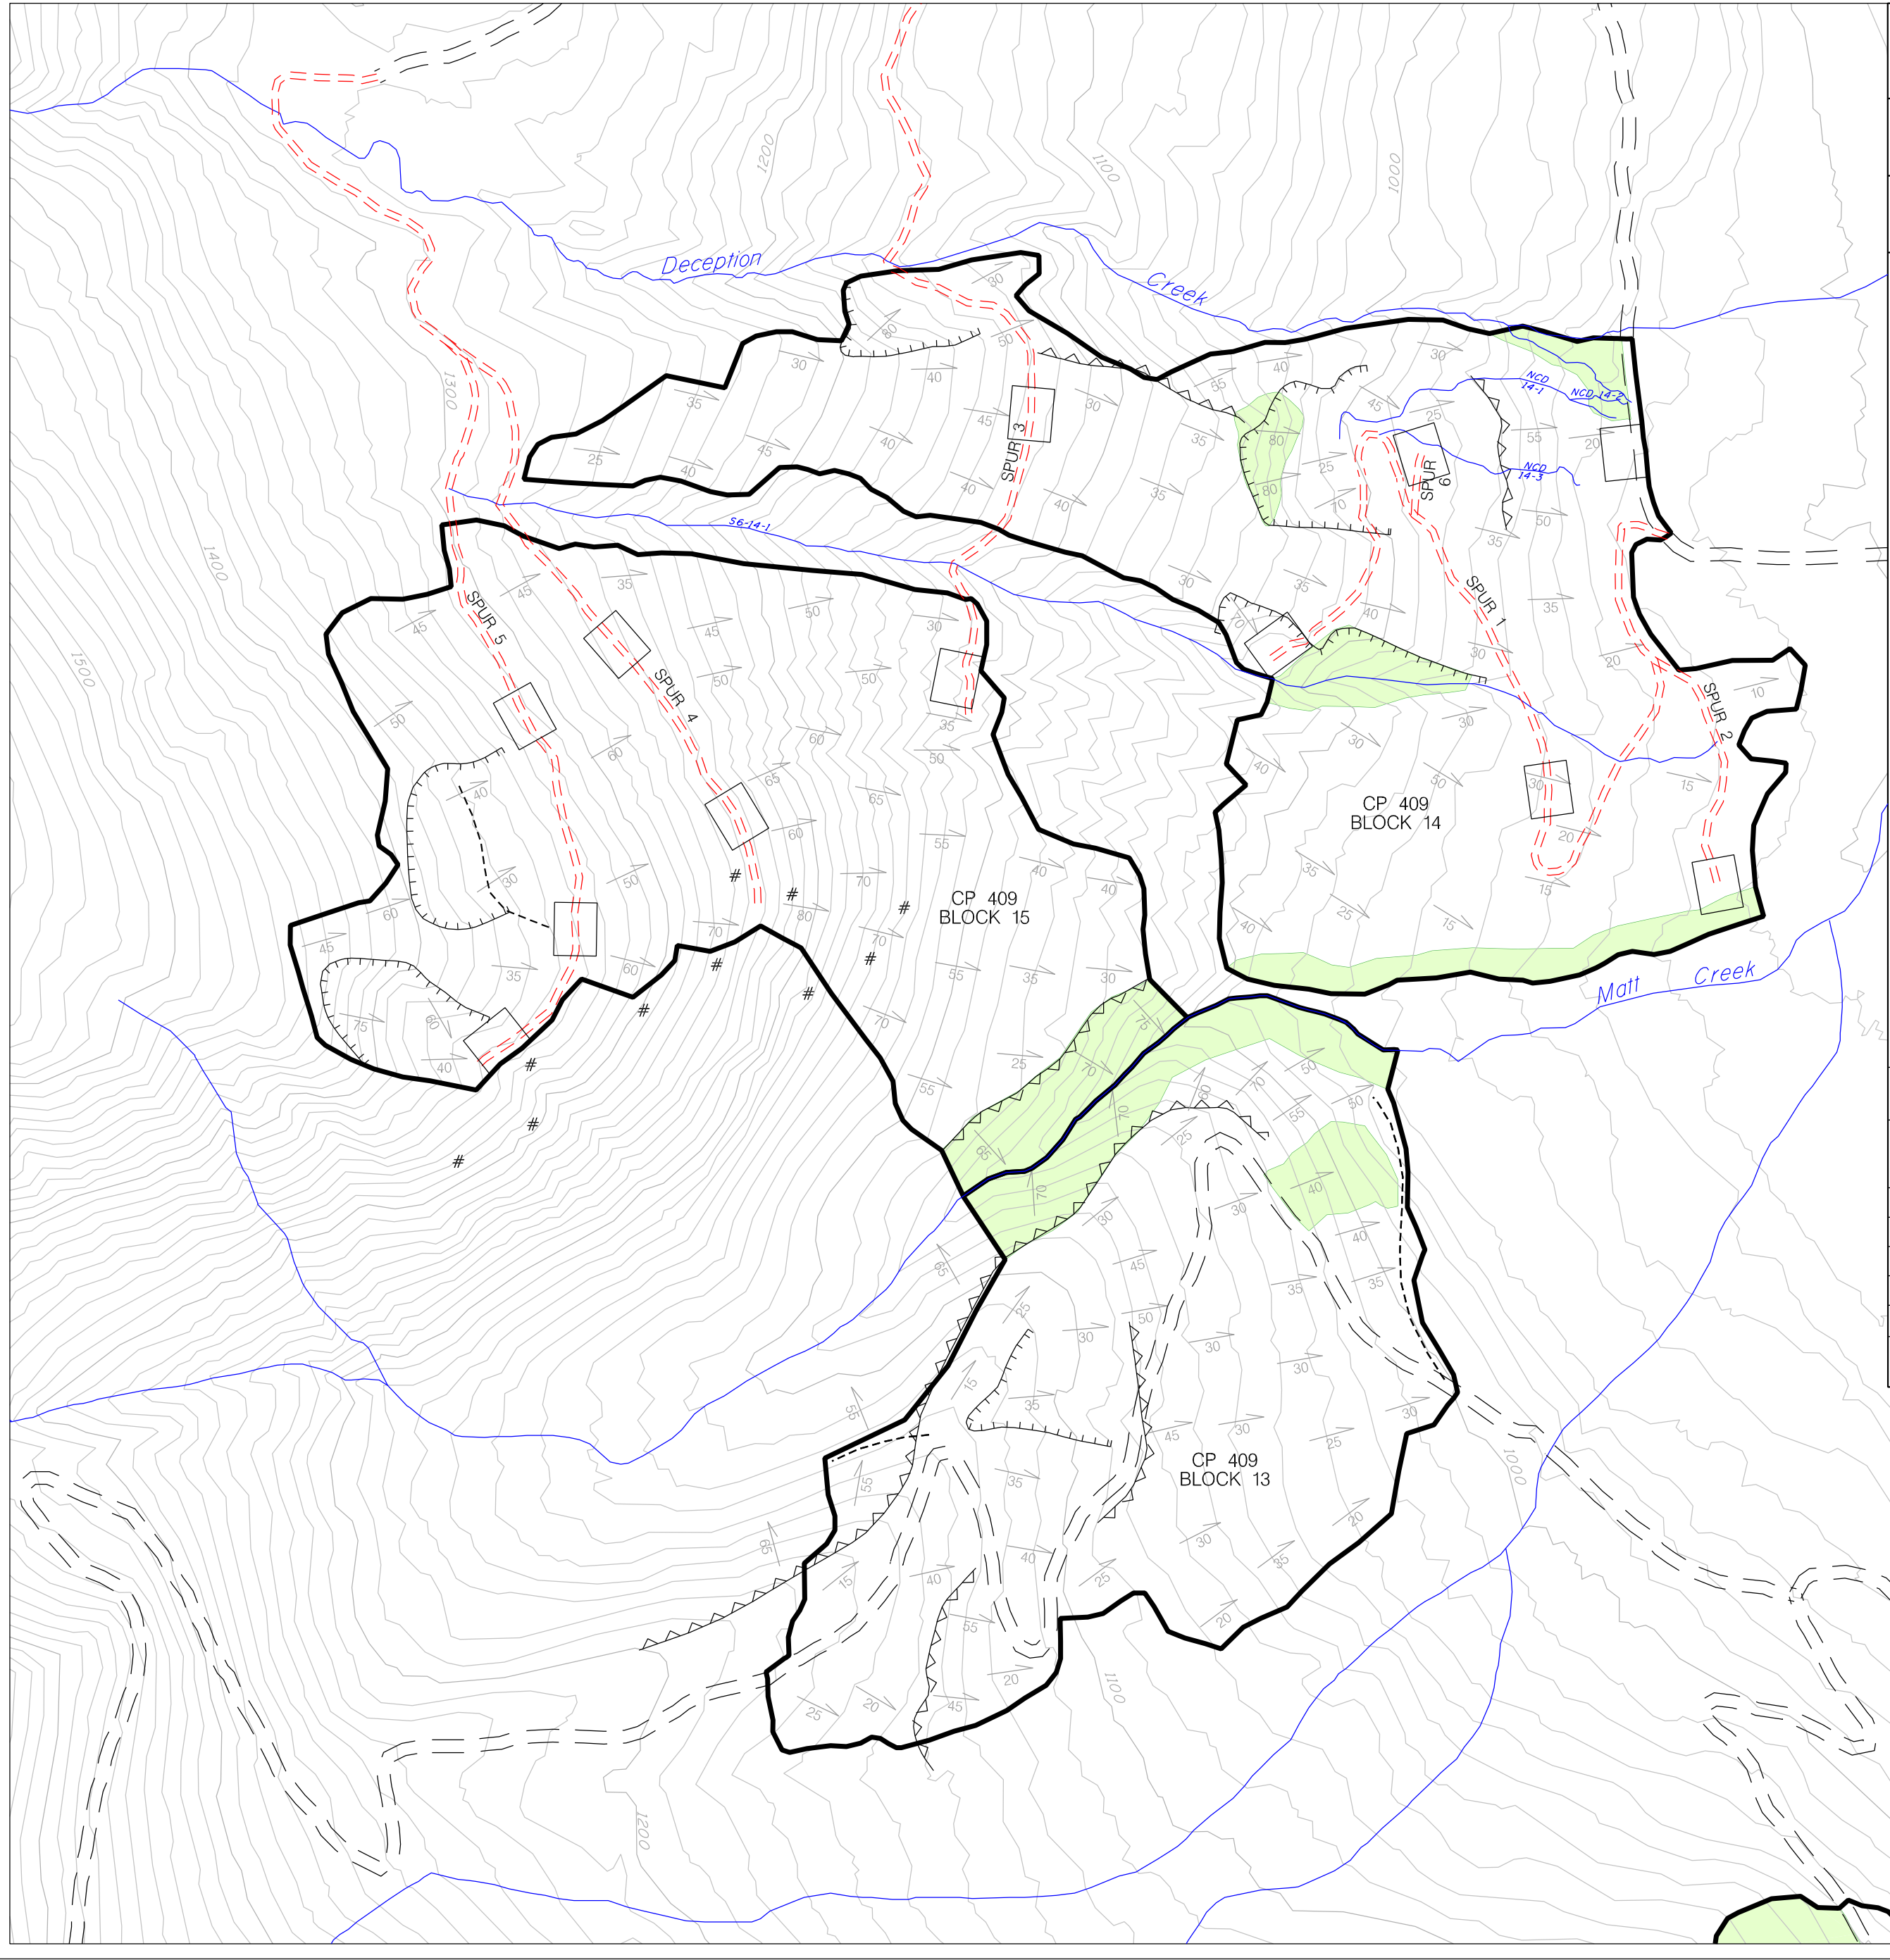
DRAWN: TRIPWIRE	
CHECKED: CP	
SITE PLAN	FIGURE: 3

According to previous terrain mapping, the southeastern majority of the block is unrated, or considered Stable (S) by default, while the northwestern remainder is rated Unstable (U) terrain. At the request of PWP, a geotechnical assessment was completed for the entire block. It is understood the proposed cut block will be harvested as a clear cut with reserves, while utilizing both ground-based and cable-based harvesting equipment. A site plan of Block 13 is shown in Figure 3.

Block 13 is characterized by irregular and variable terrain. Slopes generally range from 20% to 40% with limited, steeper slopes (up to 70%) below a convex slope break across the northeastern area. Surficial soils observed along existing cut bank exposures, tree churns and shallow test pits consist predominantly of moderately well-drained, mantled deposits of in-situ, silt-dominant till and colluviated till deposits affected by large, relic (inactive) landslide features.

The proposed harvest area encompasses a broad, topographic shoulder separating Mat Creek and a southeastern tributary watercourse with limited upslope catchment area. As a result, site conditions are considered predominantly dry. No significant surface watercourses or groundwater emergences were encountered.

A distinct, convex slope break along the southern sidewall of the Mat Creek gully discontinuously extends along the northwestern boundary and within the proposed harvest area. Slopes below break typically measure 50% to 70%.

No evidence of recent or imminent slope instability was identified within the proposed harvest area or the immediate adjacent terrain during the field review.

According to previous terrain mapping, the lower (southeastern) area of the block is unrated, or considered Stable (S) by default, while the upper remaining majority is rated Unstable (U) terrain. At the request of PWP, a geotechnical assessment was completed for the entire block. It is understood the proposed cut block will be harvested as a clear cut with reserves, while utilizing both ground-based and cable-based harvesting equipment. A site plan of Block 14 is shown in Figure 3.

The lower area of Block 14 encompasses the remnant alluvial fans of both Deception Creek and Mat Creek, as well as the colluvial deposition zone of relic (inactive) landslide features. The area is characterized by irregular and broken terrain with slopes generally not exceeding 30%. Surficial soils consist predominantly of well-drained deposits of alluvial silty sand and gravel and moderately well-drained accumulations of silty rubbly colluvium.

Site conditions across the lower region of Block 14 are considered primarily moist. A series of small streams and groundwater emergences migrate across the lower area.

By comparison, the upper (northwestern) remainder of the block is relatively more uniform with slopes typically ranging from 30% to 50%, while limited, steeper slopes (up to 80%) were measured across the head scarps of relic (inactive) landslide features. Soils consist of deeply-mantled, moderately well-drained deposits of in-situ, silt-dominant till and lesser accumulations of colluviated till affected by the aforementioned landslide features.

The upper majority of Block 14 encompasses the topographic shoulder separating Deception Creek and an un-named creek gully with limited upslope catchment area. As a result, site conditions throughout the upper block area are considered predominantly dry. Sporadic groundwater emergence was observed within the detached masses of the relic landslide features.

According to previous terrain mapping, the entire block is encompassed by Unstable (U) terrain. At the request of PWP, a geotechnical assessment was completed for the entire block. It is understood the proposed cut block will be harvested as a clear cut with reserves, while utilizing both ground-based and cable-based harvesting equipment. A site plan of Block 15 is shown in Figure 3.

Block 15 is predominantly characterized by relatively uniform terrain with localized areas of surface irregularities and gully features. Slopes generally range from 40% to 60% with steeper slopes (up to 80%) measured in association with near-to-surface and exposed bedrock. Soils consist of moderately well-drained, mantled deposits of in-situ silt-dominant till and variable-depth accumulations of colluviated till affected by relic (inactive) landslide features. Exposed meta-sedimentary bedrock (phyllite) was encountered within the south-central area of the block and adjacent terrain.

Site conditions are considered predominantly moist. Several streams and groundwater emergences were encountered throughout the northern majority of the block. A series of incised drainage features bisect the lower, northeastern corner. By comparison, the southern approximate third of the block encompasses a bedrock-controlled, topographic shoulder and is considerably drier.

A distinct, convex slope break (defining the northern sidewall of the Mat Creek gully) extends along the southeastern limit of the proposed harvest area. The area below the break is designated a Wildlife Tree Retention Area (WTRA) with slopes measuring 65% to 75%.

Based on the results of the assessment, the likelihood of landslide initiation as a result of the proposed timber harvesting of Blocks 13, 14 and 15 is rated as Low. The following factors were considered in determining the hazard rating:

1. Ground skidding and cable yarding across natural drainage paths and surface watercourses should be avoided. If this cannot be avoided, harvesting should be conducted during the drier months of the year, on a compressed snowpack, or effort made to ensure timber is skidded / yarded butt-first to minimize potential ground disturbance within such drainage features;

2. Timber harvesting should not be conducted under excessively wet site conditions, such as during spring snow melt or periods of heavy and prolonged rainfall;

3. A post-harvest inspection should be completed to ensure all natural drainage patterns have been maintained. Logging debris should be removed from the wetted perimeter of all watercourses and subtle drainage features to ensure an accumulation of coarse woody debris or site degradation from logging operations does not result in a drainage diversion. These measures include ensuring the drainage network (i.e. culverts and ditch lines) along permanent roads remain functional, as intended;

4. All temporary access trails may be built using debris-supported fill slopes to reduce cut bank excavation and the potential for groundwater interception. Appropriate drainage control measures must be implemented to ensure all natural drainage paths are maintained. All trails must be fully rehabilitated concurrently with completion of the proposed timber harvesting. If harvesting is to be conducted during winter months, trails should be seasonally deactivated prior to the freshet by out sloping where practical and installing cross ditches to maintain natural drainage patterns.
