February 12, 2019

Porcupine Wood Products Ltd.  
Box 850  
Salmo, BC  
V0G 1Z0

**RE: TERRAIN STABILITY ASSESSMENT**  
**BALFOUR FACE, CP 409, BLOCKS 7, 8 and 9**

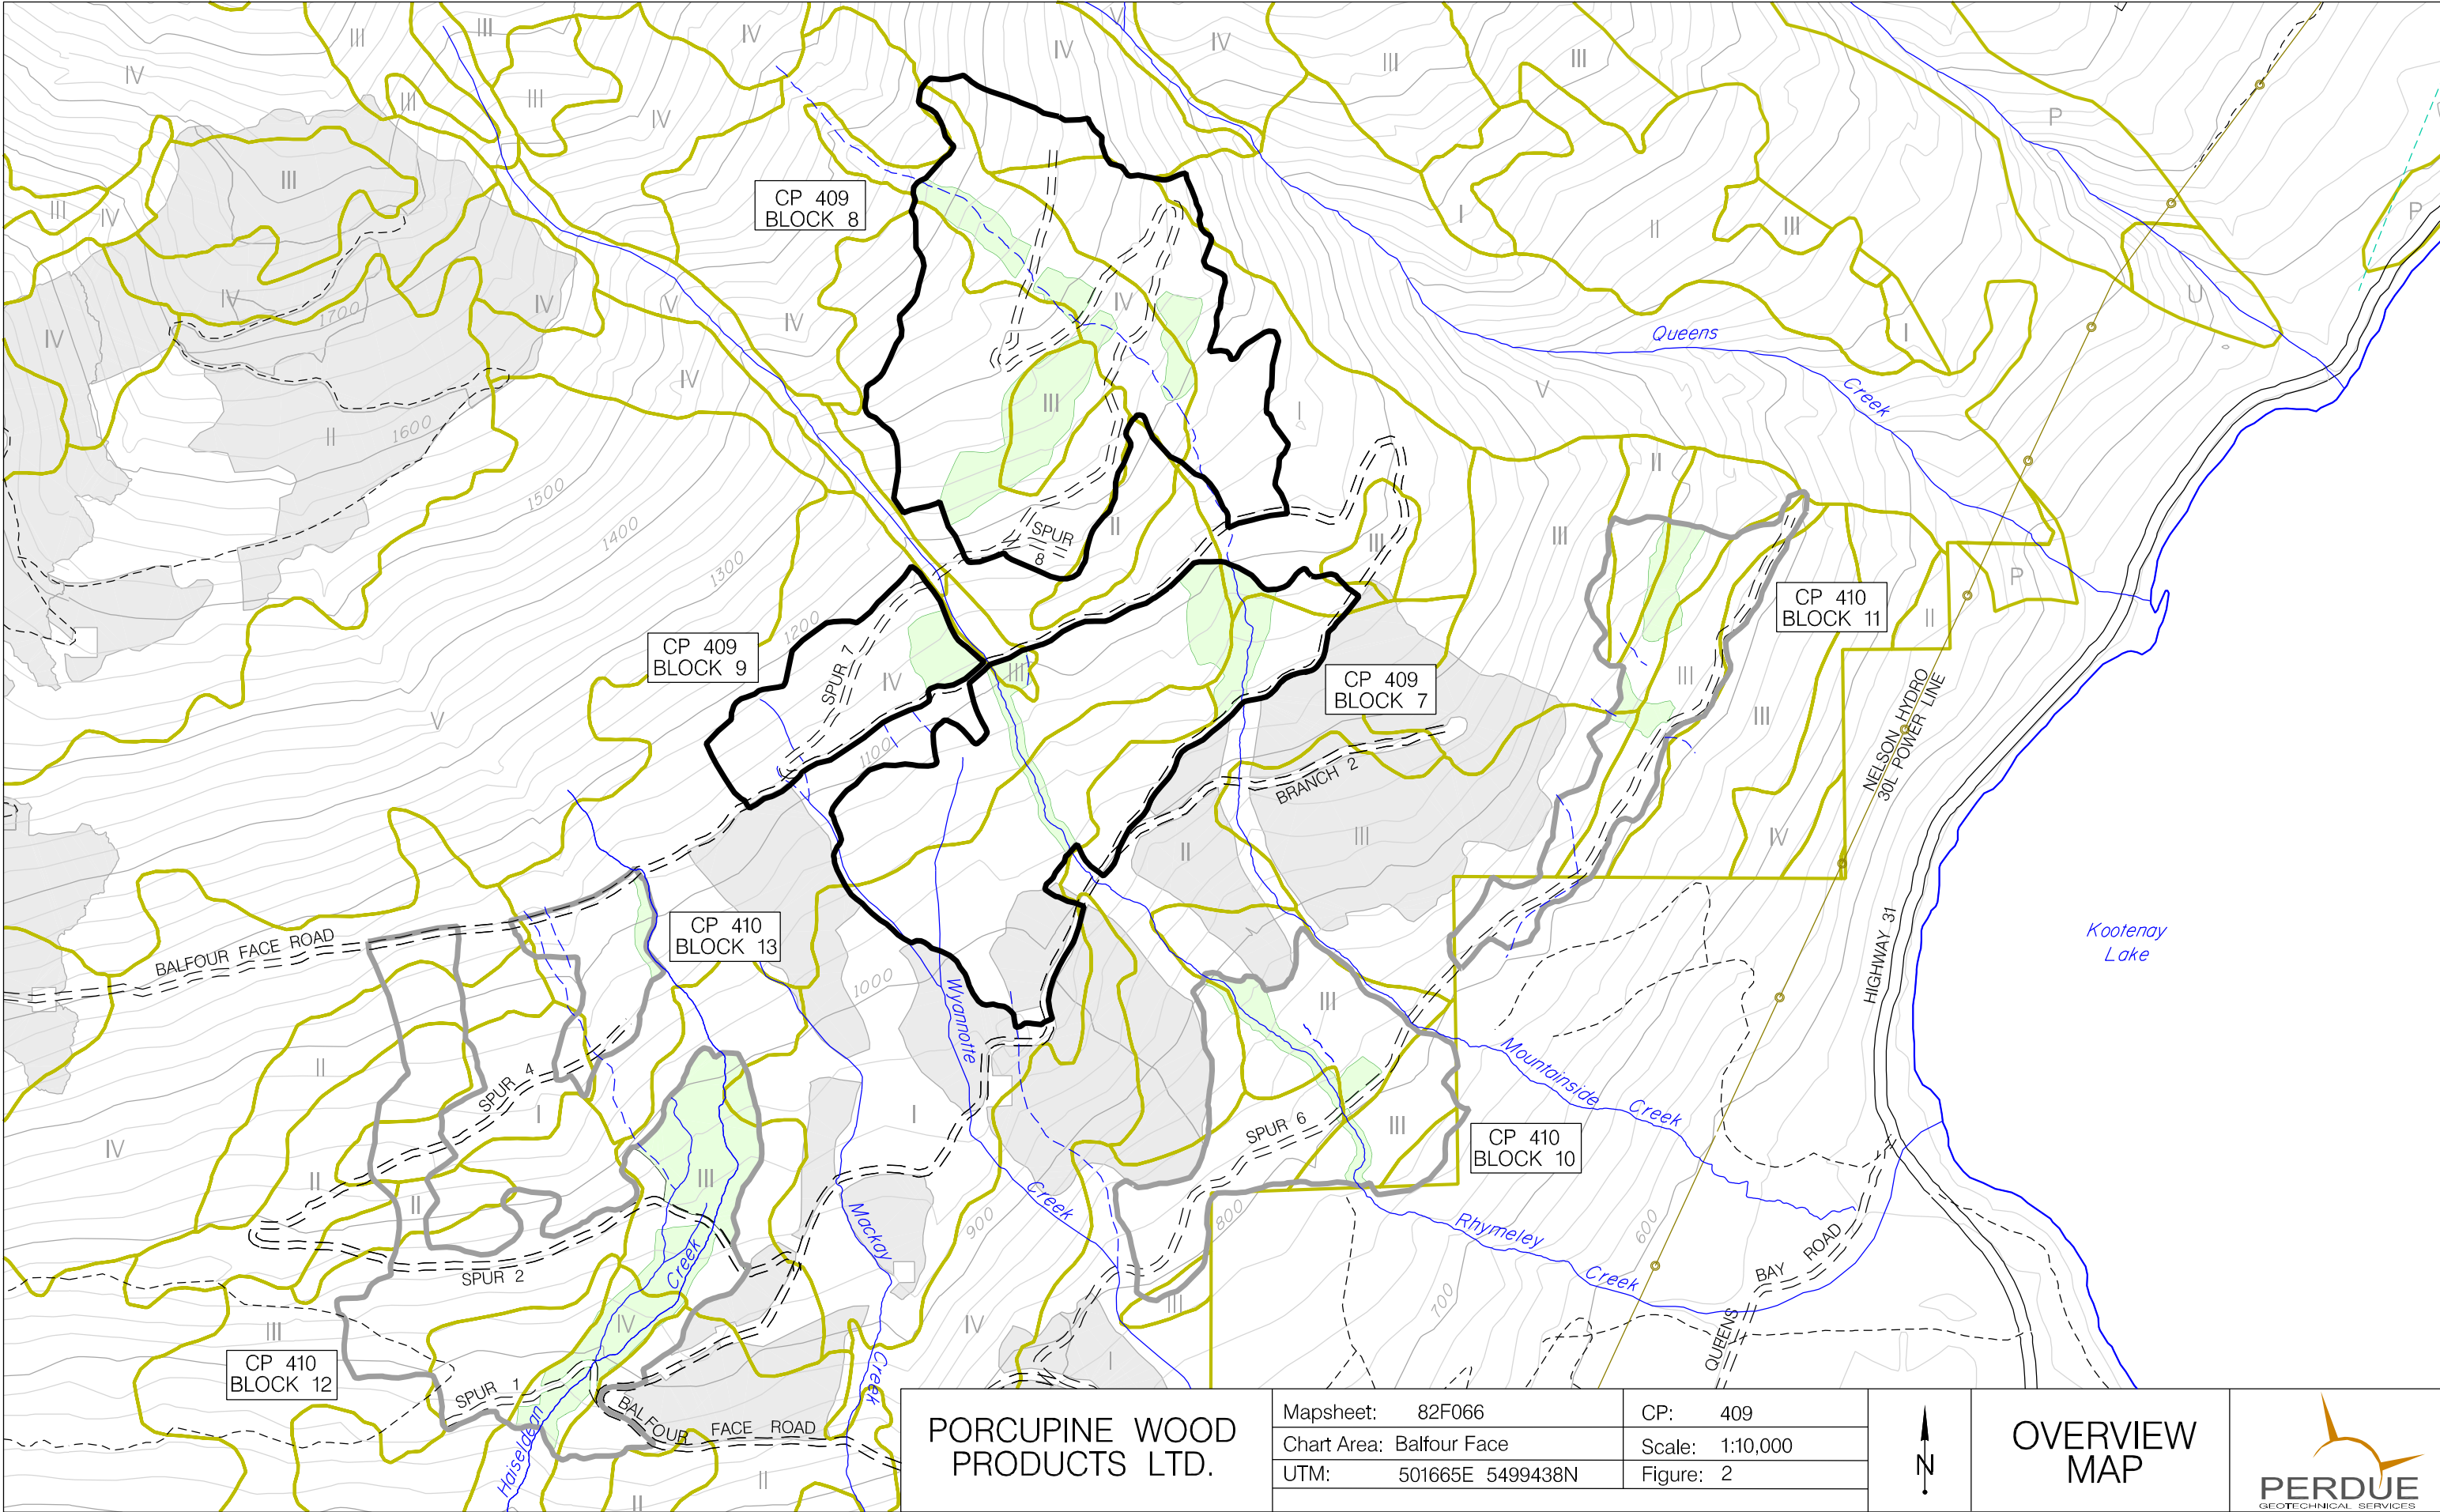
CP:	409
Scale:	1:10,000
Figure:	2

Detailed terrain stability mapping for the proposed development area was provided by PWP. Terrain Survey Intensity Level (TSIL) B mapping was completed by Kutenai Nature Investigations Ltd. and summarized in a report entitled *"Terrain and Soil Inventory, West Arm Demonstration Forest (WADF)"*, April 1997. The terrain hazard polygons are shown on Figure 2.

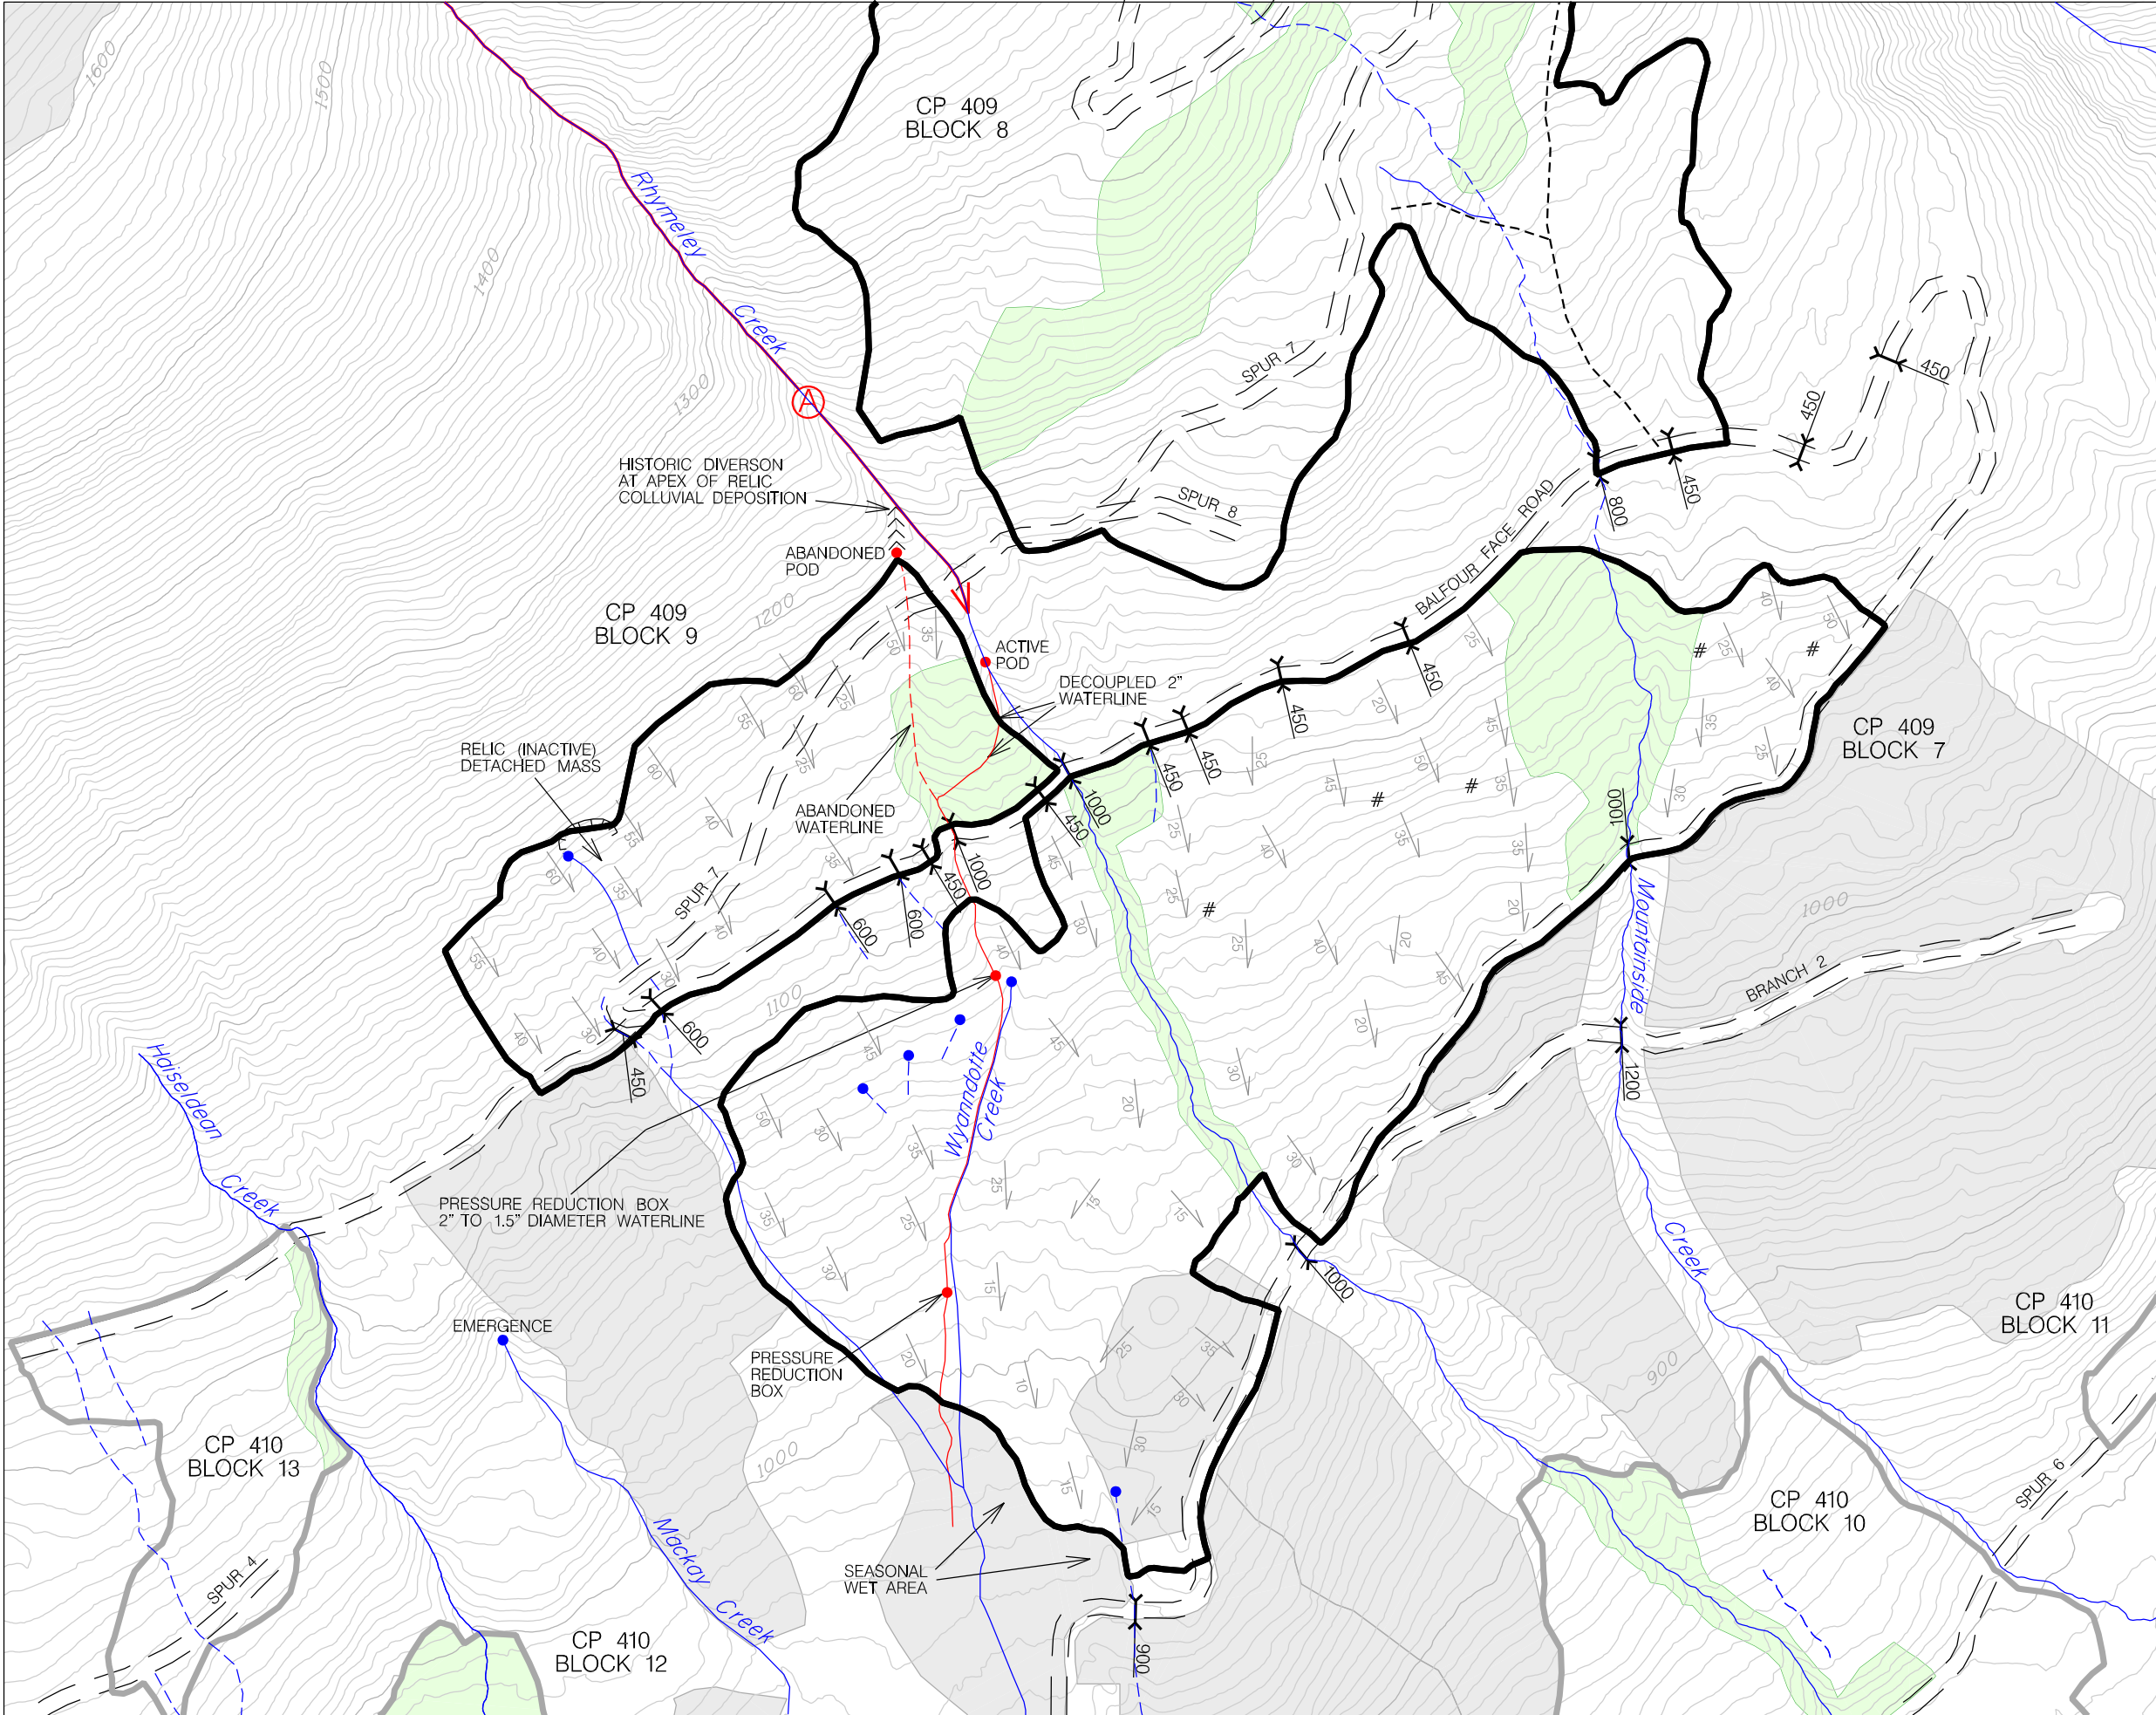
FL:	A30171	MAP REF:	82F066
DISTRICT:	SELKIRK	PROJECT:	18006-002
DATE:	FEBRUARY 2019		
DRAWN:	TRIPWIRE		
CHECKED:	CP		
SITE PLAN	FIGURE:		
	3

Block 7 is characterized by slightly irregular and broken terrain that is primarily governed by the underlying igneous bedrock. Slopes generally do not exceed 30% with localized, steeper gradients measuring up to 50%. Surficial soils observed along existing cut bank exposures, tree churns and shallow test pits consist predominantly of well-drained, mantled deposits of silty sand till and lesser accumulations of sandy silty rubbly colluvium.

A review of Light Detection and Ranging imagery (LiDAR, provided by PWP), in combination with Google Earth imagery (2003, 2009 and 2016) and field observations, identified a remnant (inactive) colluvial deposition feature, associated with the Rhymeley Creek drainage feature, bisecting the west-central area of Block 7 and encompassing the southwestern corner of the block. Rhymeley Creek is confined within an incised, bedrock-controlled gully within the proposed harvest area boundaries and encompassed by a narrow Wildlife Tree Retention Area (WTRA) along its length. The relic feature is inferred to represent historic mass wasting during the deglaciation process along the Kootenay Lake valley (more than 10,000 years ago).

No evidence of recent slope instability was identified within the proposed harvest area or immediate adjacent terrain during the field review.

Block 9 is characterized by relatively uniform terrain with slight irregularities and an overall concave slope configuration. Slopes generally range from 25% to 40% across the lower (southeastern) area of the block and gradually increase up to 60% across the upper (northwestern) remainder. Soils observed along existing (recently excavated) cut bank exposures consist of well-drained, mantled deposits of silty sand till and lesser, discontinuous accumulations of sandy silty rubbly colluvium.

Rhymeley Creek flows along (outside) the northeastern harvest boundary within a variably-incised draw. The northeastern area of the block encompasses the upper extent of the relic, colluvial deposition mass associated with Rhymeley Creek, as described in the preceding Block 7 observations. Sitkum Consulting Ltd. (SCL)<sup>1</sup> described an historic, southwestern diversion of Rhymeley Creek into the Wyandotte Creek draw at 1200 m elevation. Recent field observations by PGS identified the diversion at the apex of the remnant colluvial feature, approximately 35 m upslope of the northern corner of Block 9. The rudimentary diversion appears to have been hand-excavated to provide surface flow to an abandoned (non-functioning) 2-inch diameter waterline intake. The empty waterline extends downslope along the Wyandotte Creek drainage feature.

The Rhymeley Creek channel has been recently impacted by snow avalanching within the last five (5) years. Avalanche debris from the most recent event terminated approximately 40 m below the recently built Spur 7 alignment (1160 m elevation), consisting of broken timber and limited angular rock fragments. The debris was notably void of mineral soil, differentiating it from a typical debris slide event. Recent avalanche activity appears to have rendered the above-mentioned, rudimentary drainage diversion incapable of easily directing surface flow outside the Rhymeley Creek channel.

Strong groundwater emergence was encountered within the northwestern area of Block 9, along the southwestern flank of a relic (inactive) detached mass. The dimensions of the initiation zone were visually estimated to be 30 m wide, 30 m long and 4 m deep (on average). Total travel distance of the detached mass measured approximately 40 m (slope length). Slopes adjacent to the initiation zone measured 60%, and 40% adjacent to the toe of the feature. The cause of instability is inferred to be directly related to the emergence of groundwater, which is localized to the western flank of the feature. The mass wasting event predates the existing stand of timber and is presumed to be several thousands of years old.

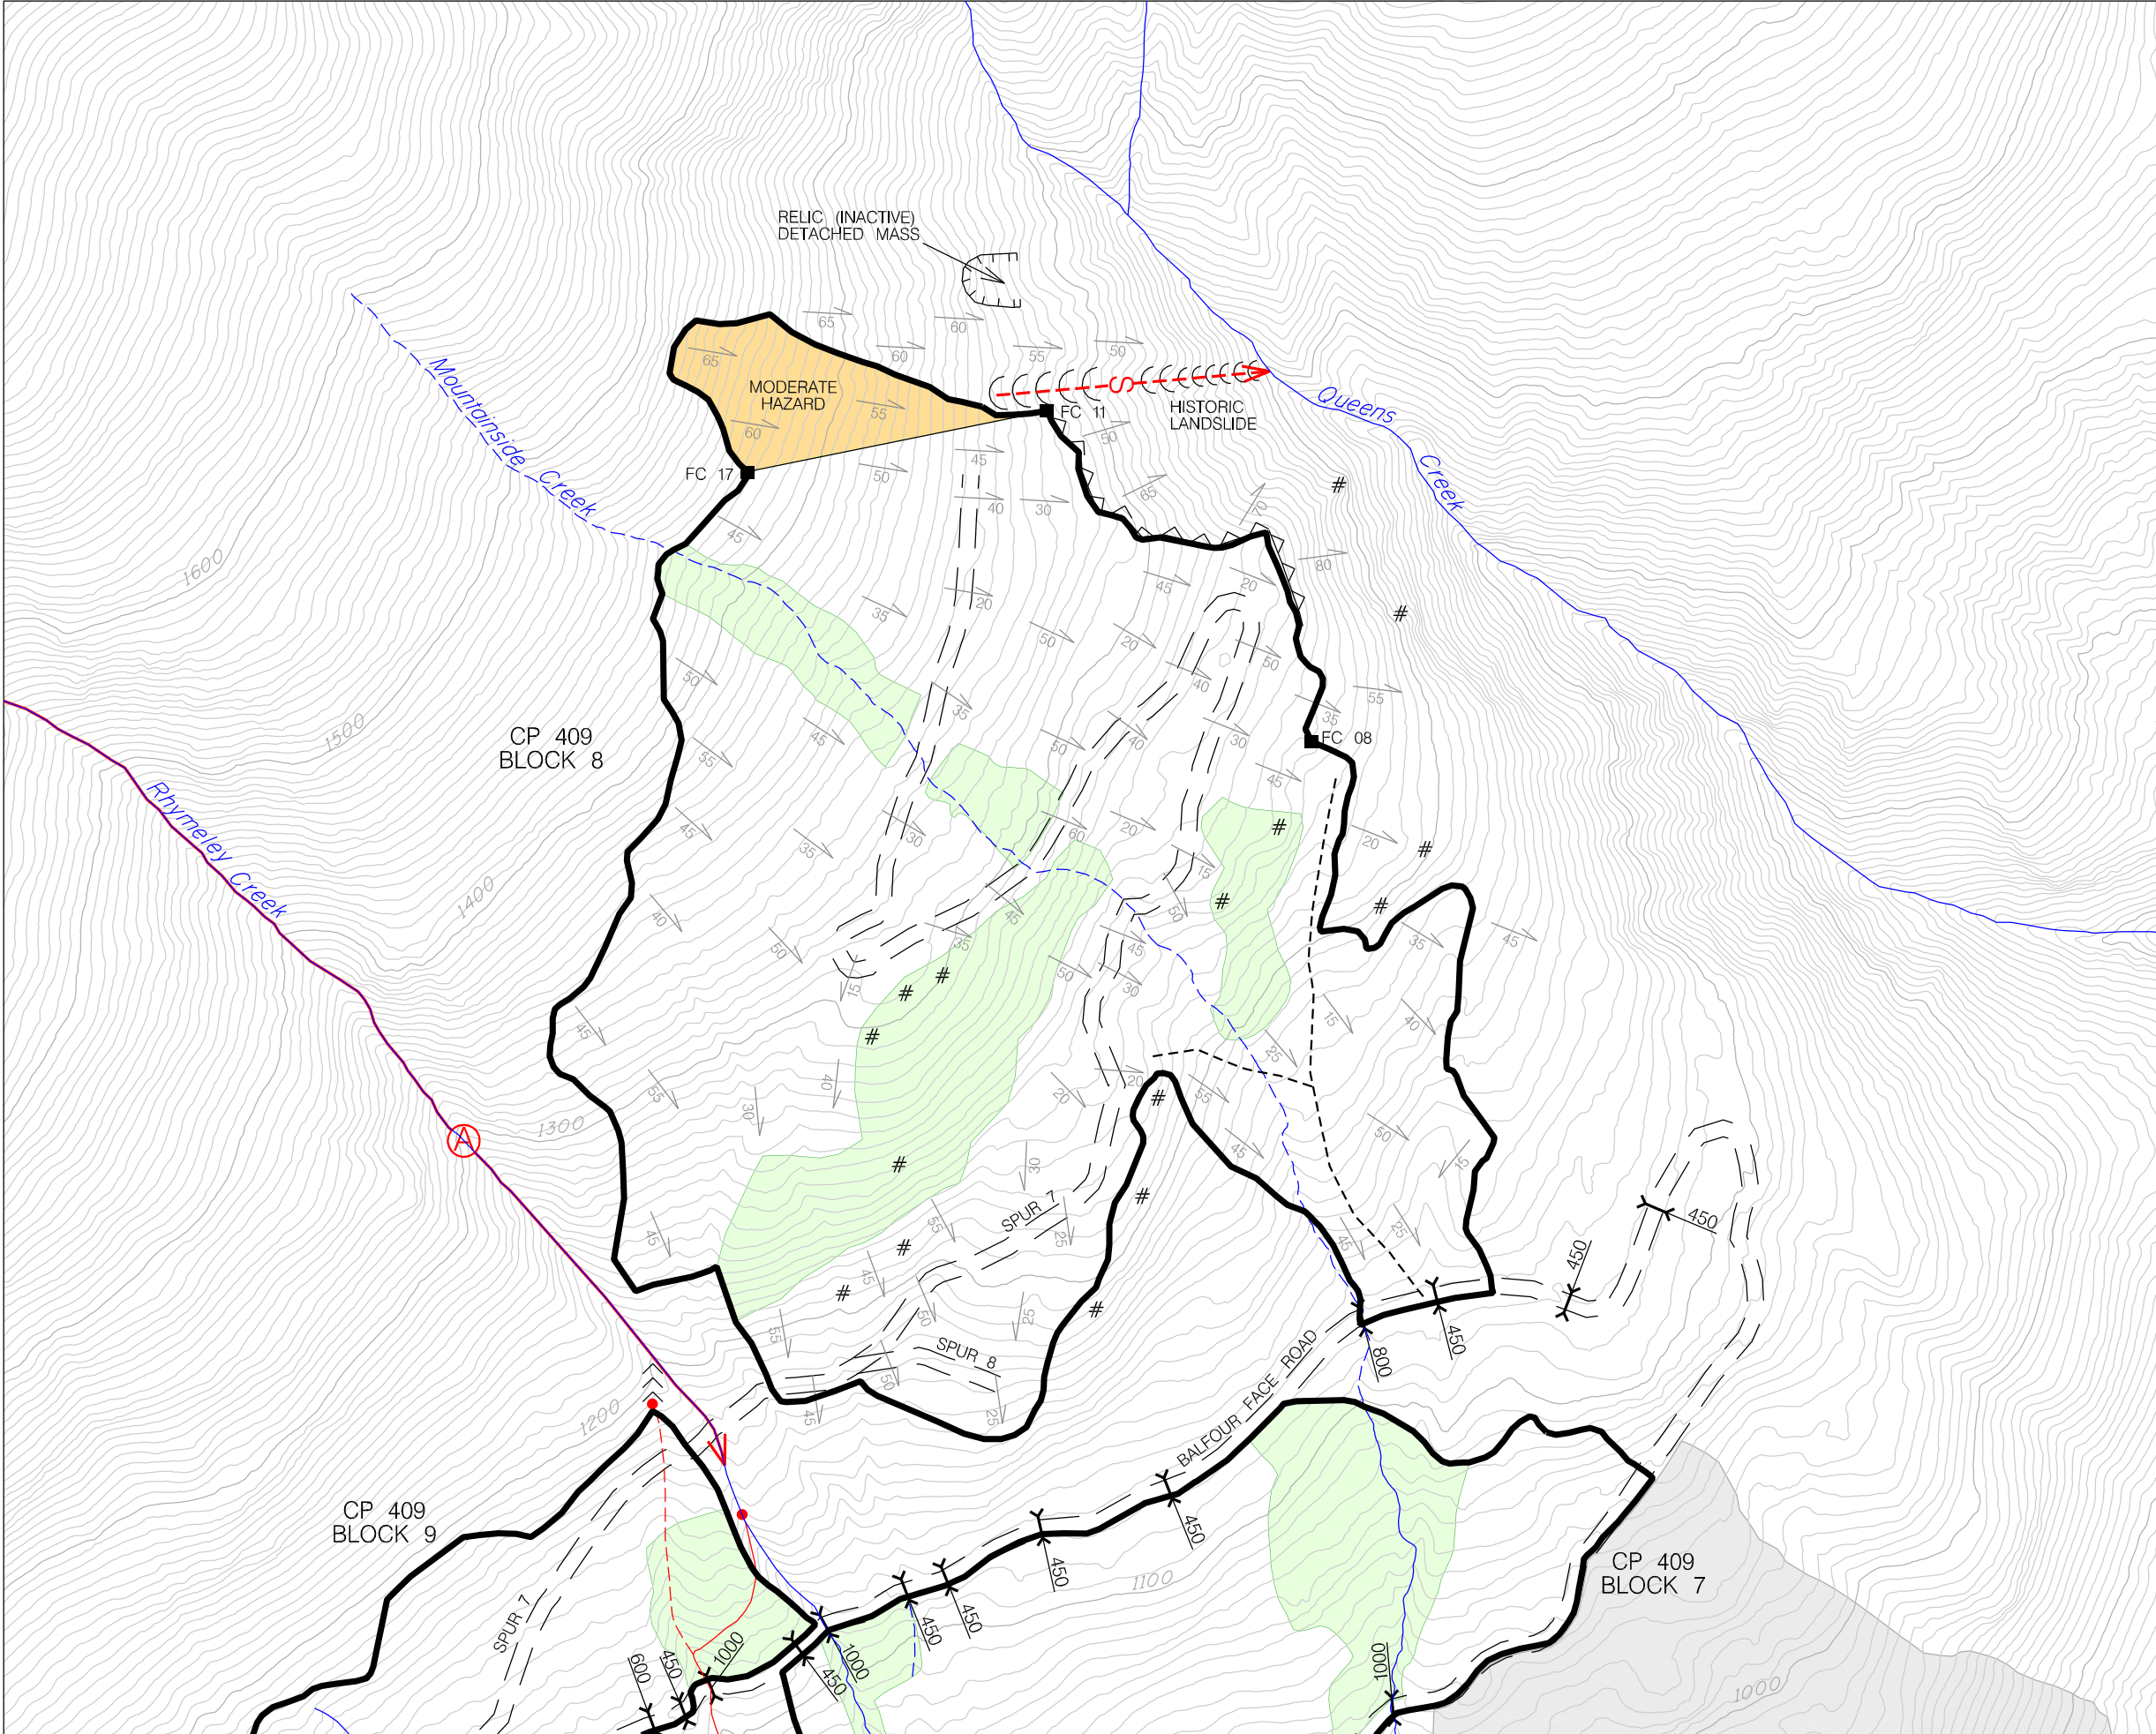
FL: A30171	MAP REF: 82F066
DISTRICT: SELKIRK	PROJECT: 18006-002
DATE: FEBRUARY 2019	
DRAWN: TRIPWIRE	
CHECKED: CP	
SITE PLAN	
FIGURE: 4

Block 8 is characterized by variable terrain. The lower (southeastern) approximate two-thirds is irregular and broken that is predominantly governed by the near surface, underlying bedrock. By comparison, the upper (northwestern) remainder is more uniform with slight irregularities. Slopes throughout the block typically range from 20% to 45% with limited steeper slopes measuring up to 60%.

Overall, site conditions throughout Block 8 are considered primarily dry. Mountainside Creek is a seasonal watercourse that bisects the block along a variably-incised drainage feature. Localized moist sites were identified in close proximity to Mountainside Creek and within the northern corner of the block, which transitions to moist site conditions approximately 40 m south of Falling Corner (FC) 11.

Slopes are less steep below the northern corner of Block 8 (north of FC 11), measuring 50% to 65% with evidence of historic slope instability and wetter site conditions. The headwall of an historic landslide was encountered immediately north of FC 11 and below the proposed harvest boundary. The dimensions of initiation zone measured 12 m wide, 25 m long and 2 m deep (on average). Evidence of seasonal groundwater emergence was observed within the head scarp region, which is presumed to be a primary contributing factor of slope instability. The age of the failure is estimated to be 100 to 150 years old, and may correlate with the most recent wildfire activity to affect the area.

A relic (inactive) detached mass was identified approximately 150 m below the northern limit of the block, across the lower sidewall of the Queens Creek gully. The dimensions of the initiation zone measured 40 m wide, 40 m long and more than 4 m deep. Slopes adjacent to the initiation zone measured 55% to 60%. The detached mass appears to have traveled 40 m to 50 m (slope distance) and terminated approximately 50 m above Queens Creek. Slopes below the residual deposition mass measured 90% to 110%. Site conditions are considered moist, although no indication of seasonal groundwater emergence was observed at the time of the field review. The relic feature predates the existing stand of timber and is presumed to have occurred several hundred or thousands of years ago. The cause of instability was not conclusively determined.

Based on the results of the assessment, the northern corner of Block 8 is rated as **Moderate**. Due to the presence of moist site conditions and historic, seepage-induced mass wasting immediately below the proposed harvest area, timber harvesting will increase seasonal groundwater levels and increase the likelihood of further slope instability. The potentially hazardous area of Block 8 measures approximately 4.4 hectares (ha) in size and is defined as the area north of a linear line connecting Falling Corners 11 and 17, as illustrated on Figure 4. The hazard rating for this area of the block and the potential downslope / downstream effects were conveyed to Mr. Mike Kit (pers. comm., September 17, 2018).

The northern, 4.4 ha area of Block 8 has been identified as having a Moderate likelihood of post-harvest landslide initiation. The proposed harvest area should be amended to exclude this area of the block.
