July 30, 2018

**RE: TERRAIN STABILITY ASSESSMENT
BALFOUR FACE, CP 410, BLOCKS 10, 11, 12 and 13**

Regards,
PERDUE GEOTECHNICAL SERVICES LTD.

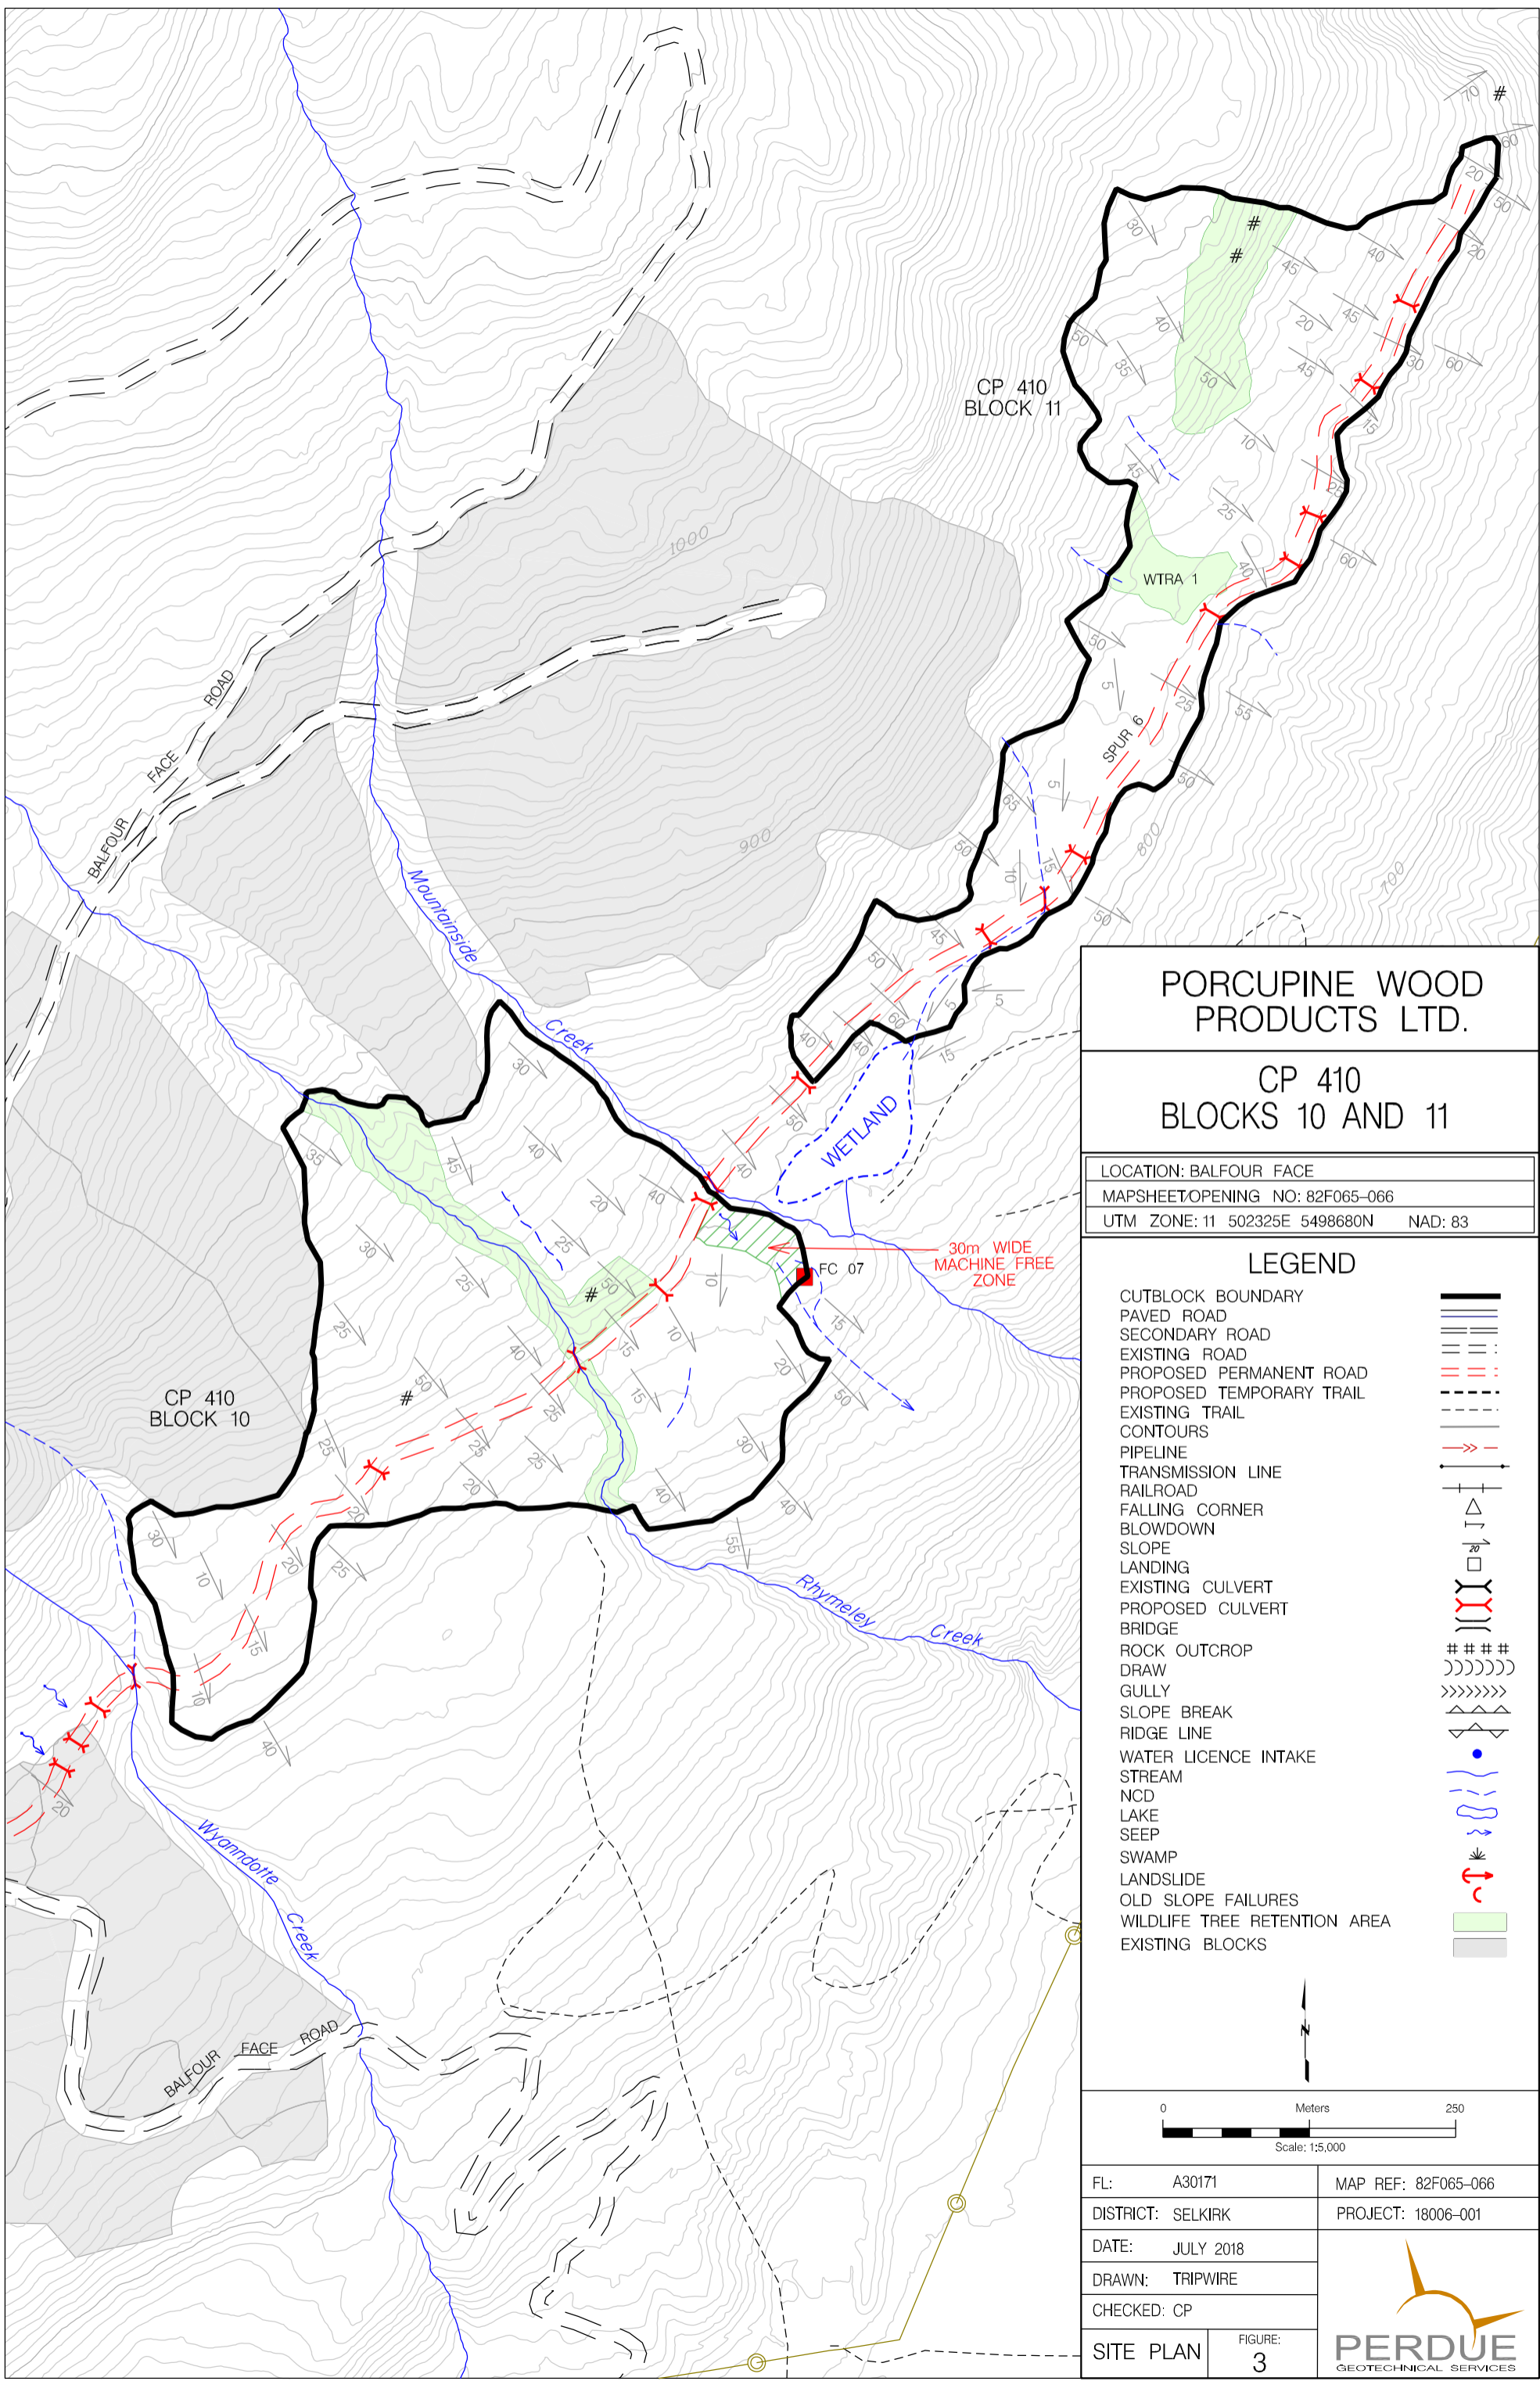
| SITE PLAN | FIGURE: 3 |

Block 10 is characterized by slightly irregular, broken and benched terrain. Slopes generally measure less than 30% with localized, steeper slopes measuring up to 60% in association with near-to-surface, bedrock-controlled features. Surficial soils observed along existing (recently excavated) cut bank exposures, tree churns and shallow test pits consist predominantly of well-drained, mantled deposits of glaciofluvial silty sand and gravel across the lower area of the block. Soils across the upper remainder consist of moderately well-drained, thinly mantled deposits of sandy silt till and lesser accumulations of sandy rubbly colluvium. Infrequent exposures of coarse-grained igneous bedrock was observed across the steeper, upper slopes.

Site conditions throughout the western majority of the block are considered dry, while the eastern remainder is discernibly wetter. Rhymeley Creek bisects the central area of the block within a well-incised, predominantly bedrock-controlled gully. A lesser, poorly confined seasonal stream flows along the northeastern side of Rhymeley Creek, beyond the confines of the larger drainage feature. Wyandotte Creek and Mountainside Creek flank the southwestern and northeastern extents of Block 10, respectively. Wyandotte Creek is well-confined within an incised gully, while Mountainside Creek is less confined adjacent to the block and poorly-confined downstream of the Spur 6 crossing.

An earlier field review in May 2018 identified dispersed, surface flow adjacent to Mountainside Creek within the lower, western area of Block 10, resulting from poor channel confinement, low-gradient terrain, windfall and an ATV trail built across the creek. Surface flow broadly migrates towards the main channel, northeast of the block, but some seasonal flow migrates downslope to the southeast, outside the confines of the defined channel.

Block 11 is characterized by slightly irregular, broken and benched terrain. Slopes generally measure less than 30% with localized, steeper slopes measuring up to 70% in association with near-to-surface, bedrock-controlled features. Surficial soils observed along existing (recently excavated) cut bank

exposures consist predominantly of well-drained, mantled deposits of glaciofluvial silty sand and gravel across the lower (southeastern) area of the block. Soils across the upper remainder consist of moderately well-drained, thinly mantled deposits of sandy silt till and lesser accumulations of sandy rubbly colluvium. Infrequent exposures of coarse-grained igneous bedrock were observed in association with the steeper, upper slopes.

Site conditions throughout the majority of the block are considered dry with seasonally moist areas. A series of seasonal groundwater emergences were identified along and immediately above the upper harvest boundary. Surface flow emerges approximately 50 m upslope of Wildlife Tree Retention Area (WTRA) 1, infiltrates into the permeable colluvial and glaciofluvial soils and re-emerges along the lower harvest boundary.

Additional seasonal surface flow emerges along the upper harvest boundary and migrates to the southwest along a slightly in-sloped topographic bench. Earlier field observations in May 2018 identified a broad area of surface ponding within the southeastern area of Block 11 that flows into a broad wetland area, immediately northeast of Mountainside Creek.

The terrain downslope of Block 11 is generally steeper than in-block observations. Lower slopes generally range from 40% to 60% with steeper slopes up to 100% in association with exposed bedrock outcrops. Soils are variable, consisting of mantled deposits of sandy silt till and rubbly colluvium approximately above 700 m elevation; and mantled, interlayered deposits of fine-grained glaciolacustrine and coarser glaciofluvial soils downslope thereof.

The Nelson Hydro (30L) power line extends across the lower slopes at approximately 650 m elevation. Several old, heavily-overgrown access trails appear to have been built to facilitate the installation of the power line and conduct timber harvesting within private land (Lots 5 and 6, NEP1570, District Lot 12075) several decades ago. The trails ascend from Highway 31 and were built using antiquated push-fill construction methods with insufficient drainage control measures across steep terrain. Evidence historic and recent slope instability was identified along the abandoned access structures.

A 2-inch diameter polyvinyl chloride (PVC) surface waterline diverts water from Queens Creek and extends across the hillside to the southwest, immediately above the 30L power line corridor. Evidence of several historic breaches were identified along the waterline that resulted in landslides along its length. Two active breaches were identified at UTM coordinates 503102E / 5498752N and 503020E / 5498684N, approximately 150 m and 190 m upslope of Highway 31, respectively. The poorly maintained waterline and inappropriate conduit material presents a significant risk to the highway and private land below.

Recommendations were forwarded to PWP to defer harvesting the lower, cable area (approximately 8.8 hectares), to reduce the Equivalent Clearcut Area (ECA) above the aforementioned concerns identified across the lower slopes. Figure 4 illustrates the amended harvest boundary.

A 30 m wide machine free zone should be established along the lower, northeastern harvest boundary, extending from the Spur 6 crossing of Mountainside Creek to Falling Corner (FC) 07. Repeated machine traffic adjacent to the machine free zone should be avoided to prevent rutting. Upon completion of the proposed timber harvesting, coarse woody debris should be removed from the creek channel to ensure surface flow migrates unimpeded along the present channel.

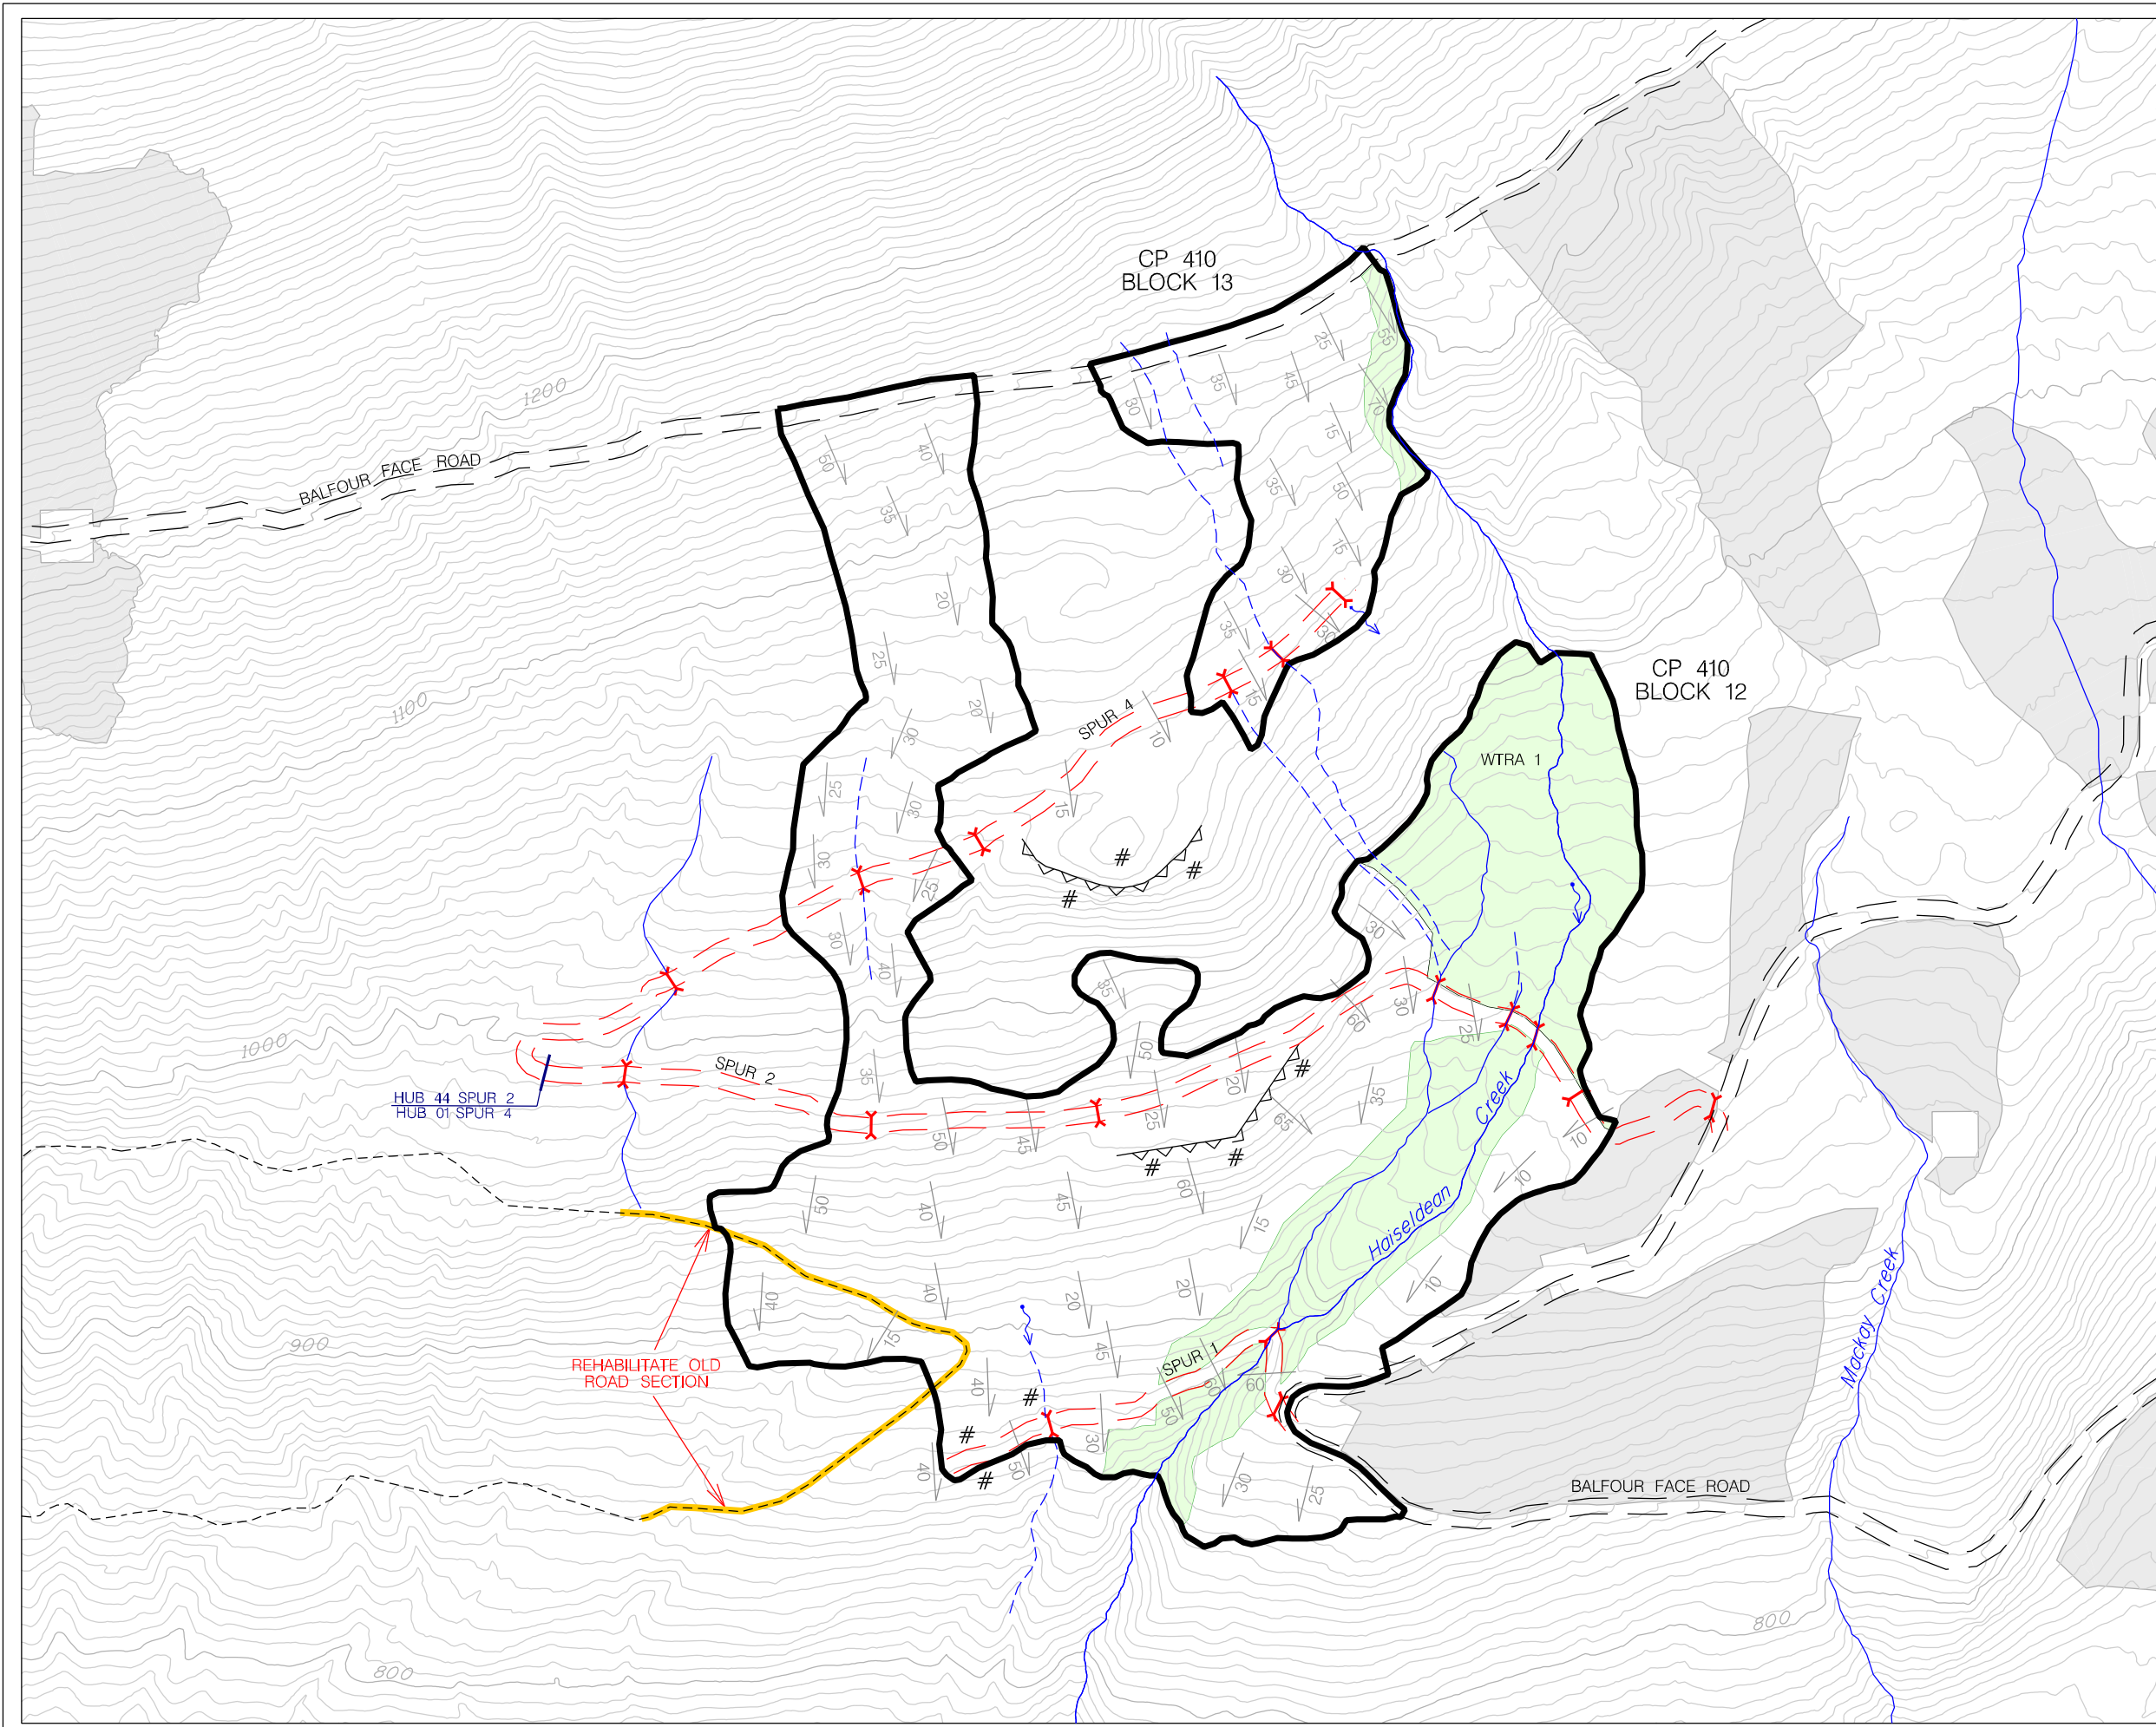
| SITE PLAN | FIGURE: 4 |

Block 12 is characterized by slightly irregular and broken terrain. Slopes generally measure 20% to 45%. Limited, steeper slopes (up to 70%) were encountered in association with exposed bedrock within the east-central area of the block. Soils predominantly consist of moderately well-drained, mantled deposits of sandy silt till. Lesser accumulations of overlying rubbly colluvium were identified across the south-central region, below bedrock outcrops within and above the proposed harvest area. In addition, overlying deposits of glaciofluvial (possibly alluvial) silty sand and gravel were identified in the southern extent of the proposed harvest area.

Site conditions throughout Block 12 are considered predominantly dry with localized, seasonally moist areas. Light, seasonal surface flow was identified along a shallow draw in the western area of the block, between the proposed Spur 2 and Spur 4 alignments. Additional, light, seasonal emergence was encountered in the southern area of the block, approximately 50 m upslope of the proposed Spur 1 road.

Haiseldean Creek bisects the southeastern area of Block 12 within WTRA 1. Light, seasonal surface flow was identified above the uppermost section of the existing Balfour Face Road during the annual freshet (May 2018), along with multiple groundwater emergences within and upslope of WTRA 1. By comparison, no surface flow was visible above Balfour Face Road during the field review in July, but strong groundwater emergence was identified beneath the coarse rock-filled road crossing.

An historic, overgrown access road and limited trail network ascends Balfour Face (west of Block 12) that was used to facilitate selective timber harvesting. An eastern switchback enters the lower, southwestern corner of the block. Earlier field observations in May 2018 identified light groundwater emergences along the cut bank of the road within the proposed harvest area. No surface drainage control measures were observed along a limited length of the historic road within, immediately adjacent to and downslope of Block 12. A limited network of trails was identified within the upper (northern) area of the block. The trails were heavily overgrown and built across gentle terrain with minimal cut bank excavation.

Block 13 is characterized by slightly irregular and benched terrain with slopes generally ranging from 15% to 30%. Soils consist of moderately well-drained, mantled deposits of sandy silt till. Exposed igneous bedrock was identified along Balfour Face Road, above the proposed harvest area.

Site conditions throughout the block are considered moist. A series of small, poorly-confined seasonal streams bisect the western approximate half of the block that originate as groundwater emergences directly above Balfour Face Road. Haiseldean Creek emerges from beneath the coarse rock-filled road crossing at the northeastern corner of Block 13, at a similar elevation as the aforementioned emergences.

Seasonal groundwater emergence was identified along the cut bank of an historic, overgrown access road within the southwestern corner of the block with no surface drainage control measures along the in-block length. As a result, the section of the abandoned road within, immediately adjacent to and downslope of Block 12 should be rehabilitated concurrently with the completion of timber harvesting to restore natural drainage patterns.
