August 7, 2018

Porcupine Wood Products Ltd. Box 850 Salmo, BC V0G 1Z0

RE: TERRAIN STABILITY ASSESSMENT LAIRD CREEK, CP 410, BLOCK 1 and SPURS 1, 2 AND 3

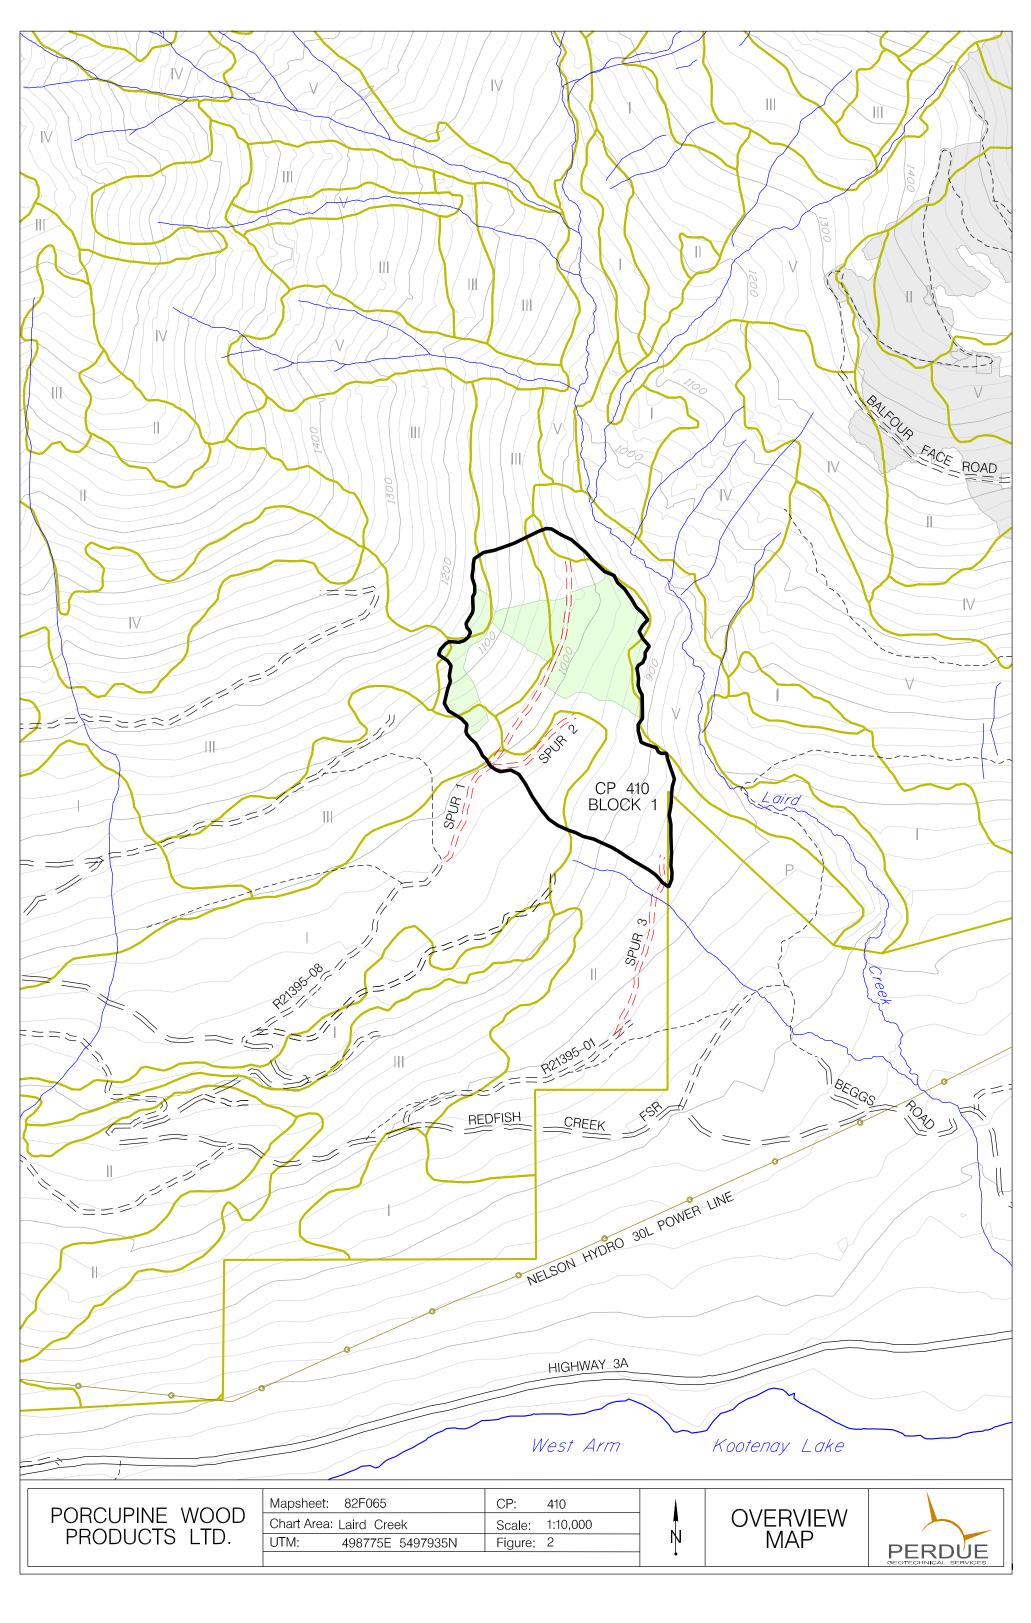
Figure 2 - CP 410, Development Overview Map (1:10,000 scale)

Detailed terrain stability mapping for the proposed development area was provided by PWP. Terrain Survey Intensity Level (TSIL) B mapping was completed by Kutenai Nature Investigations Ltd. and summarized in a report entitled *"Terrain and Soil Inventory, West Arm Demonstration Forest (WADF)"*, April 1997. The terrain hazard polygons are shown on Figure 2.

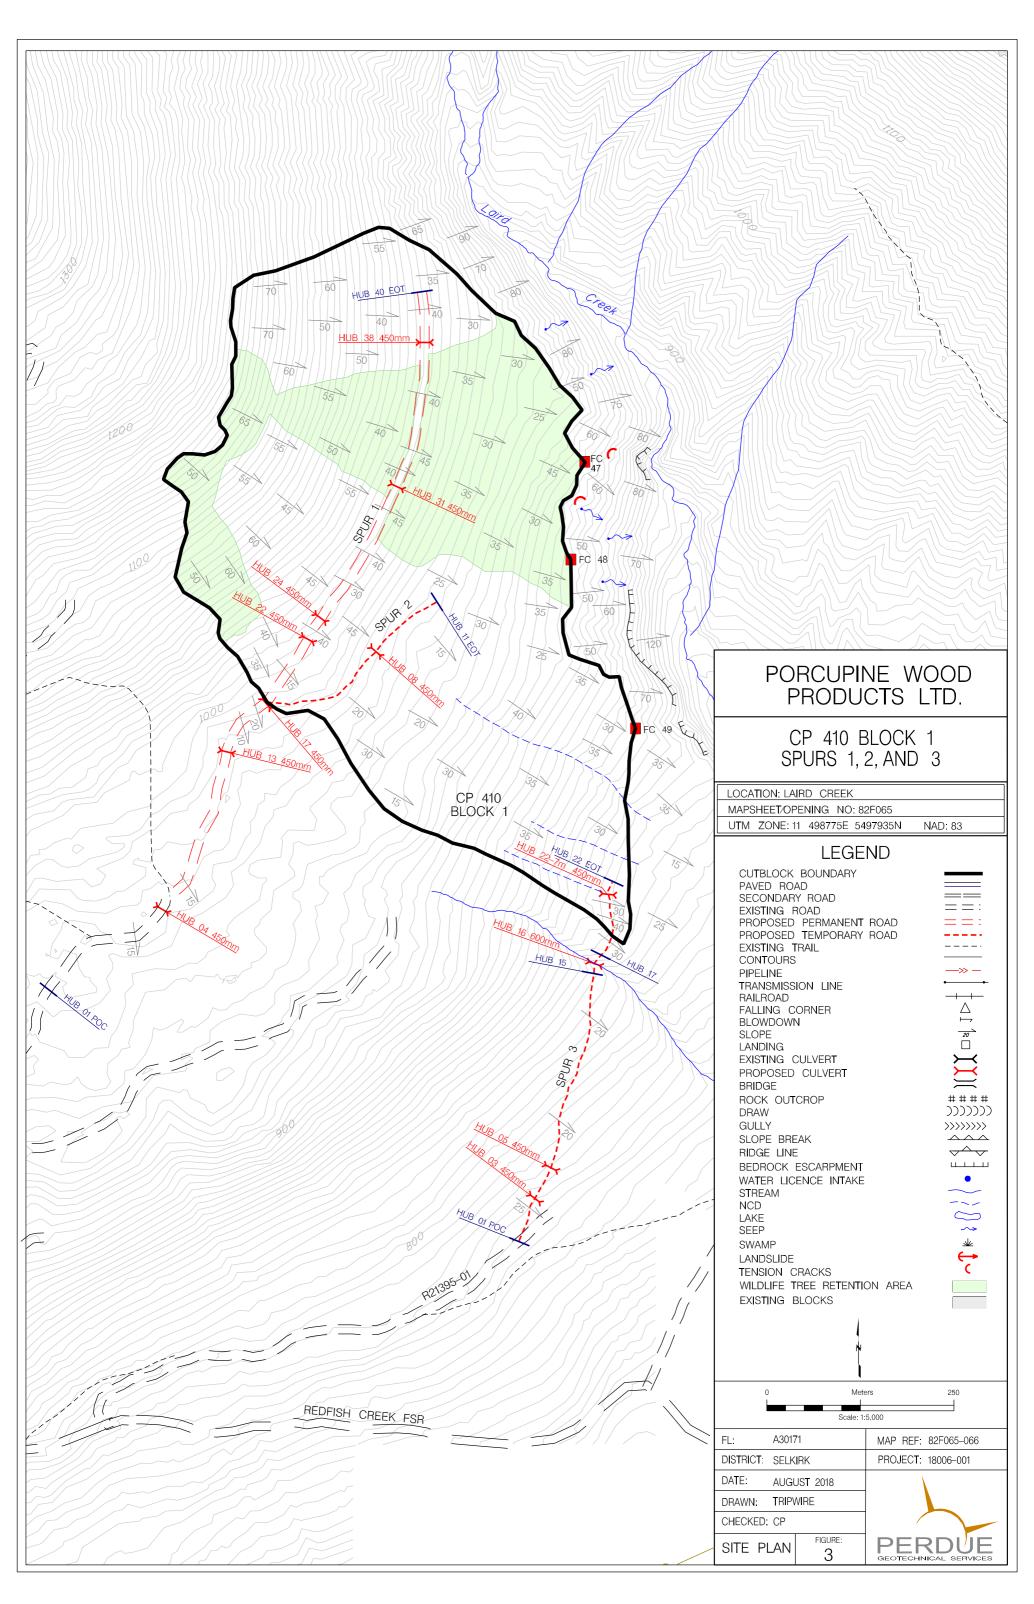
Figure 3 - CP 410, Block 1 and Spurs 1, 2 and 3 Site Plan Map (1:5,000 scale)

According to previous terrain mapping, the upper (western) majority of the block is encompassed by Terrain Stability Class (TSC) I, II and III terrain, while the lower (eastern) edge and lower slopes directly coupled with Laird Creek are rated TSC V. At the request of PWP, the geotechnical assessment was completed for the entire block. It is understood the proposed block will be harvested as a clear cut with reserves, while utilizing both ground-based and cable-based harvesting equipment. A site plan of Block 1 is shown in Figure 3.

Block 1 is characterized by slightly irregular terrain with an overall concave slope configuration. Slopes throughout the lower, approximate half of the block (downslope of the proposed Spur 1 alignment) typically measure 30% or less, while the upper remaining area generally range from 40% to 60%. Limited, steeper slopes (up to 70%) were encountered in the northwestern corner in association with near-to-surface bedrock.

The lower (eastern) harvest boundary extends along a distinct, convex slope break, north of Falling Corner (FC) 49. The downslope terrain is generally steeper than in-block observations with slopes ranging from 50% to more than 100%. Surficial soils predominantly consist of well-drained, shallow accumulations of silty sandy rubbly colluvium and lesser, mantled deposits of clayey sandy silt till. The till deposits were more dense and finer-grained than till deposits identified further upslope, within the proposed harvest area. The lowermost slopes, immediately above and adjacent to Laird Creek, are predominantly bedrock-controlled, as evidenced by frequent exposures of igneous bedrock.

Generally, site conditions below Block 1 are considered dry. Several gullies and draws bisect the lower slopes that are inferred to be the result of historic mass wasting in response to Laird Creek eroding its incised gully and over-steepening the steep sidewall slopes. Earlier field observations in April and May 2018 identified seasonally moist site conditions below the block, approximately between FCs 47 and 48. Light seepage emergence was observed approximately 40 m to 60 m below the slope break. In addition, two small tension cracks were identified below the slope break, to the northeast and south of FC 47. Limited wind-throw activity was encountered within and downslope of the proposed harvest area with no resulting slope instability.

Provided the following recommendations in the subsequent section (below) are followed, the likelihood of landslide initiation as a result of the proposed timber harvesting of Block 1 is rated as Low. The following factors were considered in determining the hazard rating:

- Ground skidding across natural drainage paths and surface watercourses should be avoided. If this cannot be avoided, harvesting should be conducted during the drier months of the year, on a compressed snowpack, or effort made to ensure timber is skidded butt-first to minimize potential ground disturbance within such drainage features;

- Timber harvesting should not be completed during excessively wet conditions, such as during the freshet and/or prolonged, heavy periods of rainfall;
- A post-harvest inspection should be completed to ensue <u>all</u> natural drainage patterns have been maintained. Logging debris should be removed from the wetted perimeter of <u>all</u> watercourses and subtle drainage features to ensure an accumulation of coarse woody debris or site degradation from logging operations does not result in a drainage diversion. These measures include ensuring the drainage network (i.e. culverts and ditch lines) along permanent roads remain functional, as intended.

- Temporary access trails may be built using debris-supported fill slopes (where required) to reduce cut bank excavation and the potential for groundwater interception. Drainage control measures
