July 24, 2020

RE: Site Review of CP 414 blocks 1 and 3 and proposed roads in the Deception/Deep Creek Area.

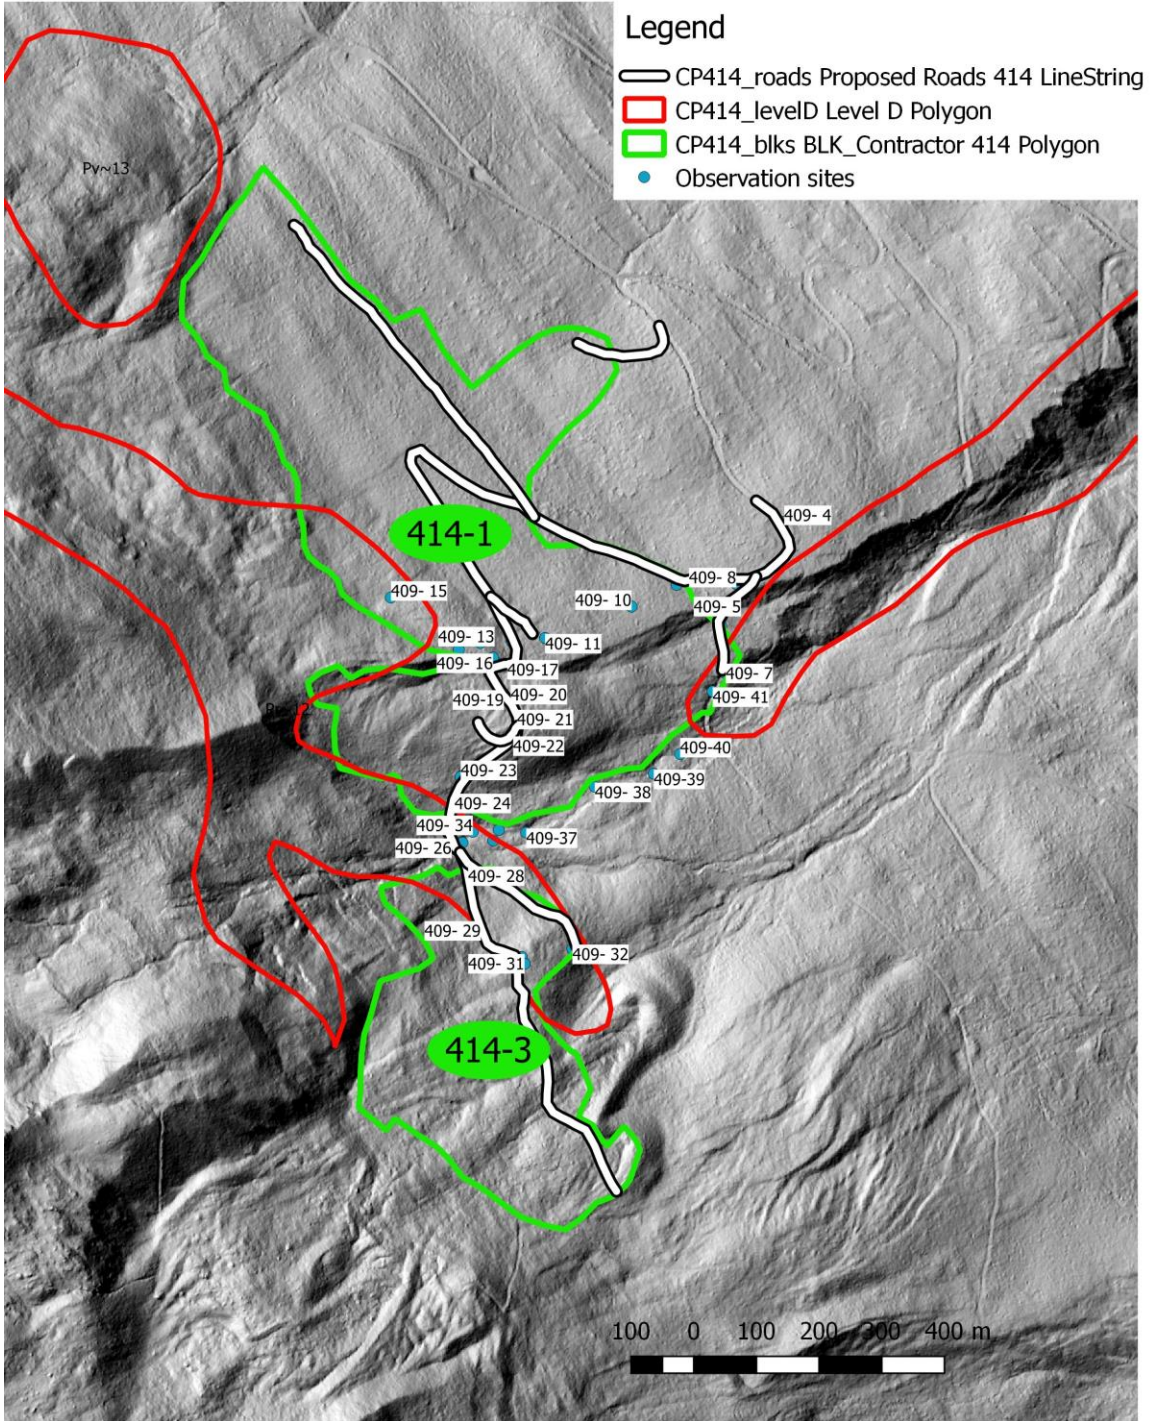
Figure 1

No evidence of instability was noted within the proposed blocks or within the stream. One small section of the proposed road crosses a short steep slope (station 409-17), it is likely that the actual road location will not traverse this slope for any length.
