APEX GEOSCIENCE CONSULTANTS LTD.

Detailed Terrain Stability Field Review

Proposed Construction of the extension of
Laird Creek Mainline, and Spurs A and B in
the Laird Creek Area
for
Cooper Creek Cedar Ltd.

13/02/2020

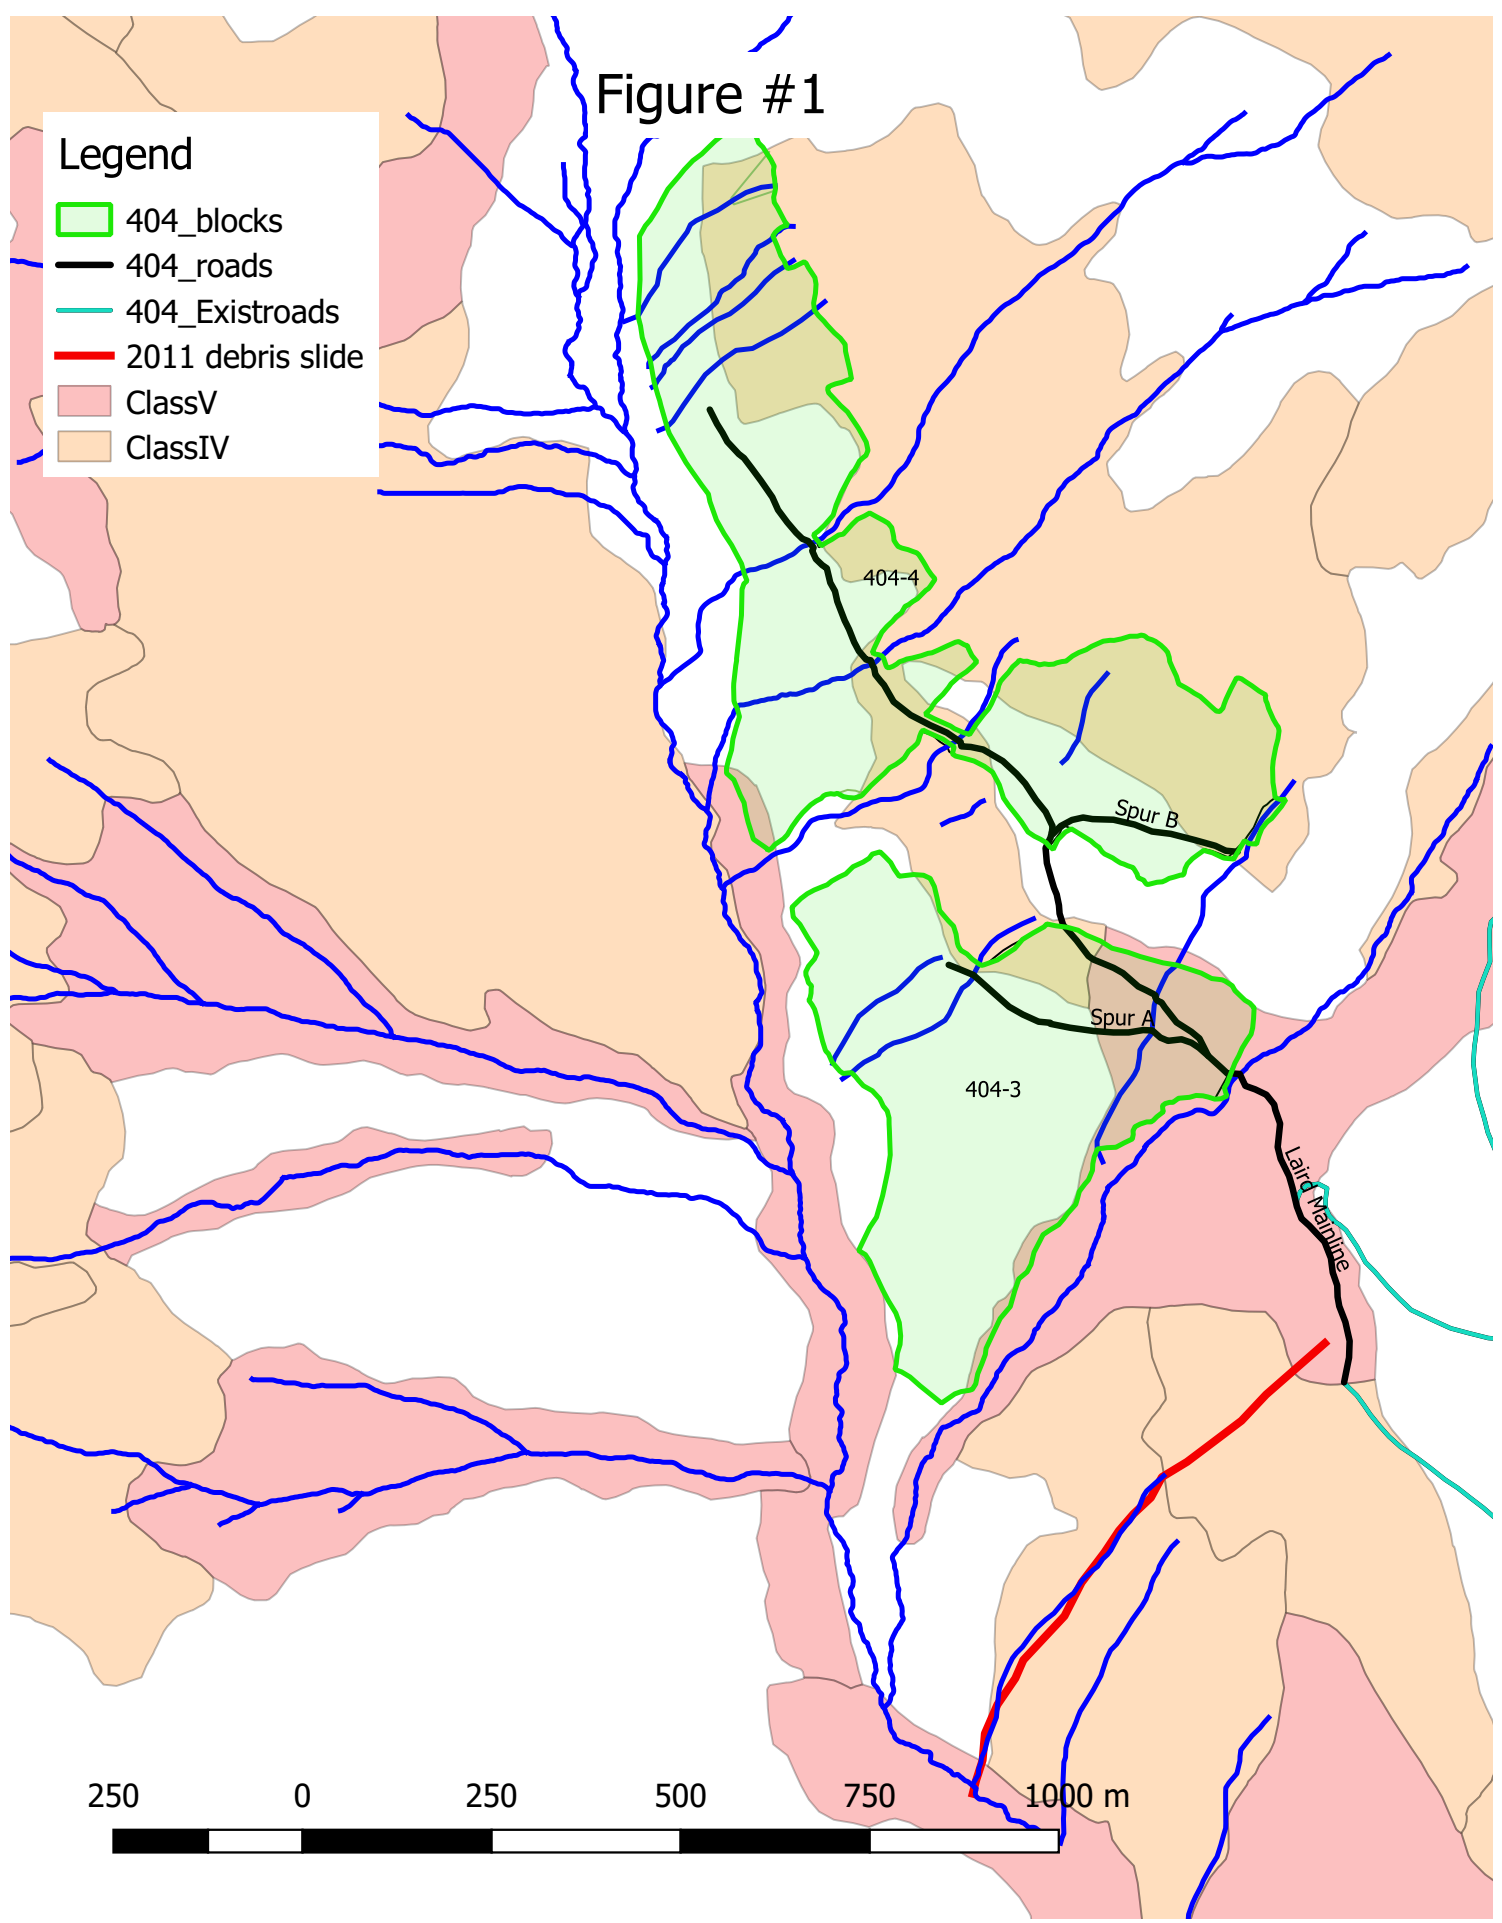
Figure #1

Mr. Kestell requested the review because portion of the proposed roads cross or are upslope of terrain mapped as Class V (unstable) and Class IV (Potentially unstable) (Greg Utzig P.Ag. 1997) as shown in Figure #1. This area is of heightened concern due to a May 2011 debris slide below the existing Laird Mainline.

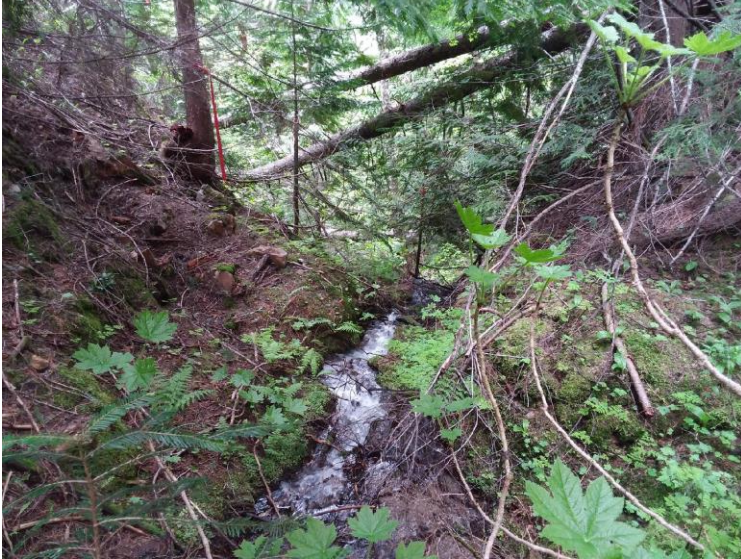
Section #9 (Hubs 83-88): The road crosses a 5m deep 2m wide gully with large boulders on east side, rock on the west side. The stream channel gradient is 75% flowing through mossy boulders, there is no evidence of recent debris flows.

Photo 1 Looking downstream at crossing.

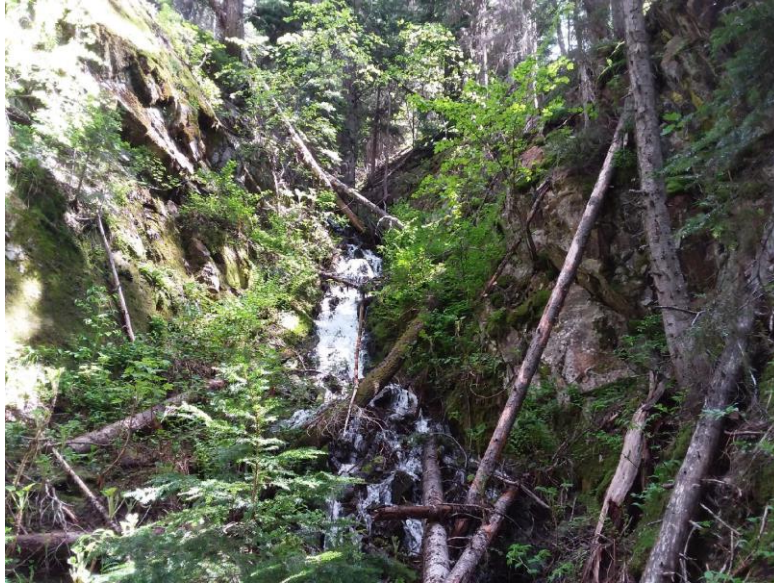
Section #11(Hubs 98-101): The road crosses a 4 to 5 m deep 3m wide rock “canyon”. The channel at the crossing location is a small rock bench, with a water fall downstream and a cascade upstream, the overall gradient upstream is 70%.

Photo 2, Stream crossing at canyon looking upstream.

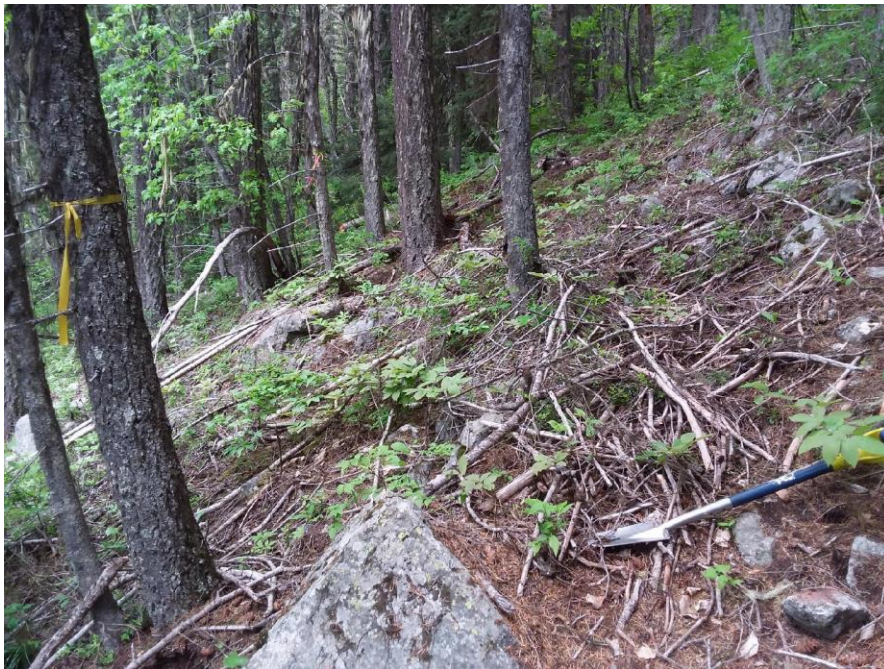
Section #12 (Hubs 101-106): This section of road is on a 70% gradient slope with shallow soils over rock.

Photo 3 Typical terrain along Section 12

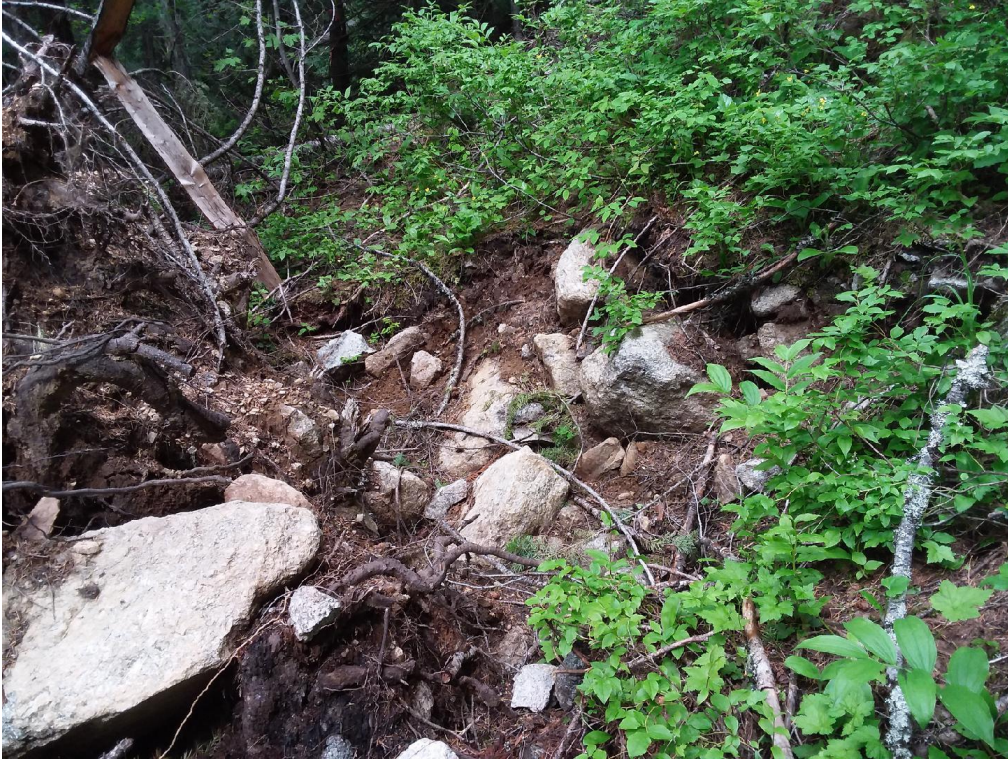
Section #13 (Hubs 106-113): This section of the road crosses a 30 to 50% gradient slope of swaled and gullied boulder gravel.

Photo 4 Typical soils Section 13
