APEX GEOSCIENCE CONSULTANTS LTD.

Detailed Terrain Stability Review

Of Proposed harvesting of Blocks 3 and 4 CP
404 in the Laird Creek Area
for
Cooper Creek Cedar Ltd.

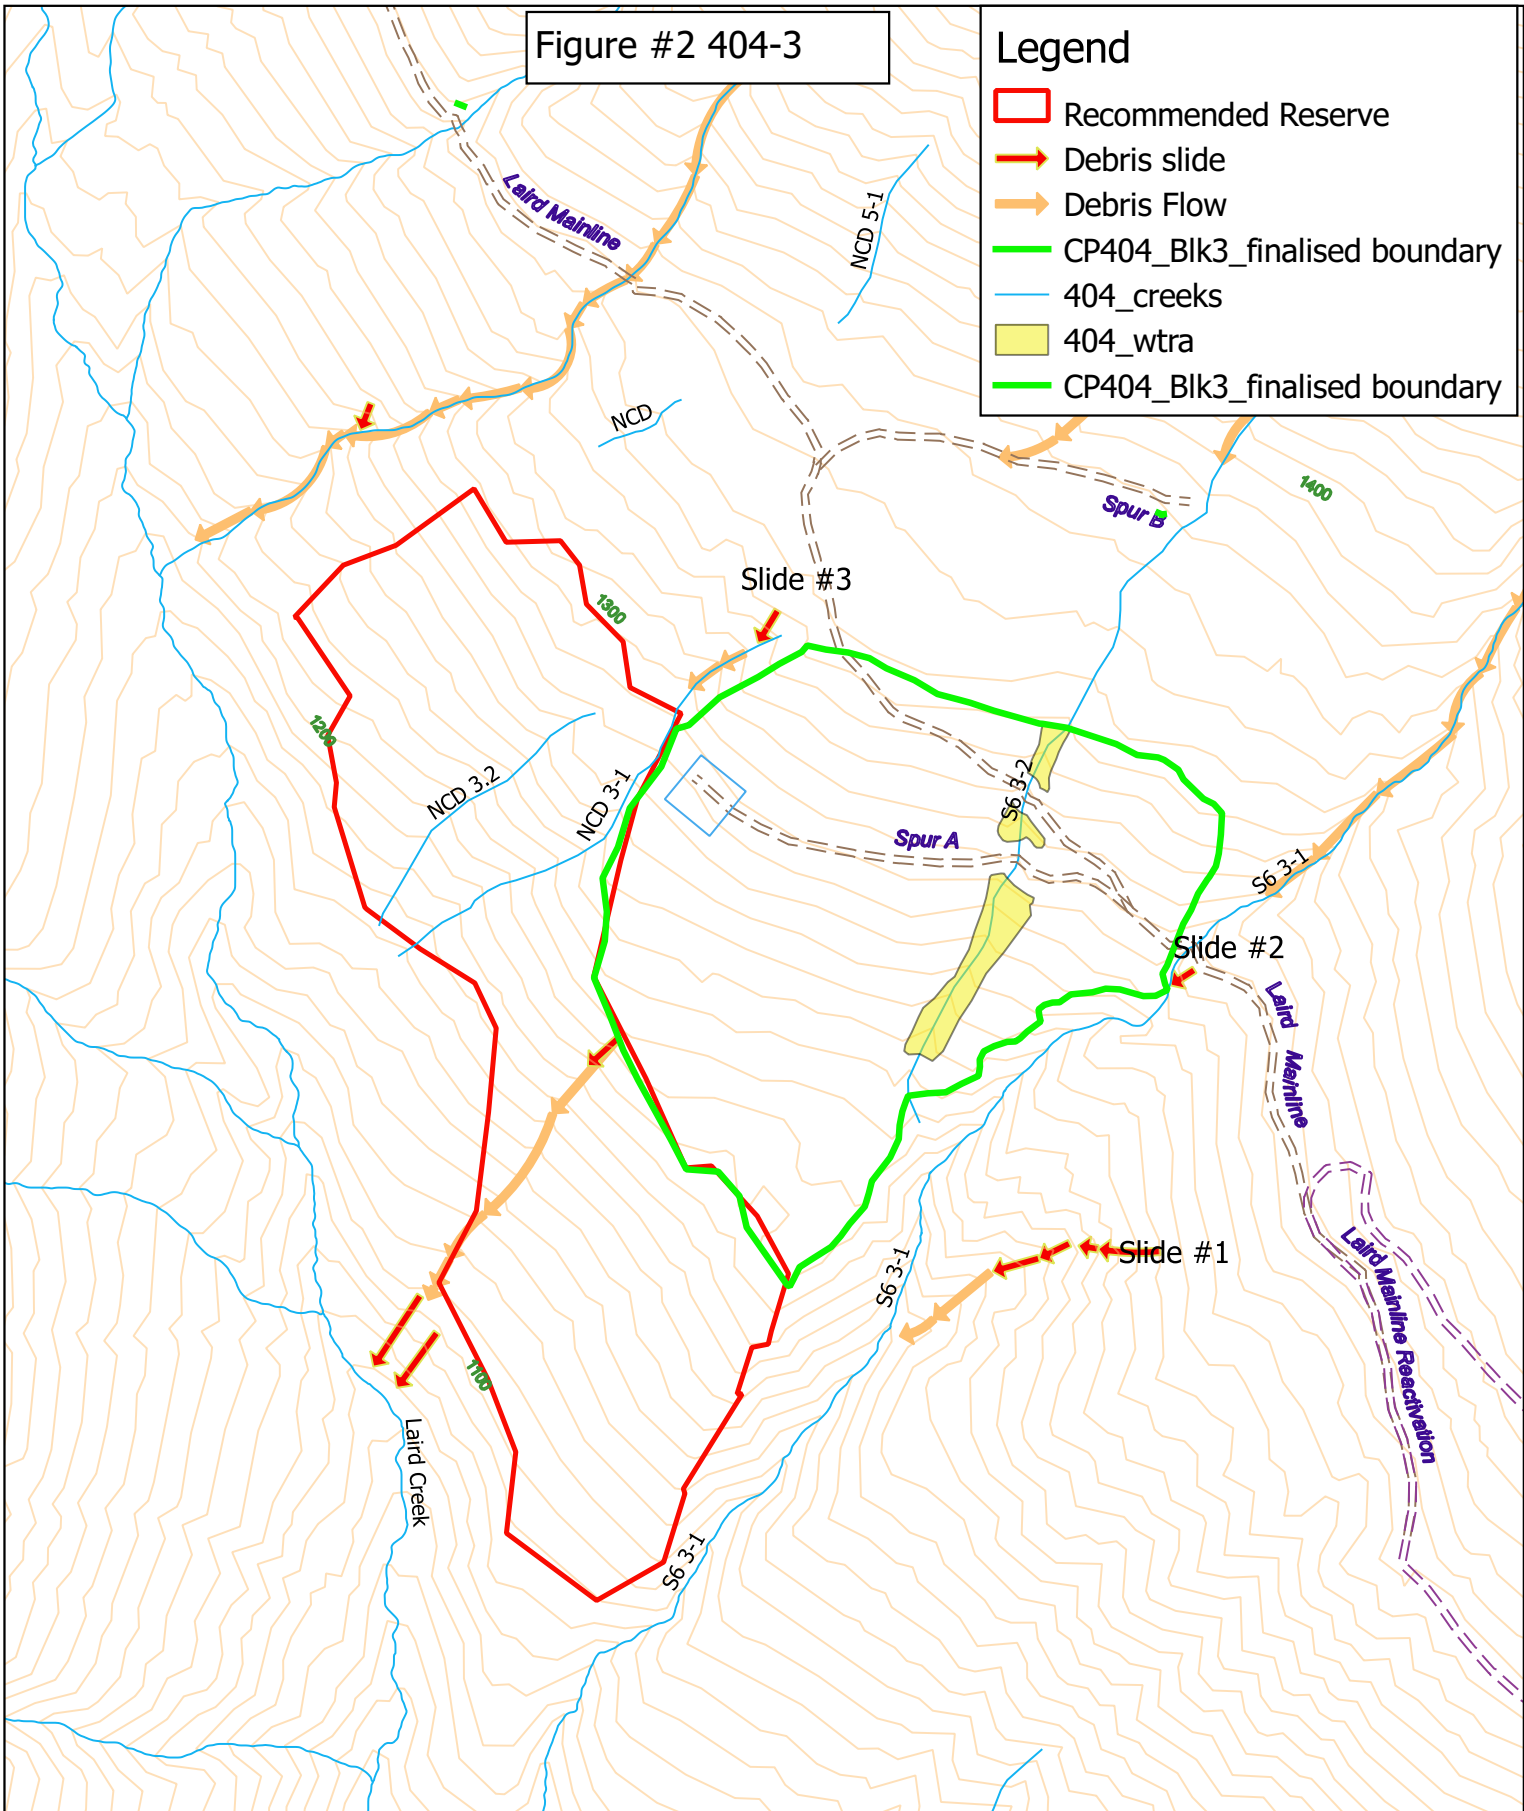
Figure #2 404-3

Portions of the proposed extension of Laird Main road and Spur A are within the upper part of Block 404-3 (Figure #2), which is within terrain mapped as Class IV and Class V terrain stability. This portion of the block has 50% slope gradient and is underlain by loose sandy boulder gravel with no evidence of instability. The southeastern boundary follows close to the slope break of a gully (S6 3-1) mapped as Class V. The steep side slope of the gully is mostly rock, there is a small boulder ridge at the top of the break that the boundary follows. Surface drainage will mostly flow southwest, parallel to the gully.

The proposed block has been stratified into a conventional portion and a cable⁴ portion (Figure #2 shows the original block configuration). The slope gradient of the conventional portion is from 15 to 30%, the cable portion is between 50 and 75% underlain by loose sandy gravel with numerous large boulders scattered across the slope.

Just below the slope break, on 75% slope, near the centre of the block, there is an ~ 100 yr. old, debris slide scarp and debris flow channel (Pa=0.01, naturally High Likelihood).

The Class V polygon downslope of the block, adjacent to Laird Creek, is underlain by sandy boulder gravel with ancient to recent debris slides (75 yr., Pa= 0.013, naturally High Likelihood) and occasional ancient to old slumps. The primary trigger for the slides is slope undercutting by Laird Creek (resulting an over steepened slope). Seeps and wet soil in the slide's scars indicate that a secondary trigger is high pore pressure within the slide scarp and/or along the toe (reduces soil strength).

Recommendations in the Hydrogeomorphic Risk Assessment included limiting the ECA linearly above these unstable slopes to 25% or less and to adjust the block boundary to exclude slide headscarps. To meet these objectives, it is recommended that the lower steep portion (roughly coincides with the proposed cable portion) be reserved (figure 2), this would exclude the 100 yr. old slide headscarp and reduce the linear ECA to ~25%. To reduce the hydrological impact of Spur A, the spur should be constructed as a short-term road or forwarding trail and reclaimed after silviculture requirements are met (ex. Planting) or within three years whichever is sooner.

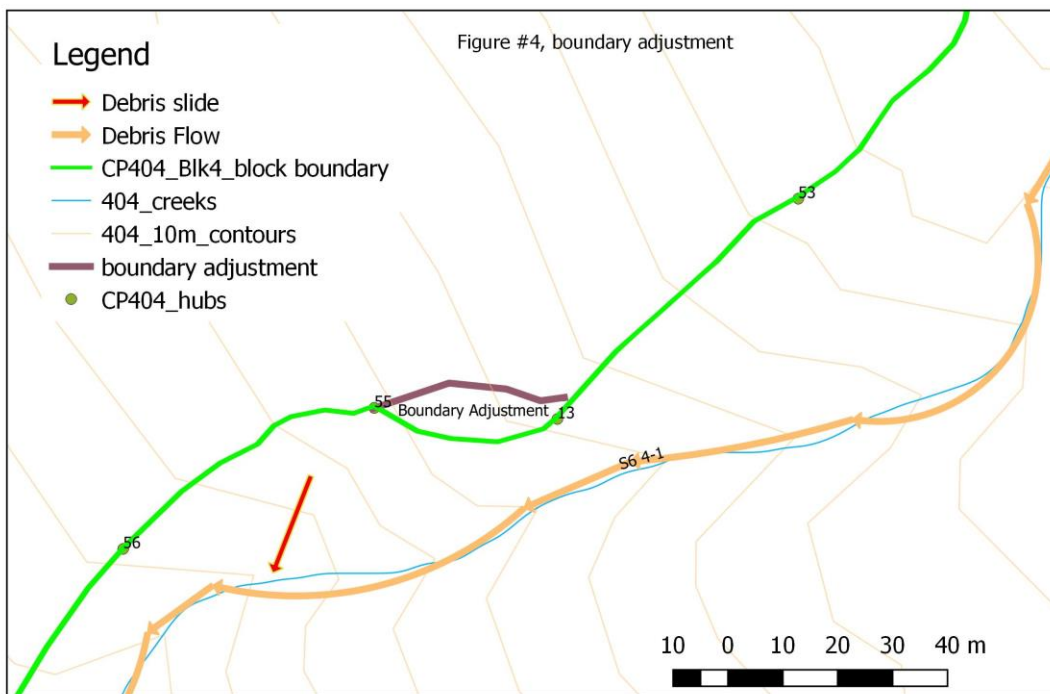
West of FC #13, upslope of stream 4-1, the boundary dips into an ancient debris slide scarp, yarding trees out of this scarp will gouge the headscarp resulting in an over steep slope and a significant increase in landslide initiation. Pull the boundary out of the slide scarp onto the slope adjacent to the slide, from hub 55 to just past FC 13 (Figure 3).
