# Detailed Terrain Stability/Karst Field Review

Proposed Harvesting and Road Construction  
in the Argenta Face Area CP 416 blocks 1 – 9;  
12- 14: Bulmer Main Line and Spurs  
for  
Cooper Creek Cedar Ltd.

2022-03-10

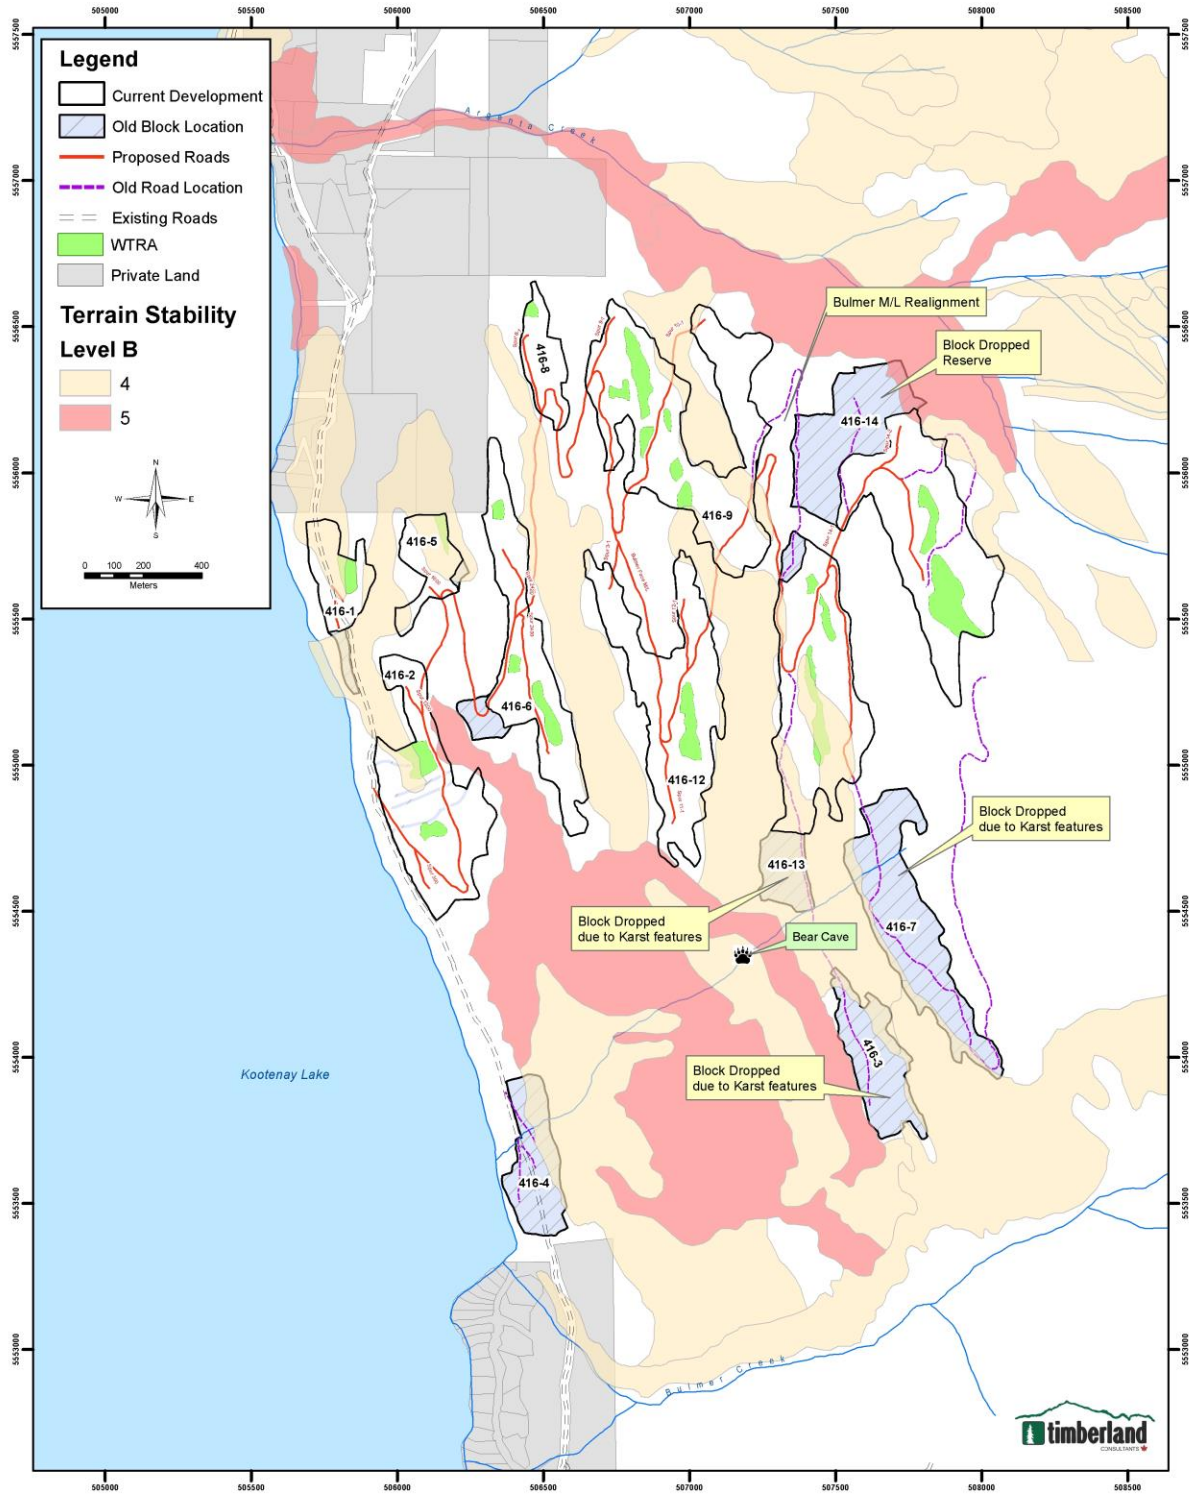
Figure #1

The development (figure #1), situated between 760m asl and 1520 m asl on Argenta Face, consists of a series of proposed cut blocks, roads, and spurs. The blocks are located on benches and sub-parallel draws. The benches or draws are separated by steeper rock-controlled slopes which correlate with the mapped terrain stability Class IV polygons. Surface slope drainage is controlled by these sub-parallel north-south trending draws, ridges, and benches (geology defined glacial scour) resulting in few definable watercourses. The Class V polygon mapped in the south part of the area outlines a large rock slump and headscarp. The slump was not assessed in detail, but it is assumed to be dormant. This failure is associated with karst features adjacent and upslope of the main headscarp.

To meet Cooper Creek Cedar's management strategy of avoiding areas of Karst, delete blocks 416-3, 416-7 and remove southern portion of 416-13 from harvesting, place a reserve in the northwest portion of 416-14, realign the portion of the proposed road below block 416-14, and delete spurs 1-16, 14-1, 15 from the proposal (figure #1).

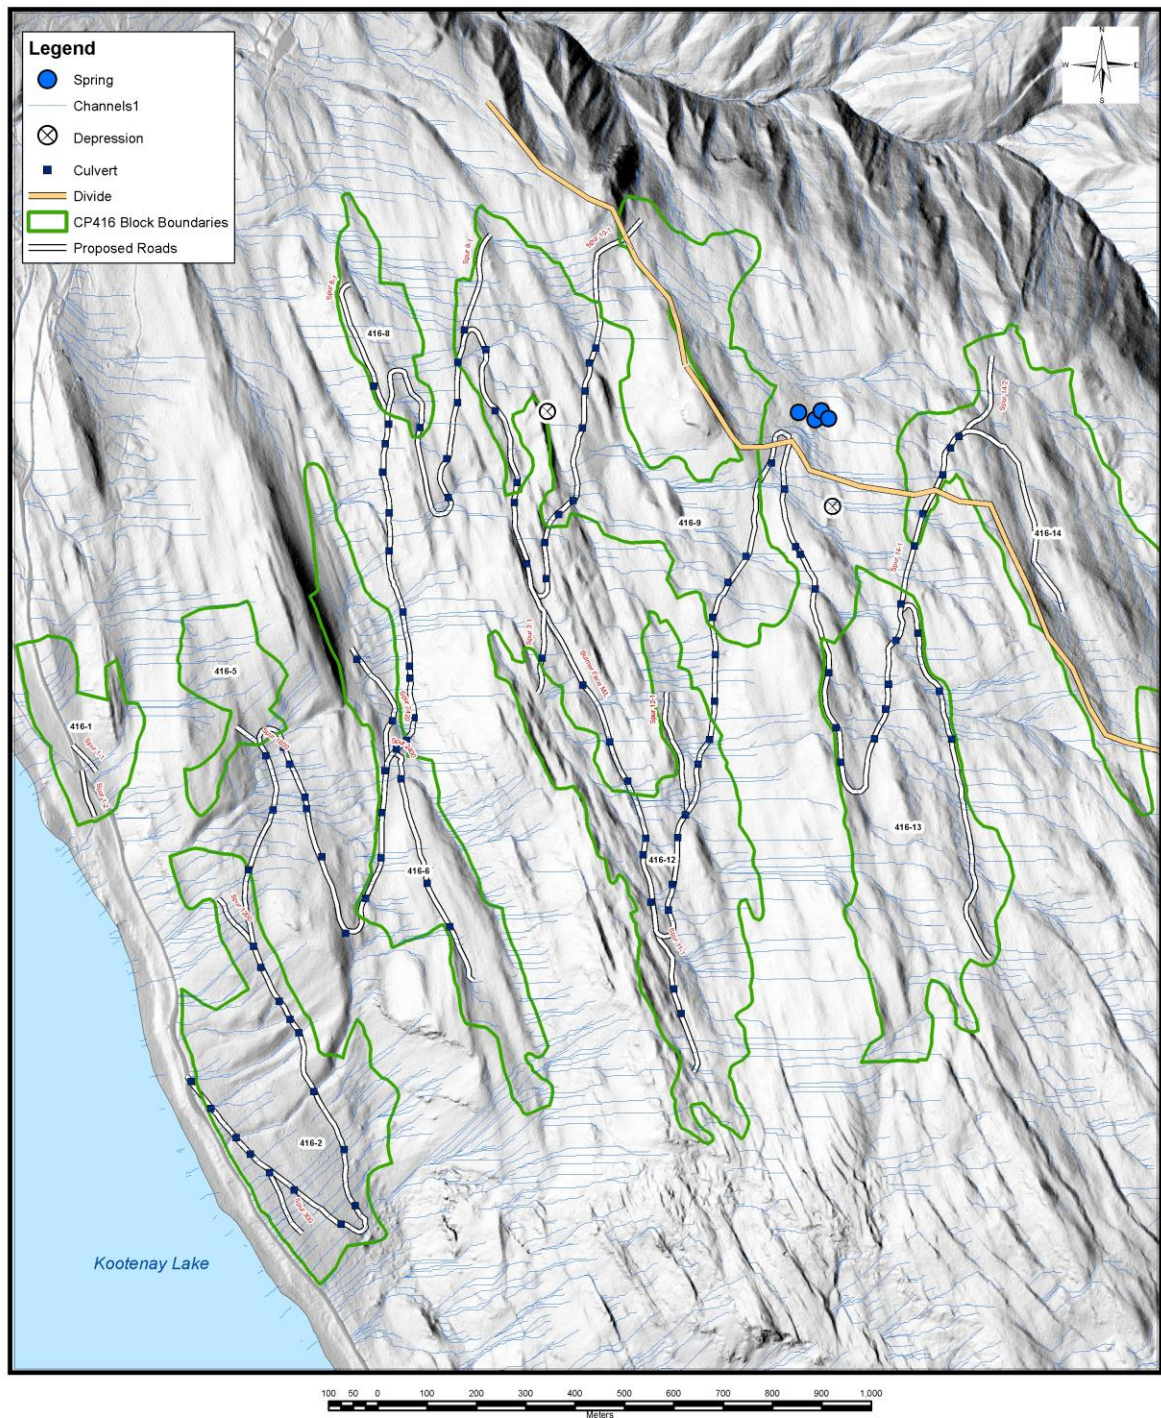
Figure #2  
DEM Derived Drainage

Glacial scouring of the slope selectively removed the phyllite (recessive) leaving small benches/draws (swales) separated by steeper rock slopes or ridges (Quartzite and to a lesser degree Limestone) sub-parallel to the contours. This topography controls the surface slope drainage on the face. Except for the noted springs and karst emergent streams in and below block 14 there is little evidence of streams or surface flows. Surface drainage patterns approximated from the DEM file using SWAT drainage delineation program (figure 2) show a “parallel” drainage pattern.

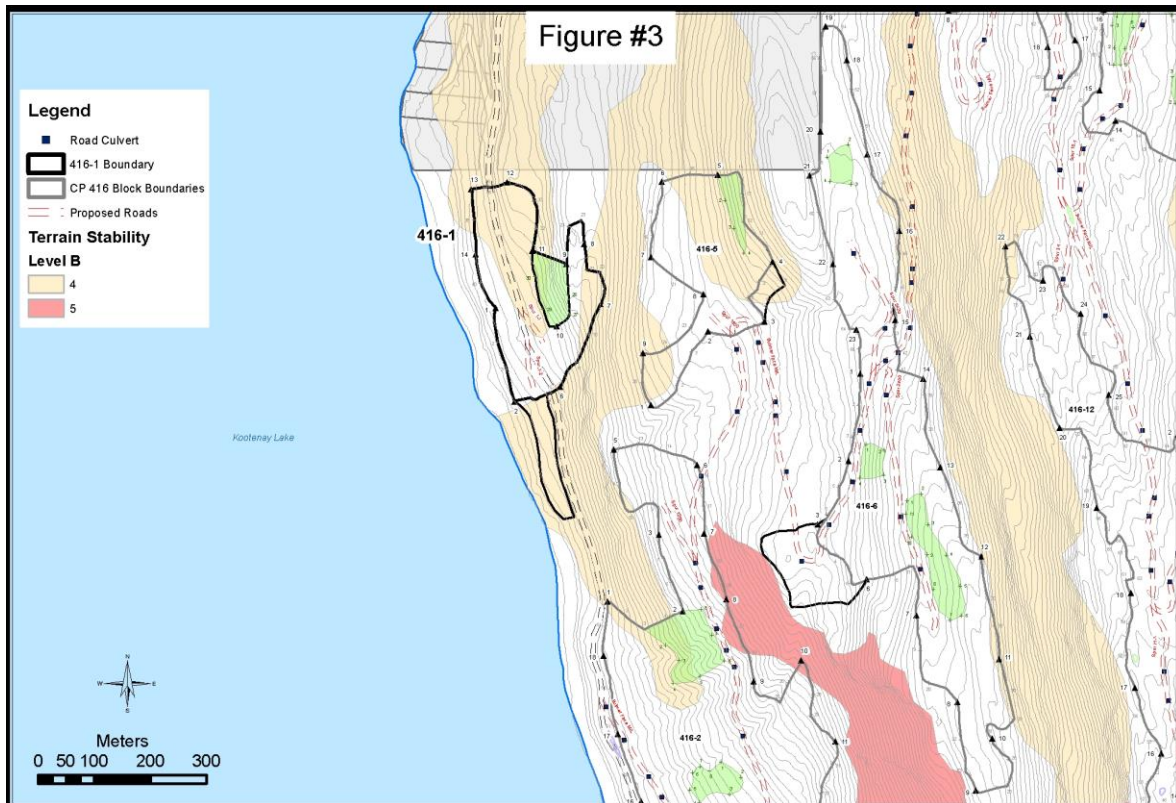
The proposed block partially straddles the Argenta-Johnson Landing Road directly upslope of Kootenay Lake (Figure #3) . Most of the lower boundary is along a small road that leads to abandoned mine shafts and old workings in the southern portion. The block lies partially within terrain mapped as potentially unstable (Class IV). The polygon underlying the north portion of the block has a 50% slope gradient and is shallow to rock, there is a small area of 85% gradient slope underlain by rubble and outcrop that within in a WTP. Below the block there is a 100% gradient slope underlain by sandy gravels with old ravelling. The southern portion of the block, that overlies a terrain polygon, is underlain by rock steps and low gradient slopes. There is no sign of instability within the proposed block.

The upper portion of the block impinges on a Class IV terrain polygon (Figure #3) which except for the eastern most portion, is a 20% to 50% gradient slope underlain by gravel and colluvium. The eastern most portion (within a wtp) is a short 75% gradient slope underlain by rock and colluvium. There is a broad bench and old road at the base of this slope. Below the block, the terrain polygon is overlying a 45% gradient slope underlain by gravel with large erratic boulders. There is no evidence of instability.

This block is located immediately west of a large class IV polygon (Figure #3). The north end of the block spans a deep rock draw. The western boundary is at the base of a 90% gradient rock face on short 70% gradient blocky colluvium apron just up from 25% gradient slope in the draw. The eastern boundary is 15m up from the flats on 60% gradient blocky colluvium apron. The southern portion of the block is typified by broad rock benches and northerly pitching draws. There is no evidence of instability.

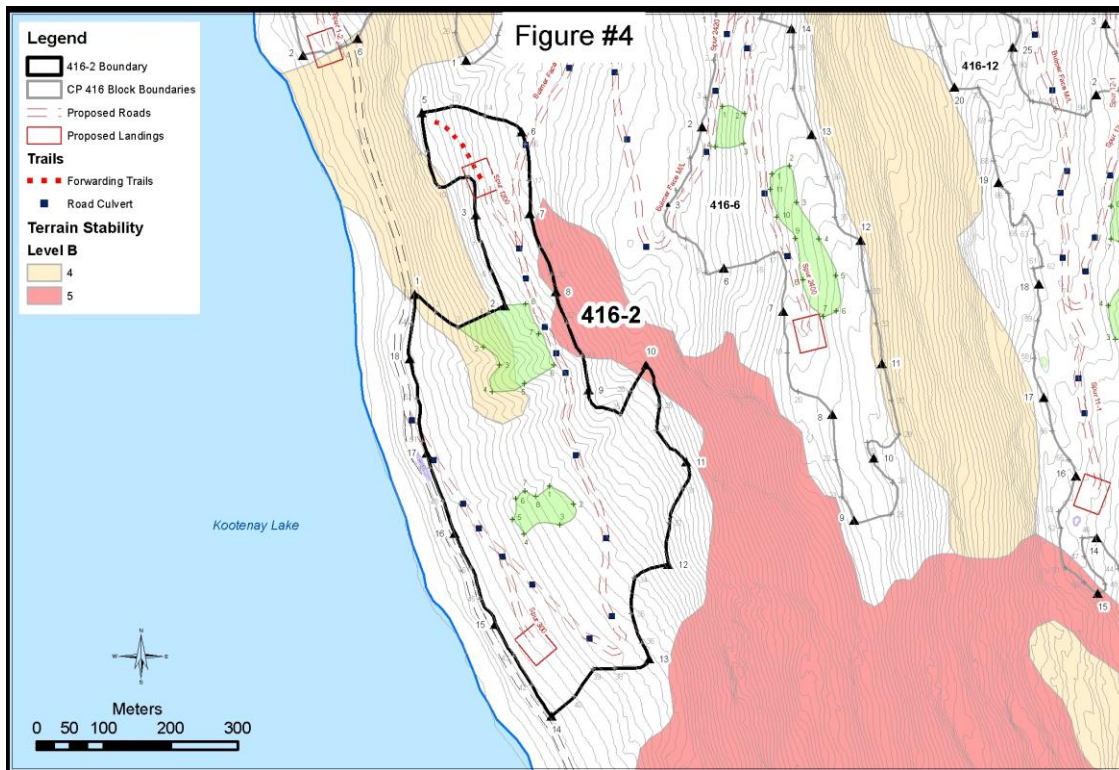
The proposed block is just upslope of the Argenta -Johnson Landing Road and immediately downslope of terrain mapped as Unstable (Class V) (Figure #4), which in this area, is underlain by benched gravelly sand, coarse colluvium, and rock outcrops with no evidence of instability.

The proposed block is underlain by bands of angular colluvium and outcrops interspersed with gravelly sand. The slope gradient is 50% or less (60% in the wtp). There is no evidence of instability within the proposed block.

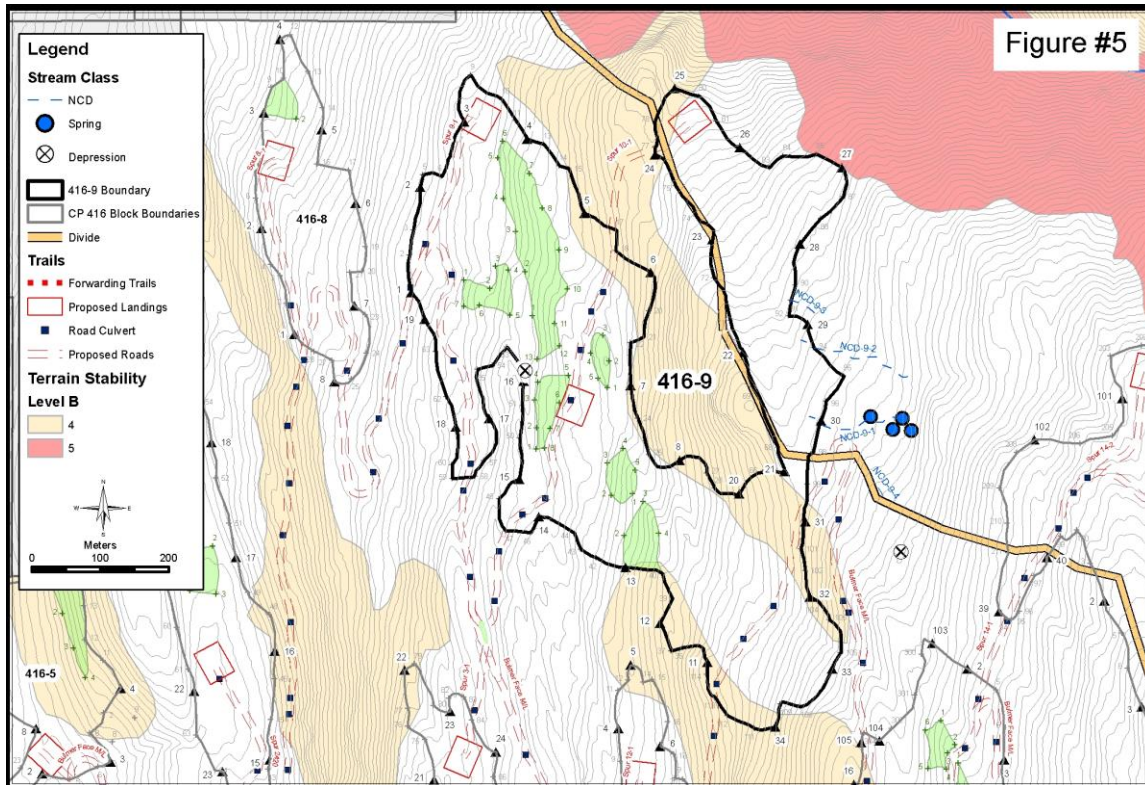
The proposed block is situated between, and impinges on, two class IV polygons (Figure #5).

The lower portion of the block is underlain by a series of broad north pitching draws/benches separated by short sharp (razor back) ridges and rock shelves. In places the boundary is located just up from a bench on the steep side slope (75%) of a ridge. The upper portion of the block is located on 45% slope gradient immediately below a 65% gradient slope underlain by coarse colluvium and rock. Except for possible rock fall from upslope there is no evidence of instability.

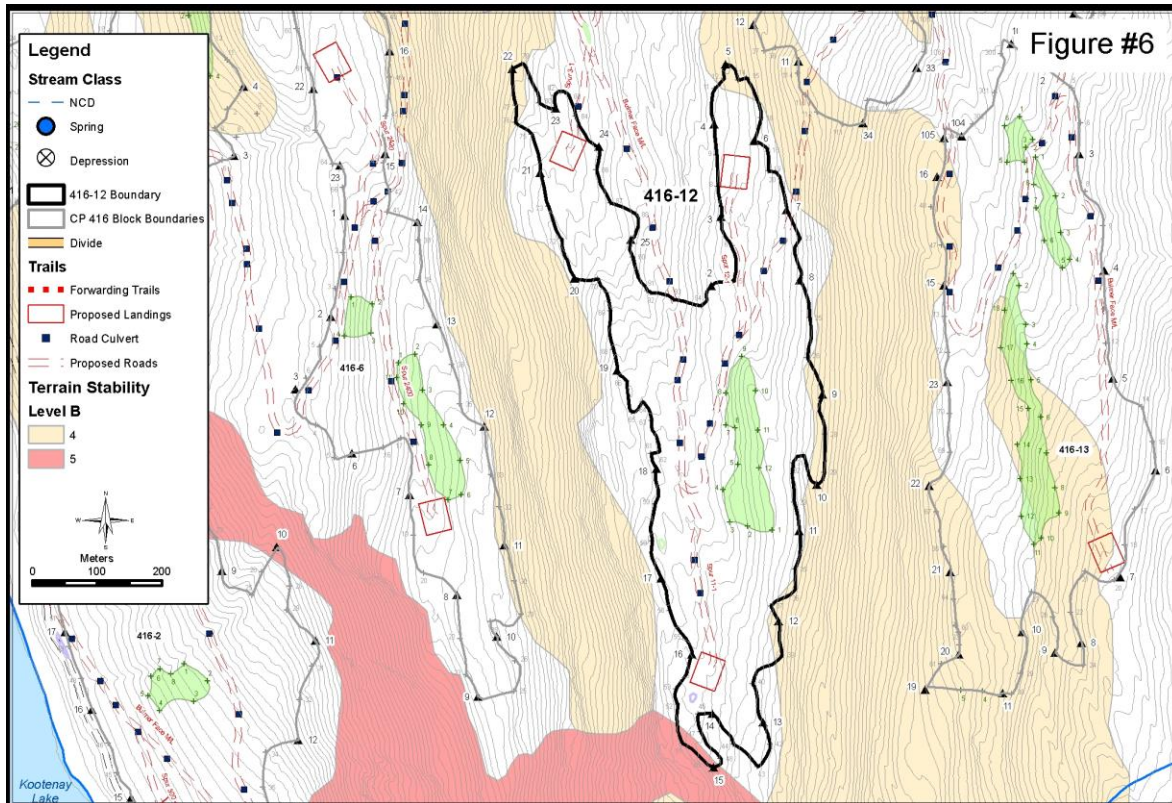
The block is situated on two broad benches underlain by silty gravel separated by a short 45% gradient slope of coarse colluvium and scattered outcrops. The block is “upslope” of a Class IV polygon (Figure #6) which delineates a series of bluffs and blocky colluvium aprons. Except for minor rockfall there is no evidence of instability.

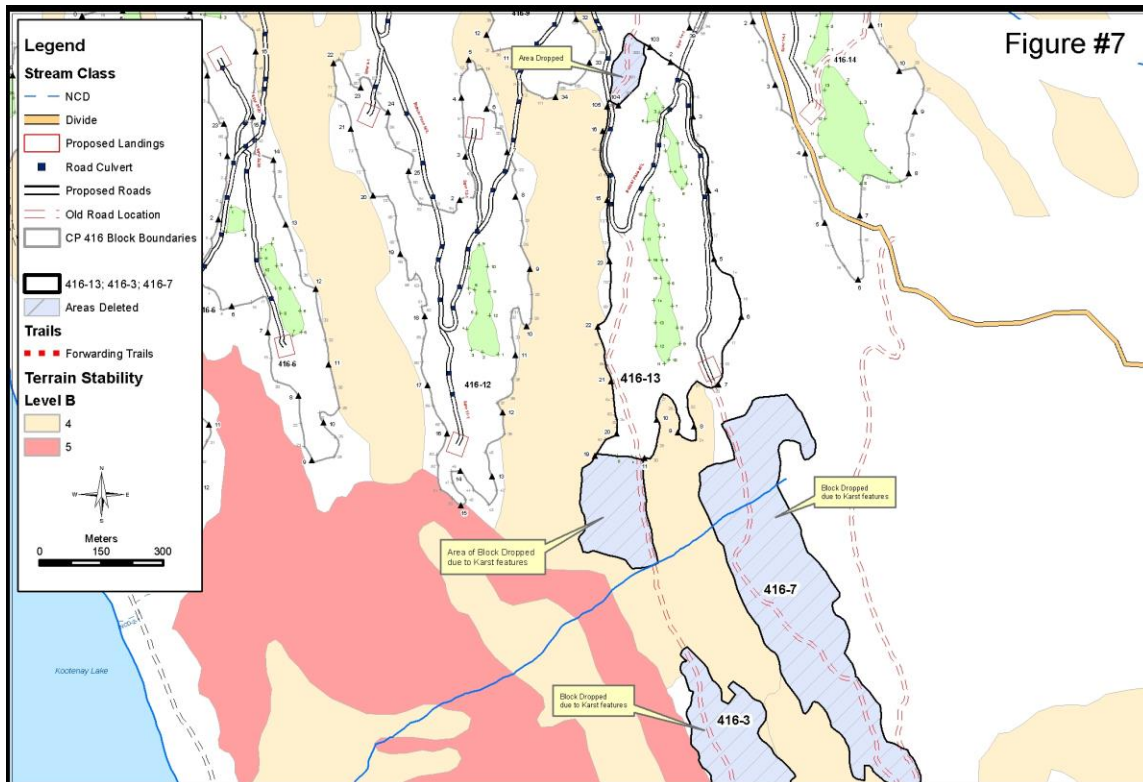
The proposed block (Figure #7) impinges on and is upslope of a terrain Class IV polygon. The northwest corner of the block extends onto a short 65% gradient slope underlain by silty sandy angular colluvium. The polygon below the block has 65% to 85% gradient slopes underlain by coarse colluvium with steep (90%) rock faces and small rock shelves. Within the block, the polygon is typified by short colluvial 55% gradient slopes and rock shelves.

There are significant karst features, including sinkholes, hillocks, and ridges in the southern portion of block 416-13. This portion of the block is adjacent to, and upslope of slump scarps associated with the large dormant rock slump just north of Bulmer Creek (Class V and IV polygons).

Apart from the dormant rock slump and isolated rock topple/fall from the steep rock faces there is no evidence of instability within or below the block.

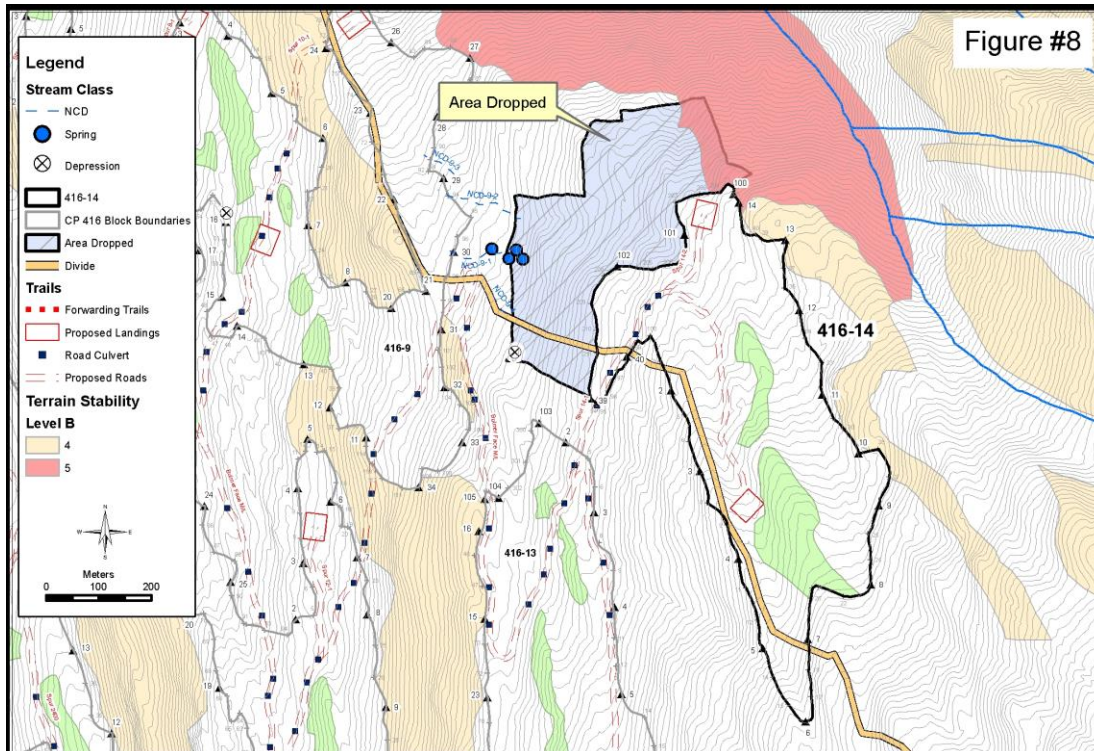
The upper portion of the block is situated on moderate gradient slopes just downslope of a snow avalanche runout zone (Figure #8). Wet and brushy areas at the termination of the avalanche zone are likely areas of accumulation of avalanche deposits that retain snow late into the spring melt. The lower portion of the block straddles a small steep rock bowl that may be a collapse feature, there are emergent streams and associated fans of loose and porous tufa (calcium carbonate precipitate) below and within the lower portion of the block. There is also a spring associated with a travertine mound deposit on the slope below the block.

Block 416-14: To avoid any potential impacts on travertine deposits, emergent springs with tufa, and collapse features, reserve the southern part of the block as shown on figure #12. This exclusion area also effectively isolates the block from direct contact with the slope to Argenta Creek.

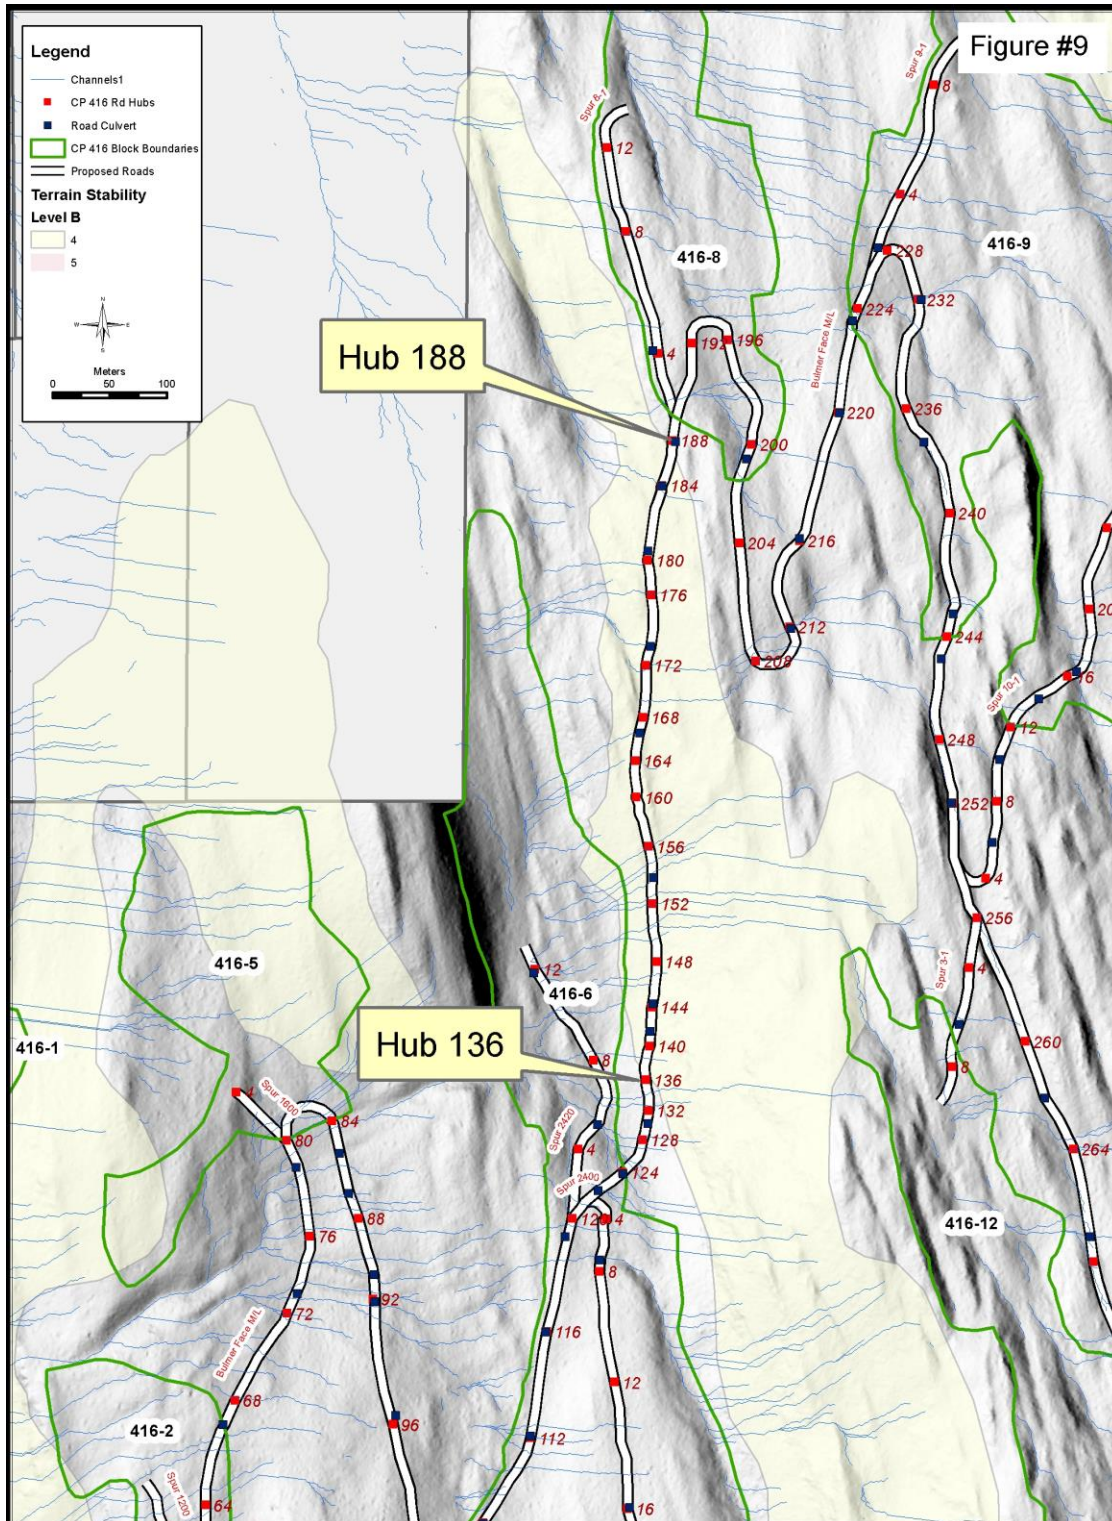
This portion of the road (figure #9) crosses terrain mapped as Class IV which has a slope gradient greater than 60% and is underlain by short rock bluffs and steep blocky talus slopes. The only instability noted was scattered rock topple.

Hubs	Slope	Material	Recommendations	Residual likelihood of slide
145-162	65-85% (Small rock faces 100%)	Blocky colluvium and outcrop	Cut in rock 0.25:1, in talus 1.1:1, key in and place coarse colluvium 1:1, FB slopes greater than 80%	L
172	50-100		1:1 fill, try not to spill over side, move center line ~ 2m into hill.	L

Hubs	Slope	Material	Recommendations	Residual likelihood of slide
185-189	65 to 100%	Blocky colluvium and outcrop	rock 8m high on cut side, blocky coll 65% down with step 10 to 15m below, key in fill.	L

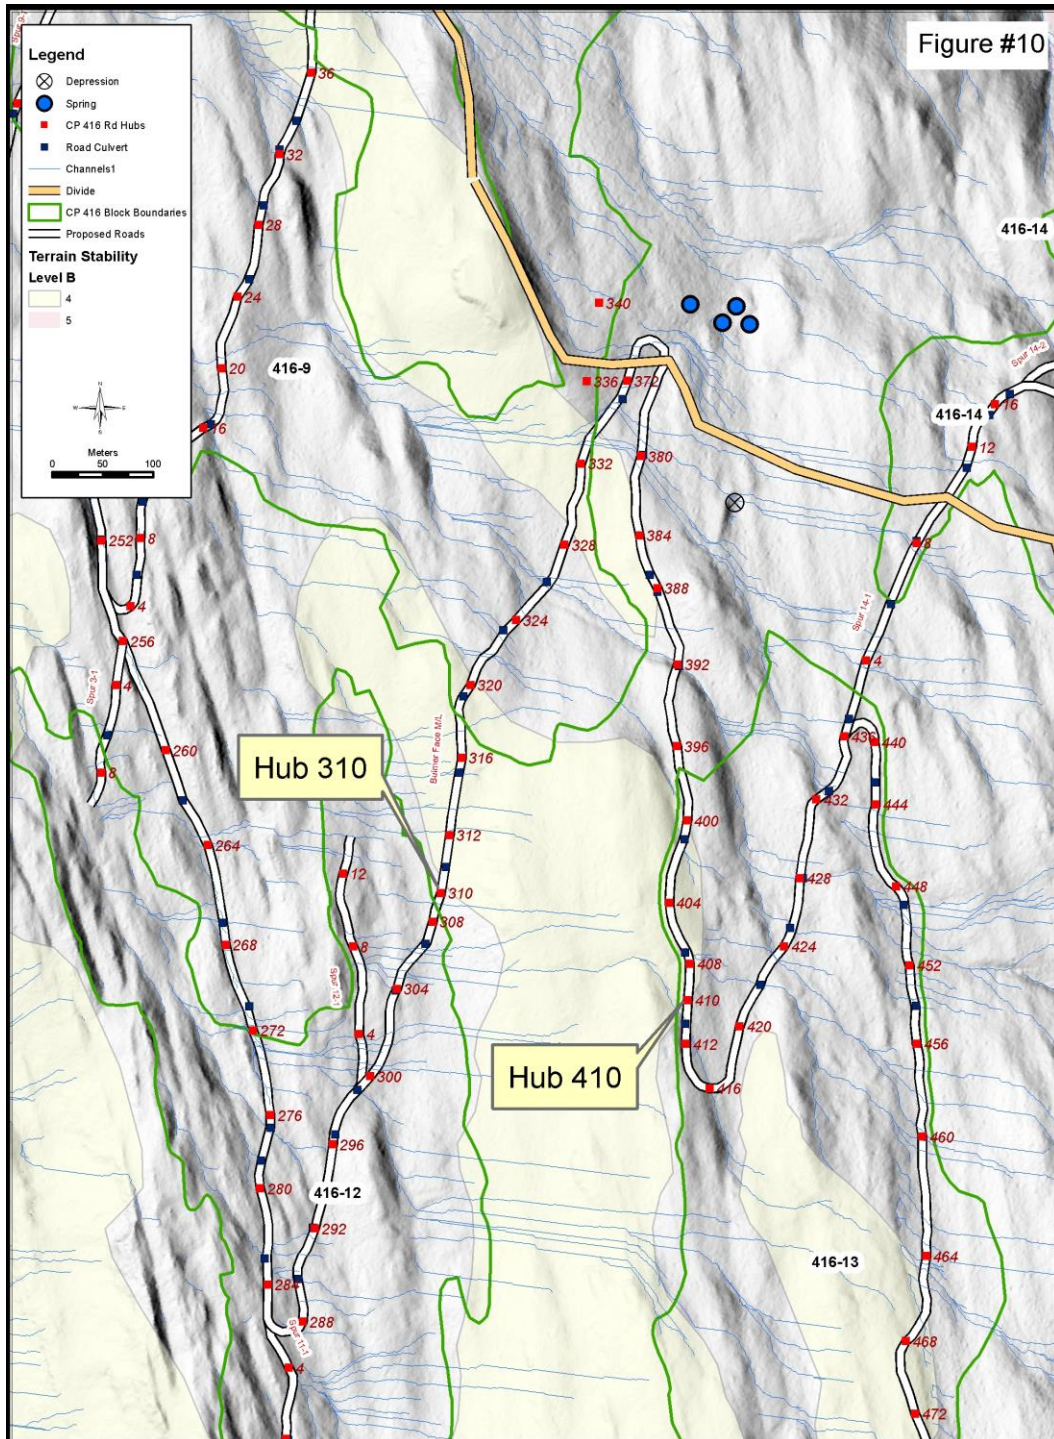
***Bulmer Main between Hubs 310 to 410: (Figure #10)***

Between Hubs 310 to 321 the road crosses a Class IV polygon which in this area has a slope gradient of 60 to 65% and is underlain by coarse colluvium and small outcrops.

The slope along the road location within the northern polygon (hubs 329-369) does not exceed 45% and is coarse colluvium below a small rock lip. Just past hub 374 the original old road alignment switched on the broad bench with multiple NCD's/emergent springs, then along the base of a slope which contained a karst emergent spring and associated travertine deposit. The road was realigned to avoid this area. The new alignment of the road switches (hubs 374-375) in dry broad flat south of this area.

Hubs	Slope	Material	Recommendations	Residual likelihood of slide
309-321	45%-65%	Coarse colluvium and rock steps	key in fill, place coarse material at no more than 1:1. Cut 0.25:1 in rock, 1:1 in colluvium (1m)	L
319	60%	Coarse colluvium	culvert marked, move culvert north 20m to sta. 321.	L
321	45%	Coarse Colluvium	Move culvert from 319 to here.	L

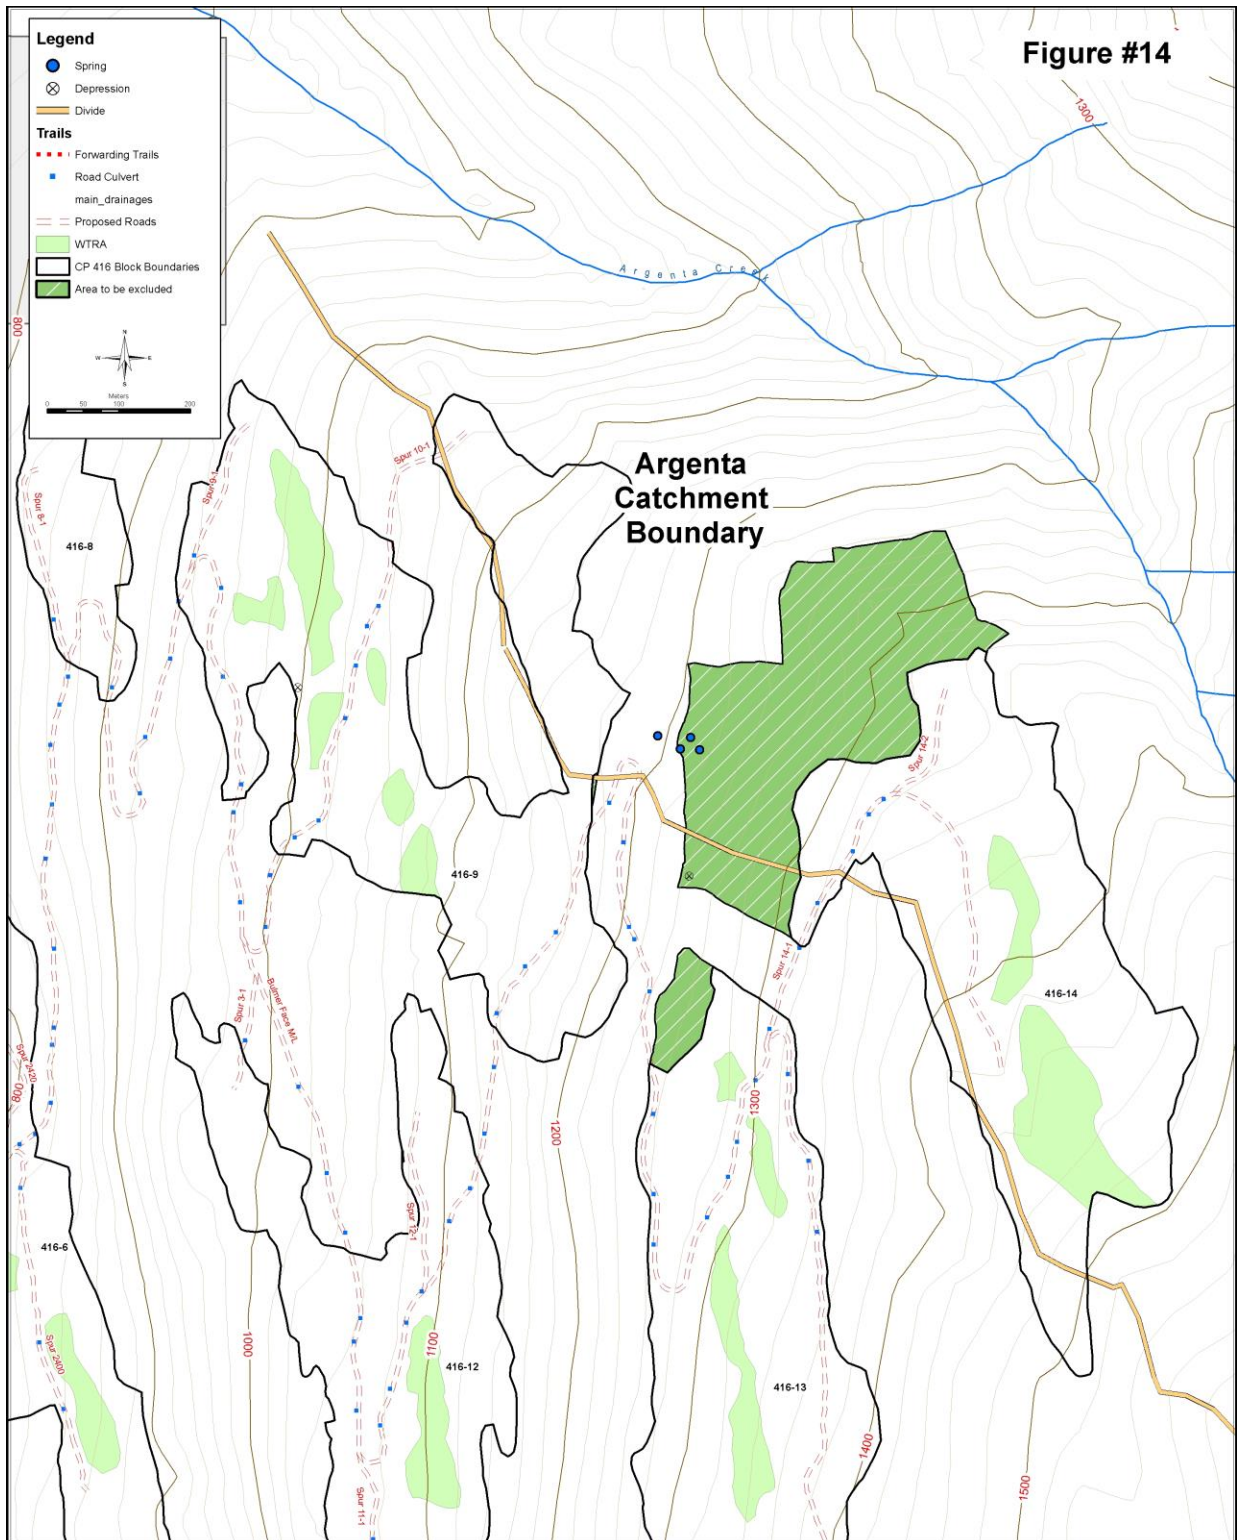
As seen on figure #14 only portions of Blocks 416-9 and 416-14 are within the Argenta Catchment. The end of Spur 10-1 just enters the mapped boundary within block 416-9 and the switch just upslope of this block is also just within the catchment. There is a low likelihood of landslides (the slope gradient within the block is  $>45\%$ ), the boundary is set back from the slope to the creek which is this location is  $\sim 55\%$ . The recommended excluded area in block 416-14 isolates the proposed harvesting from historic instability on the slope above Argenta Creek (visible on hillshade), the drainage within the block will not flow towards the noted instability. To the north, the block and in block spurs are separated from the slope to Argenta creek by a small rise. Both Blocks 416-9 and 416-14 are assessed as having a low likelihood of landslides, landslides that did initiated would not reach Argenta Creek, however due to the drainage patterns sediment may reach the stream.
