Detailed Terrain Stability Field Review

Proposed Harvesting and Road Construction
in the Salisbury Face Area (Blocks 405-1, 2,
4, 5, 6 and 7: Spurs 1-3, 4-1, 4-2, 6-1 and 6-
3)
for
Cooper Creek Cedar Ltd.

W. Halleran P. Geo, L.Eng.

13/02/2020

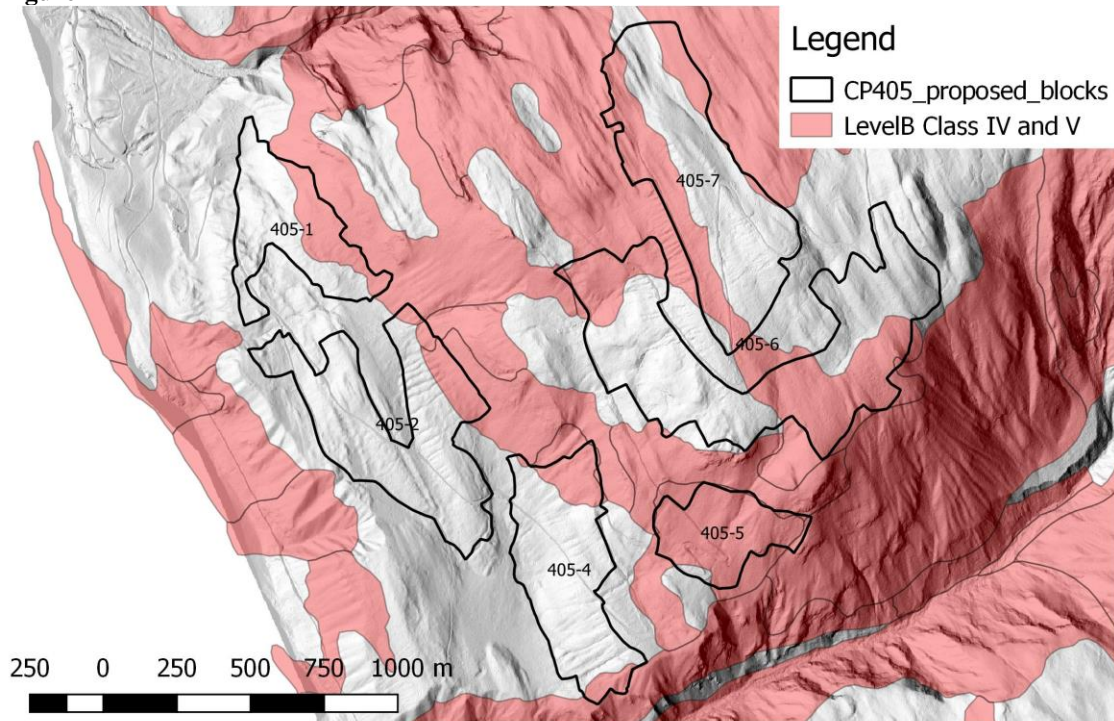
Mr. Wells noted that the digitized polygons did not precisely fit the Trim map base. The terrain stability IV and V polygons are shown on figure 2. After reviewing the plotted polygons on the lidar hillshade imagery it appears that the polygons are shifted ~ 65m west and ~ 90m north (assuming polygon boundaries correspond with obvious topographical features), confirming Mr. Wells observations. It is possible that shift is the result of different coordinate systems between the terrain polygons and underlying map. Figure 2 below shows class IV and V polygons plotted on the hillshade map derived from the Lidar DEM.

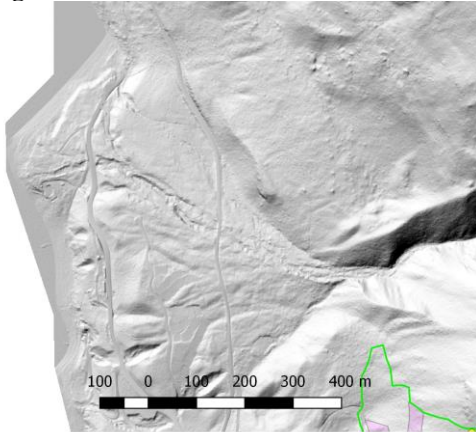
Figure 3

Debris floods are an existing hazard for both Bulmer and Salisbury. Debris floods occur when most or all the stream bedload is mobilized during a flood event and are a function of the flood frequency of the watershed. A comparison (figures 3 and 4) of the fans indicates that debris floods occur more frequently in Bulmer Creek then Salisbury, as evidenced by the debris deposits on Bulmers large “Paleo fan”. Also, the Bulmer Creek fan at lake level appears relatively large compared to current Salisbury Creek fan.

As can be seen in the figures, Bulmer Creek is poorly confined on the Paleo fan and recent fan, Salisbury Creek is well confined through the paleo fan and moderately well confined in the recent fan. The poor confinement increased the risk that the stream will avulse (jump out of the channel) and flood over the fan.

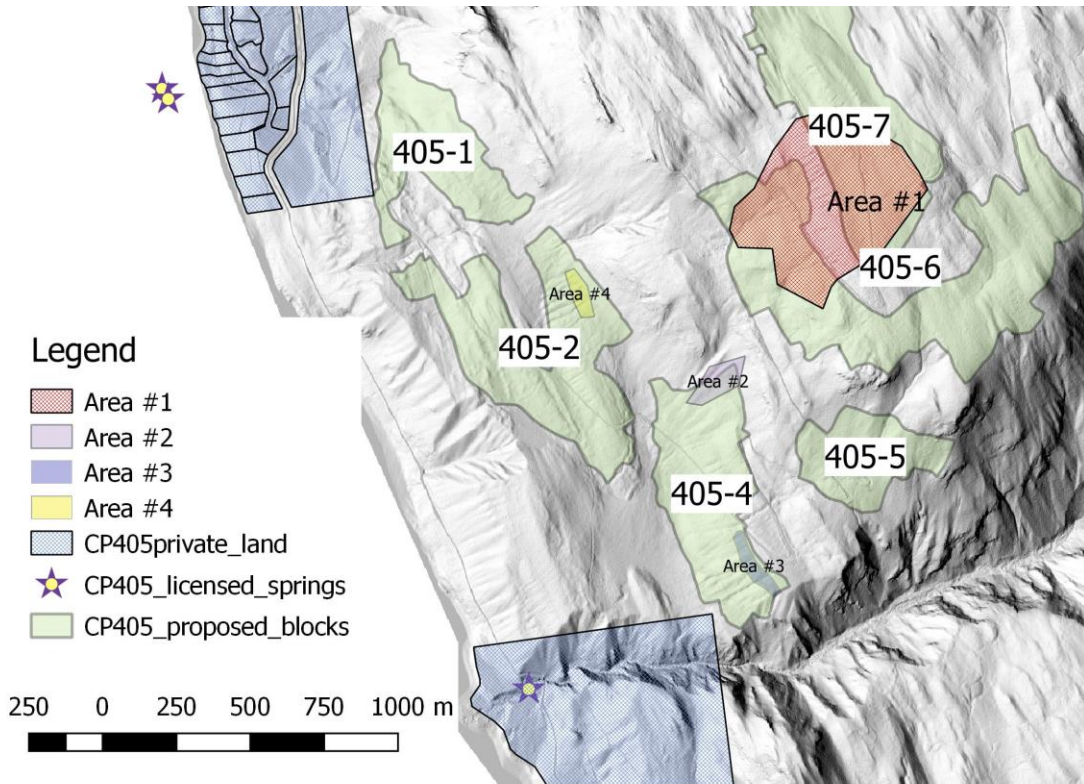
Figure 8

For the most part debris slide initiation zones are at or just below slope breaks, usually a broad bench upslope of a steep slope underlain by silty sandy gravel or silty sand. For ease of discussion the noted instability has been grouped into 4 areas shown on figure #8. Area #1 (which corresponds to W. Wells “High Hazard Zone”) outlines an area which includes recent debris slides associated with road drainage. Area #2 outlines an area which has one debris slide that appears to have occurred after the last major fire. Area #3 includes terrain that has older debris slides (250 to 500 yrs.), area #4 delineates the initiation zone of 500 yr. old slides.

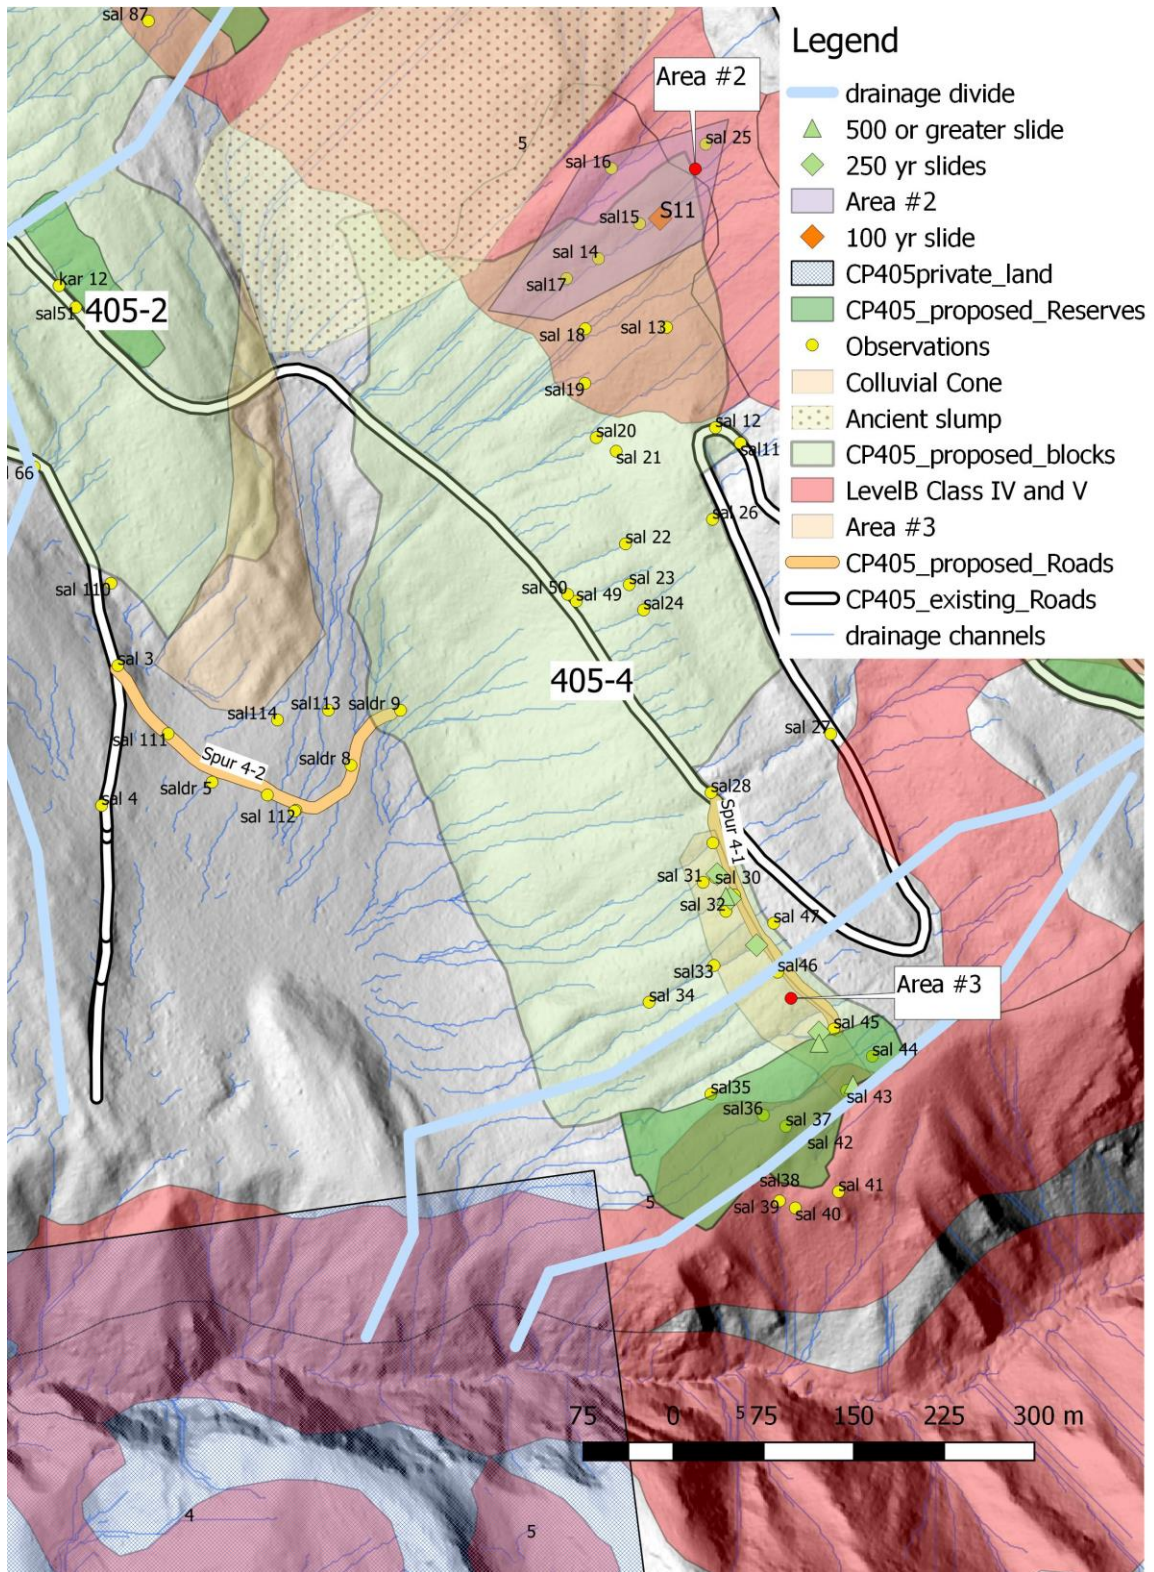
Figure 19

From sal 17 to sal 20 (within the terrain stability polygon) the slope gradient varies from 65 to 85% with short small 150% rock outcrops (quartzite and phyllite). Soil is coarse with good Bm development with scattered small mossy talus slopes. The shallow broad swales become more defined downslope.

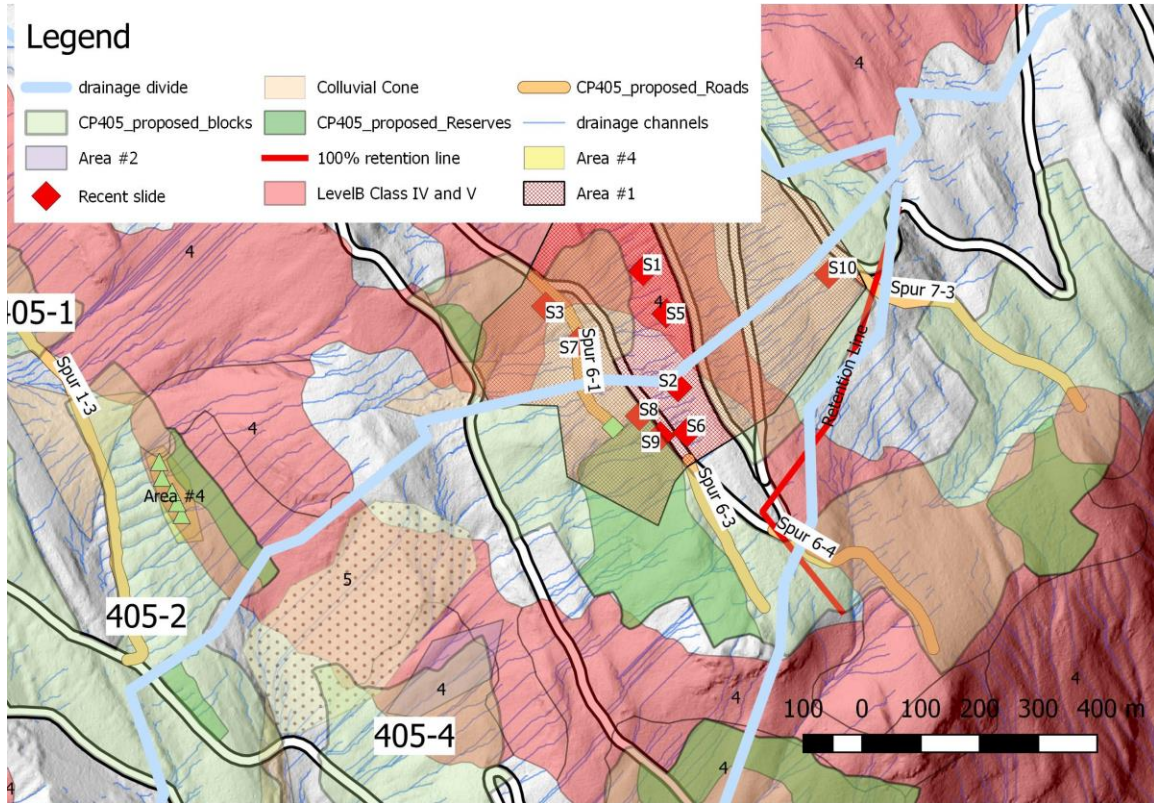
This proposed block is located along the lower midslope position. The northern portion impinges on a Class IV Terrain Stability Polygon, the southern portion is upslope of Class IV Terrain Polygon which at this location delineates small rock bluffs upslope of a broad draw. The portion of the block east of Red retention line shown on Figure 21 has been reserved (100% retention), spurs 6-3, 6-4 and 7-3 were deleted. Most of the

observations regarding this block are contained in the sections 4.4.1 (Area #1) and 4.5.4 (Spur 6-1) This block is also upslope of area #2 (section 4.4.2) and area #4 (section 4.4.4). The four recent slides (S3, S7, S8 and S9) within the block have been described in section 4.4.1.

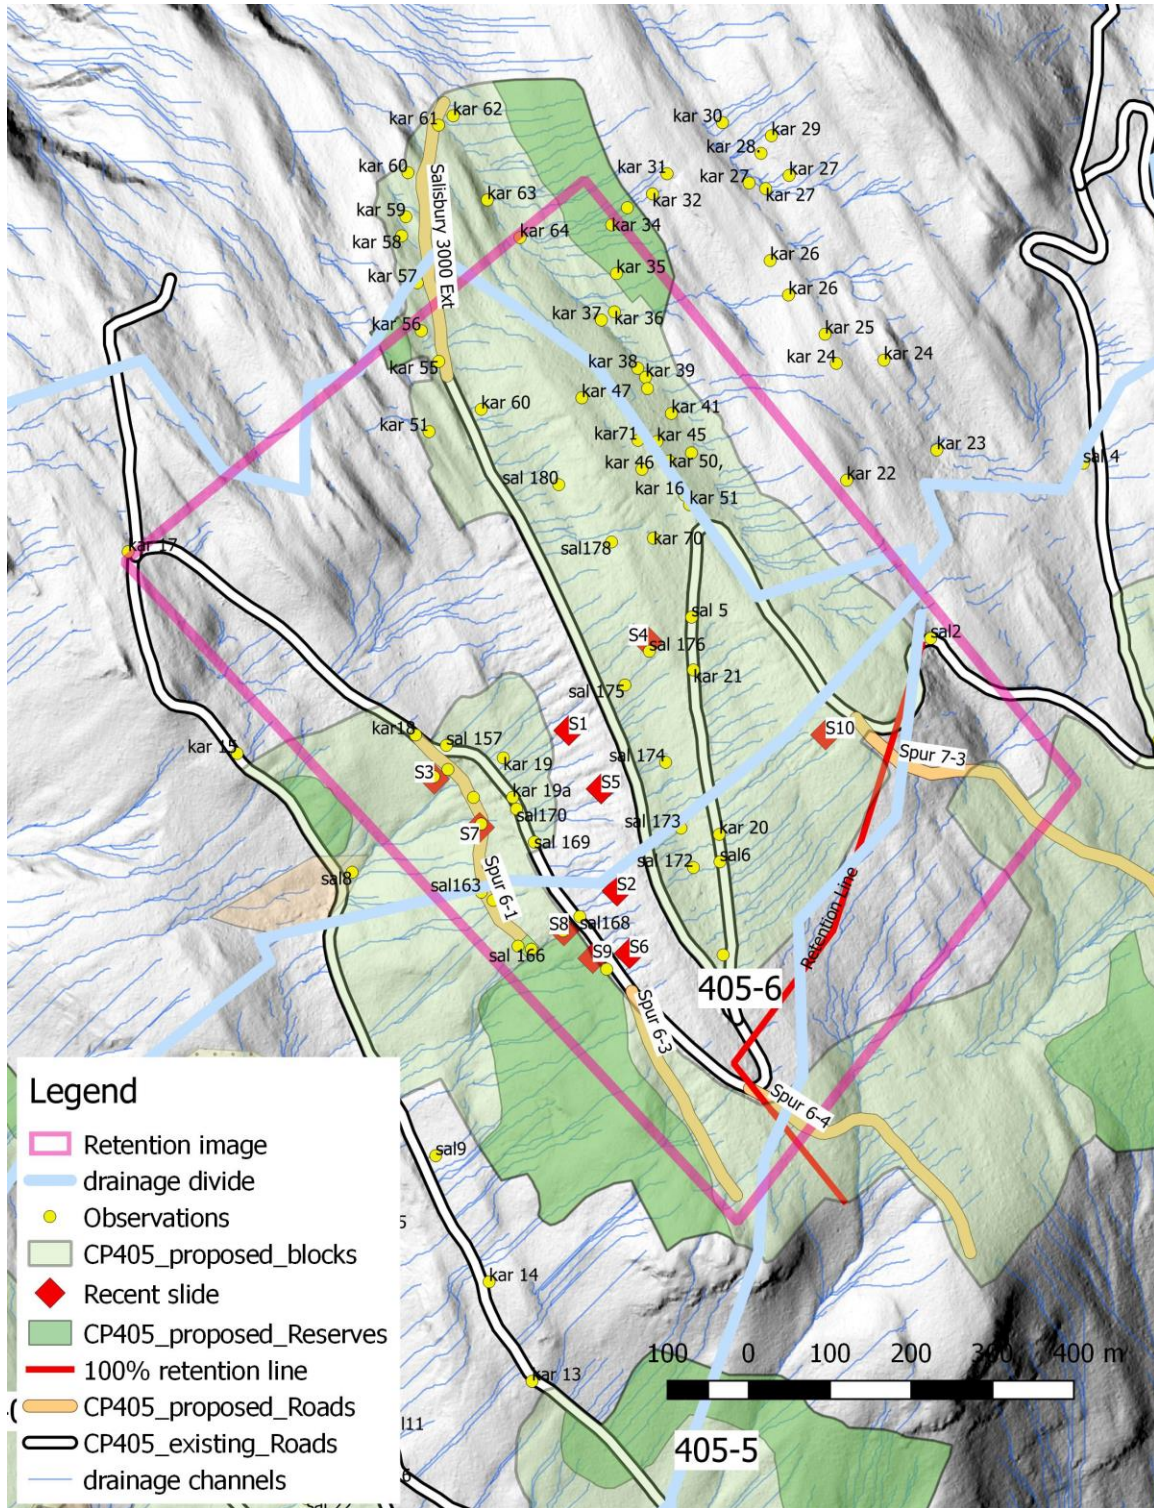
Figure 23

Much of this block is within Area #1 (Section 4.4.1) which has been discussed previously. The approximate area covered by the computer simulation image is shown on figure 23 as “retention image”. This block is near the junction of 3 to 4 approximated catchment basins, the boundaries between these basins are subtle and can be easily breached by excavated trails and roads. It is likely that the existing structures have already altered the drainage patterns.

The section of the block between Salisbury 3000 road and the FSR has been discussed previously (Area #1). Between sal 172 and 175 the slope gradient is 55% underlain by silty gravel, there is scattered devils club. The only instability noted was at sal 176, where 2 debris slides occur (S4) on a short 70% gradient step. Tension cracks on the crown

Upslope and north of this area from kar 31 to kar 71 the terrain is dry pine flats with phyllite, and quartzite steps and small bluffs mantled with silty sandy gravel. Broad flutes, depressions and benches are variable wet, some with devil's club and cedar. The slope gradient (excluding the short steep bluffs averages 25%). Two small areas of sinkholes were noted at Kar 40 and Kar 58 (discussed in Karst reconnaissance survey).
