Detailed Terrain Stability Field Review

Proposed Harvesting and Road Construction
in the Salisbury Face Area (Blocks 405-1, 2,
4, 5, 6 and 7: Spurs 1-3, 4-1, 4-2, 6-1 and 6-
3)
for
Cooper Creek Cedar Ltd.

13/02/2020

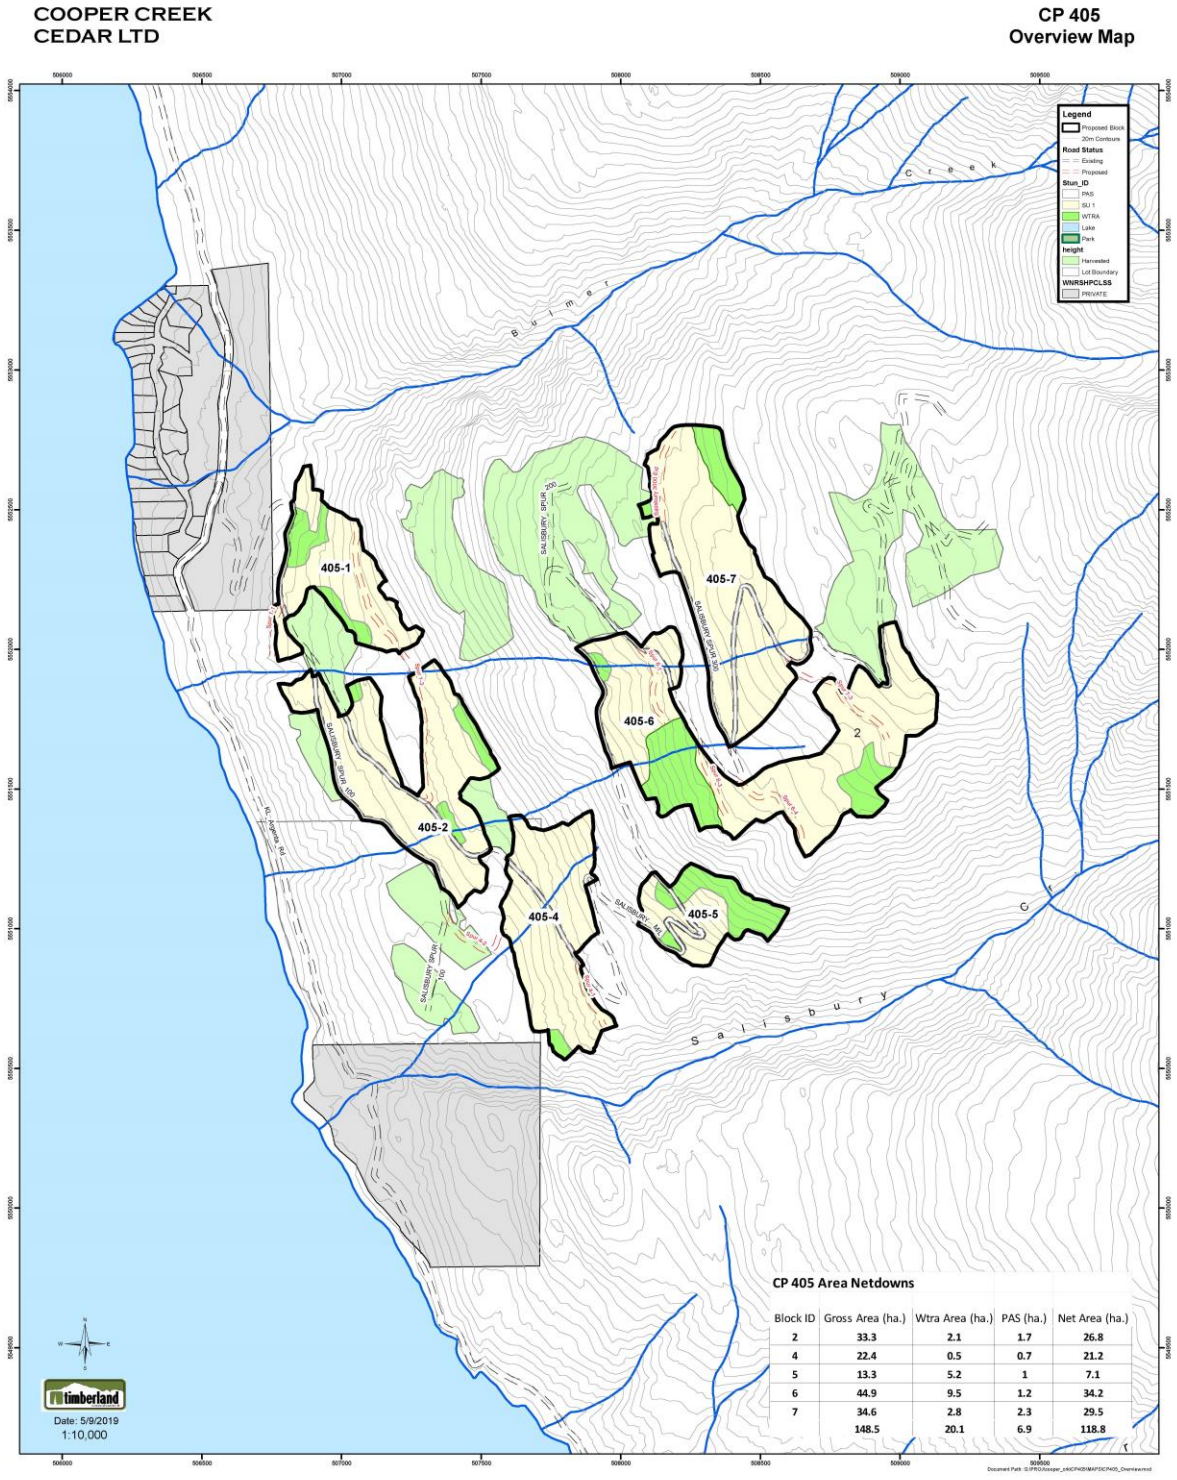
Figure 1

At the time of the request, partial retention (12-14 stems to 35-40 stems per hectare) was proposed for the lower blocks. The original proposed development is shown in figure #1, blocks 405-6 and 405-7 (and associated spurs) have been significantly modified to account for Caribou Management. The modifications include significant increase in reserves for both blocks, and for block #7 retention of 30 and 145 stems per hectare, Spurs 7-3, 6-3 and 6-4 have been deleted.

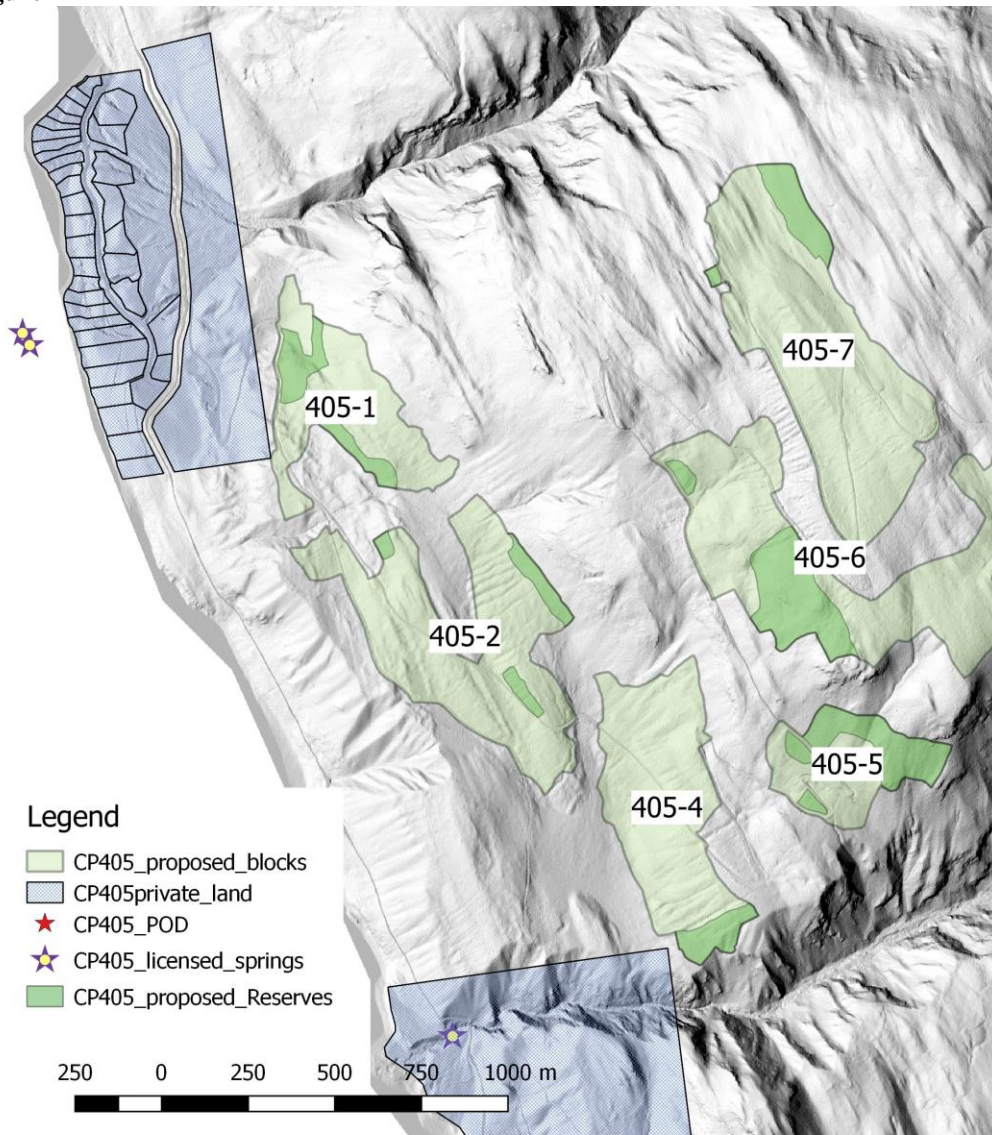
Figure 2

The licensed intakes (POD), springs and private land are shown on figure 2. As can be seen in the figure the POD's and private land are on Bulmer Creek fan and along the lower reaches of Salisbury Creek.

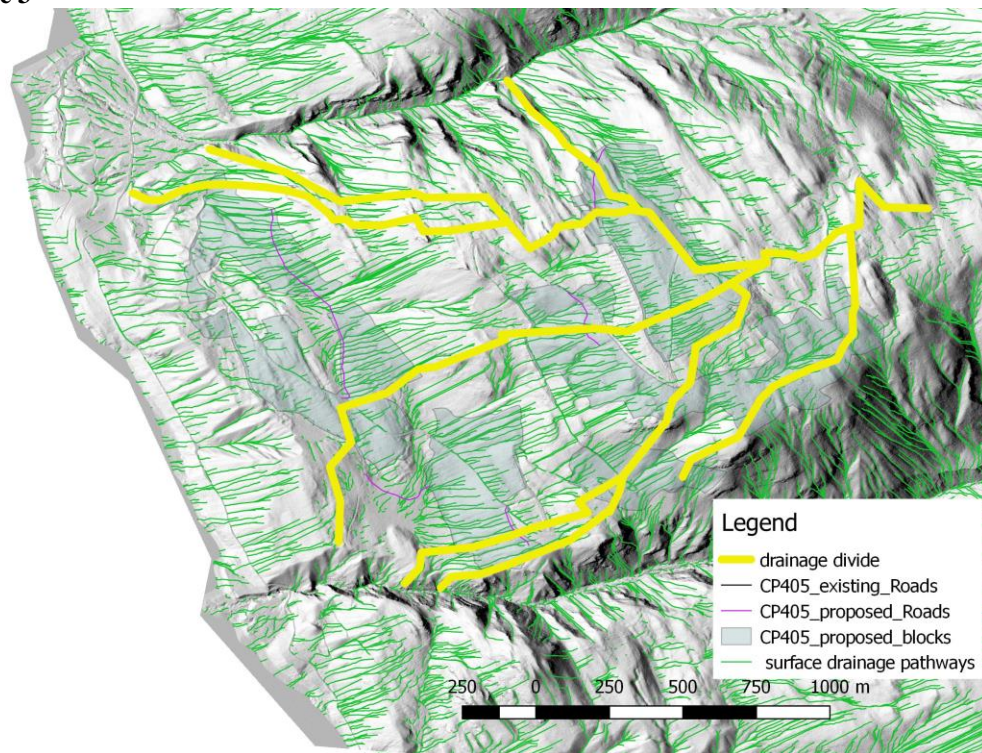
Figure 3

QGIS SWAT (Soil & Water Assessment Tool) slope drainage program was run using the lidar DEM, the slope drainage patterns (Figure 3) are dependent on the resolution of the DEM data ($\sim 1\text{m}$) and may miss small ridges, benches and other surface features that could direct the drainage. Roads and trails can also impact the accuracy as culvert locations are not incorporated. Subsurface drainage patterns are not modeled by this method. The field observations for the most part confirm the surface drainage patterns

There are possible interception and diversions of slope drainage along the FSR between blocks 6 and 7. The field review of the existing roads failed to locate any other significant diversions or interceptions of slope drainage.

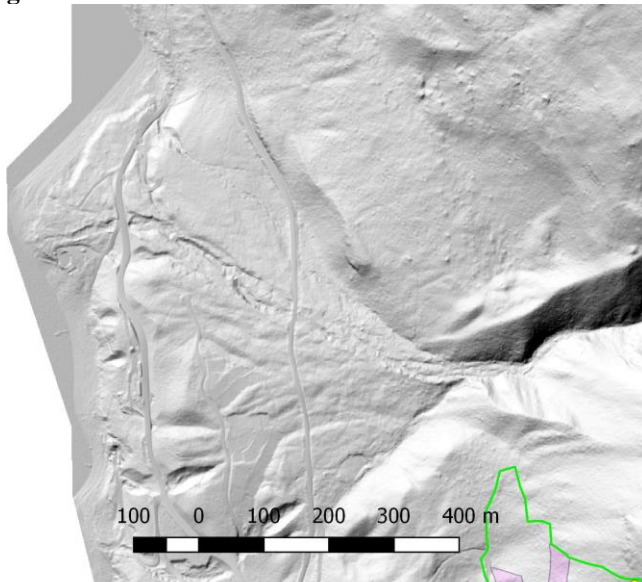
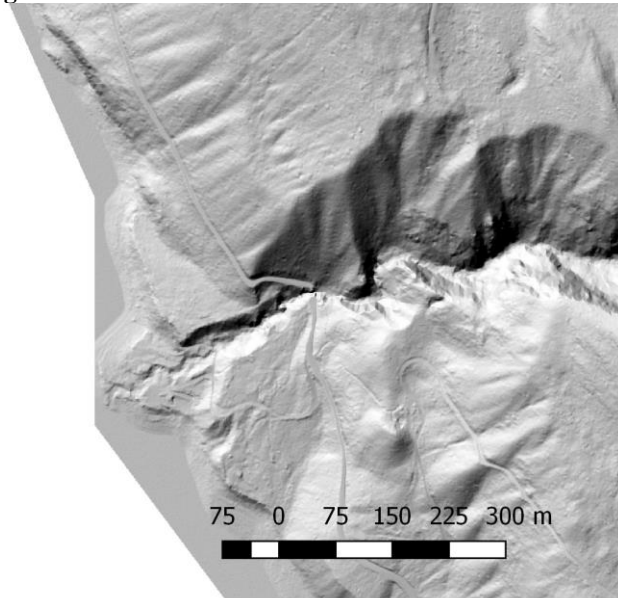
Debris floods are an existing hazard for both Bulmer and Salisbury. Debris floods occur when most or all the stream bedload is mobilized during a flood event and are a function of the flood frequency of the watershed. A comparison (figures 10 and 11) of the fans indicates that debris floods occur more frequently in Bulmer Creek than Salisbury, as evidenced by the debris deposits on Bulmers large “Paleo fan”. Also, the Bulmer Creek fan at lake level appears relatively large compared to current Salisbury Creek fan.

As can be seen in the figures, Bulmer Creek is poorly confined on both the Paleo fan and recent fan, Salisbury Creek is well confined through the paleo fan and moderately well confined in the recent fan. The poor confinement increases the likelihood that the stream will avulse (jump out of the channel) and flood over the fan.

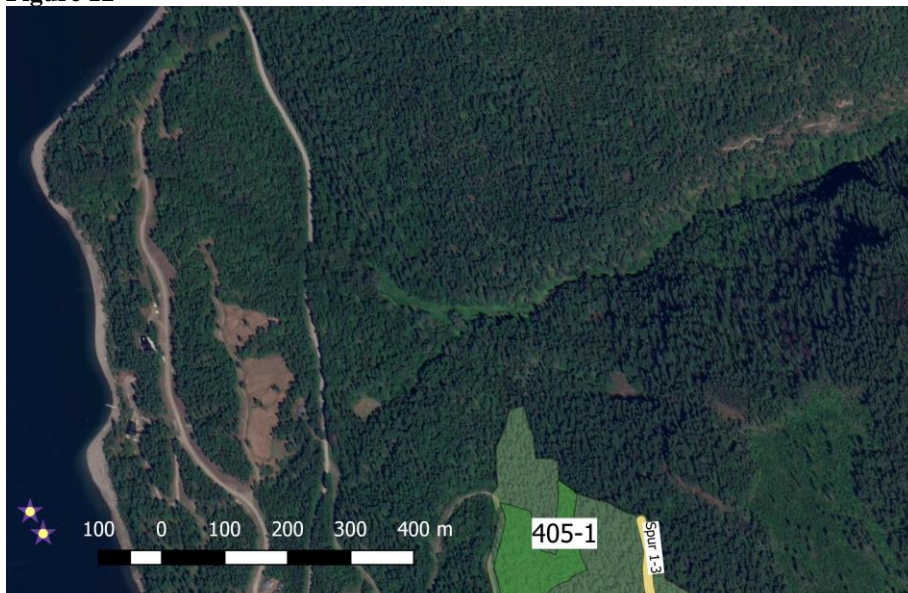
Figure 12

Although the fans were not investigated in the field, disturbed vegetation along Bulmer Creek, visible on google earth imagery, suggests that there has been a recent flood or debris flood in Bulmer Creek that terminated along the upper portions of the paleo fan.

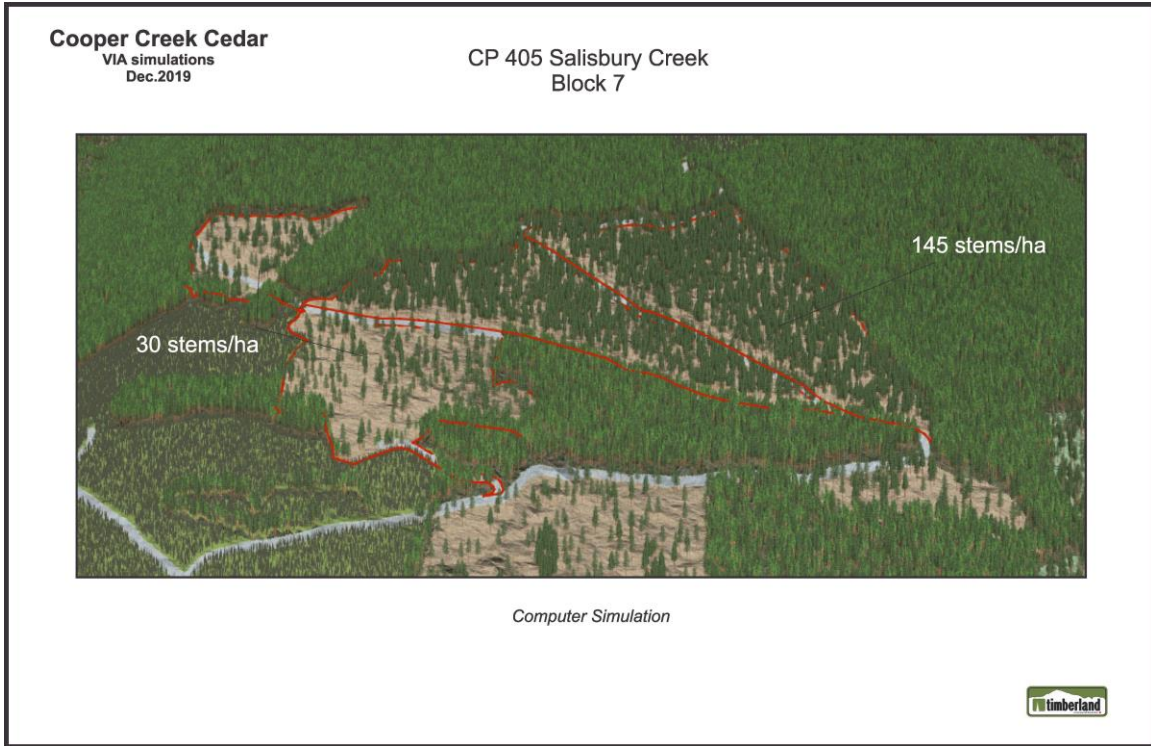
Image 1

The original layout for block 405-7 has been altered for Caribou Management. The image below is the computer-generated simulation (timberland) illustrating possible retention and distribution of the trees. The imagery shows portions of 405-6 (bottom of the image) as well.

There are two debris slides within the block and four just downslope. The conditions and causes of the slides has been discussed in detail in Section 5.6 (Block 6).

Currently there is a very high likelihood of landslides (~10yrs, Pa = 0.1). The slides are small and run out on the slopes just below (negligible possibility of impacting the elements assessed for risk).
