APEX GEOSCIENCE CONSULTANTS LTD.

Detailed Terrain Stability Field Review

Proposed Construction of the extension of
Laird Creek Mainline, and Spurs A and B in
the Laird Creek Area
for
Cooper Creek Cedar Ltd.

13/02/2020

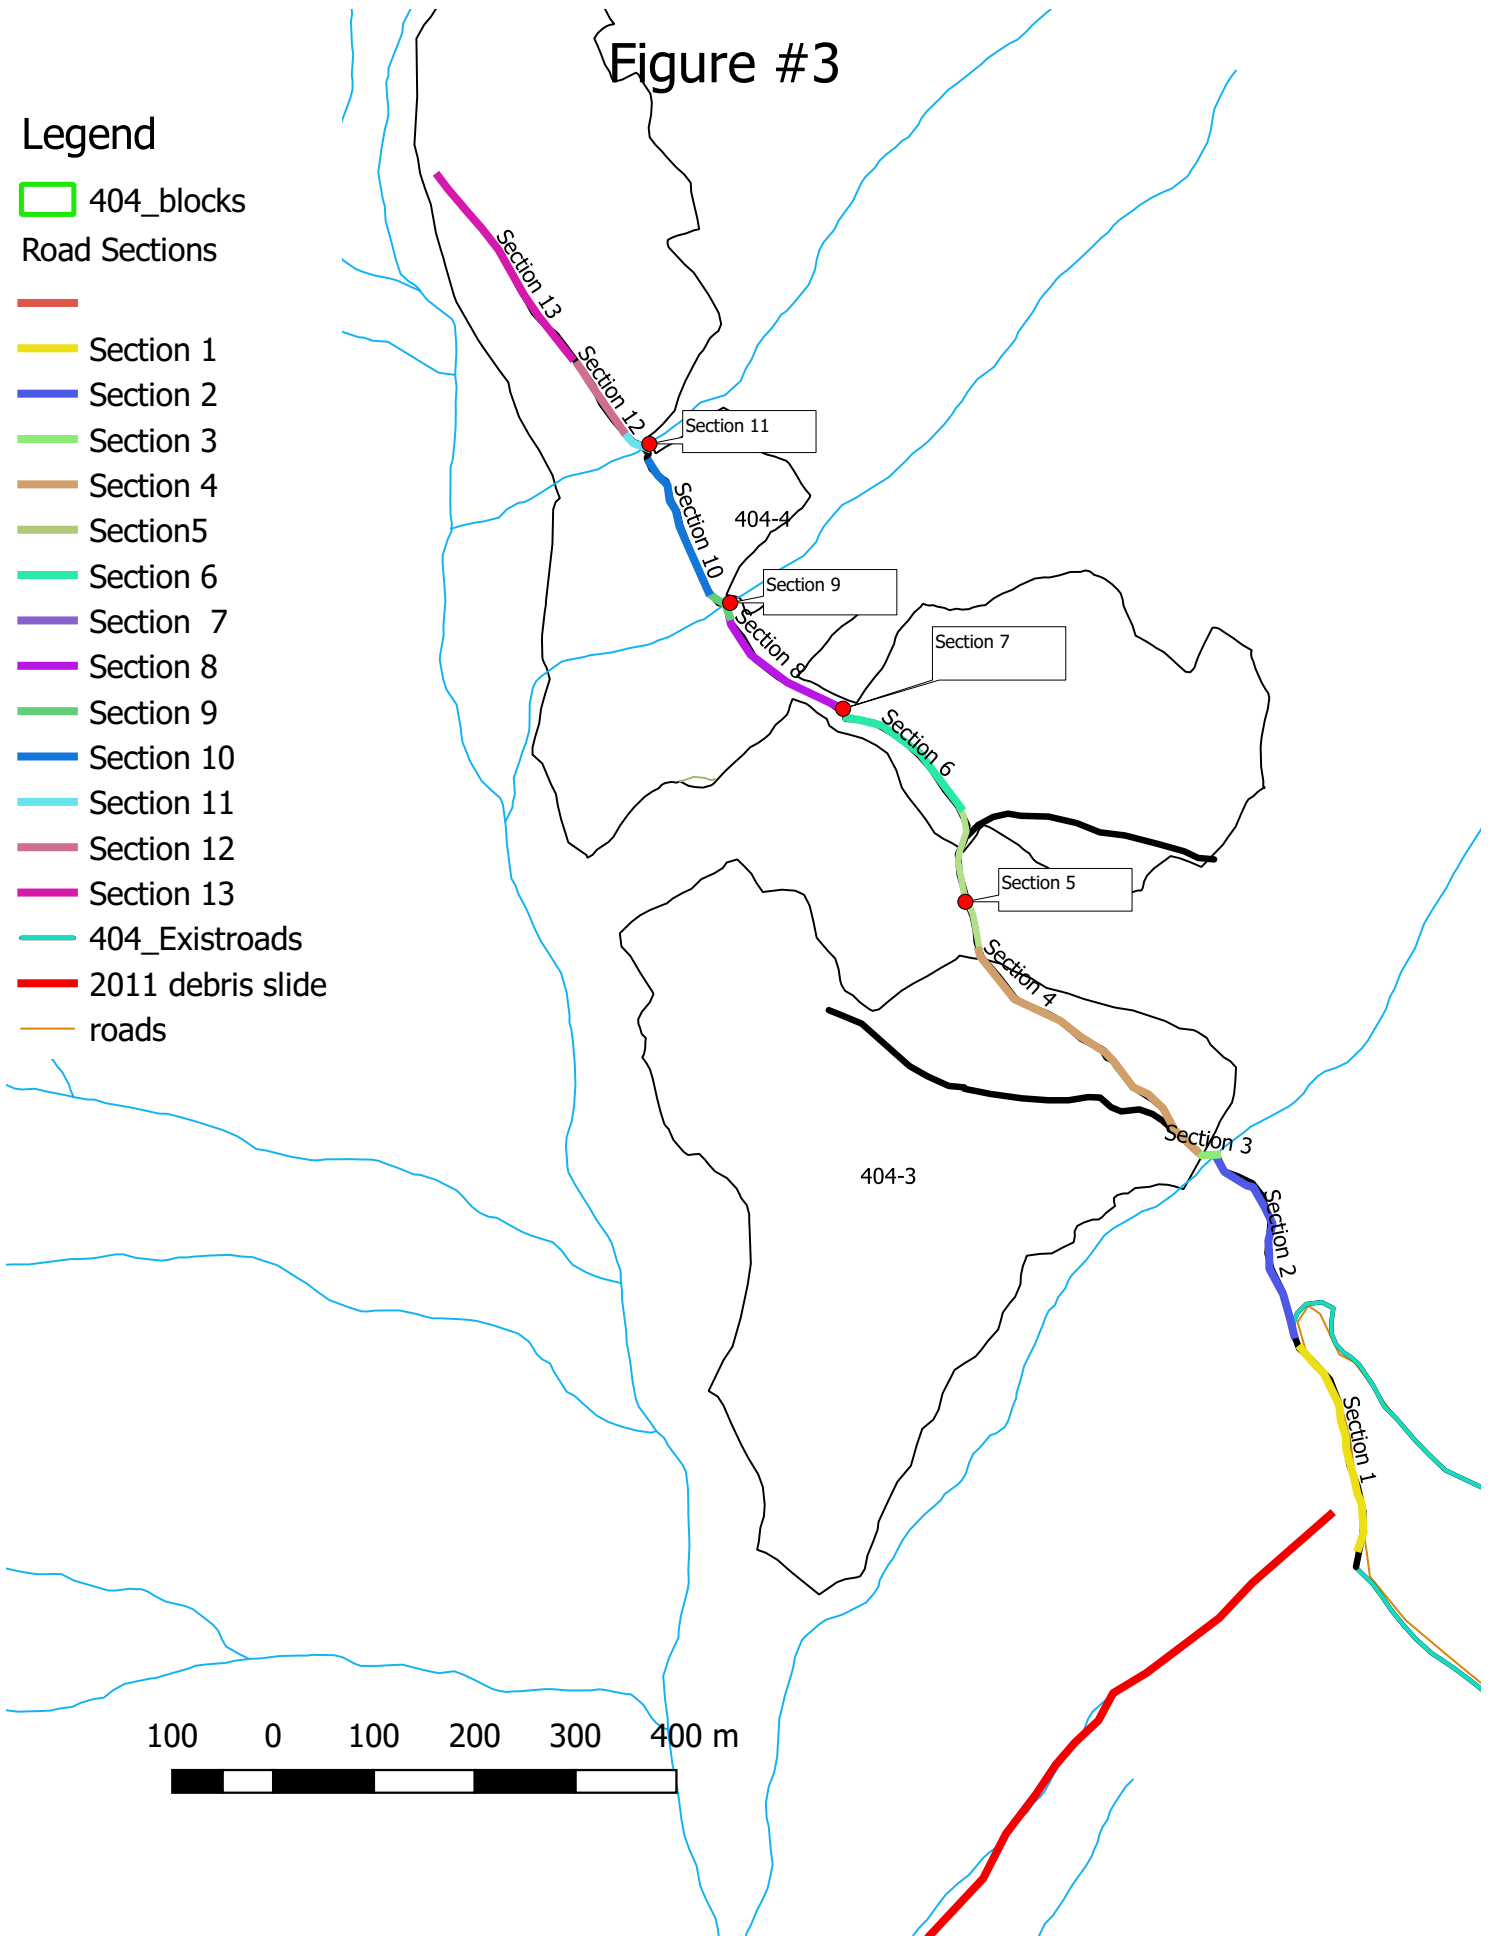
Figure #3

Section #1 (Hubs 1-7): The first 254 meters is along the recontoured segment of the Laird Mainline. This portion of the road was recontoured as part of the response to the 2011 debris slide that occurred 40 meters downslope of the southern end of this section (figure #4). A slide

investigation (Sitkum 2011) into the 2011 debris slide stated that major trigger of the slide was water diverted out of an adjacent watershed catchment into the catchment upslope of the slide. The combined flow was directed down the six stacked road lifts and discharged onto the slide scarp. After additional drainage works were completed on the road network (prior to the recontouring), the volume of discharge from this culvert onto the scarp was reduced by 80%. Since 2011 no additional slides have occurred below the cross-ditches, suggesting that the drainage control measures are adequate to maintain downslope stability.

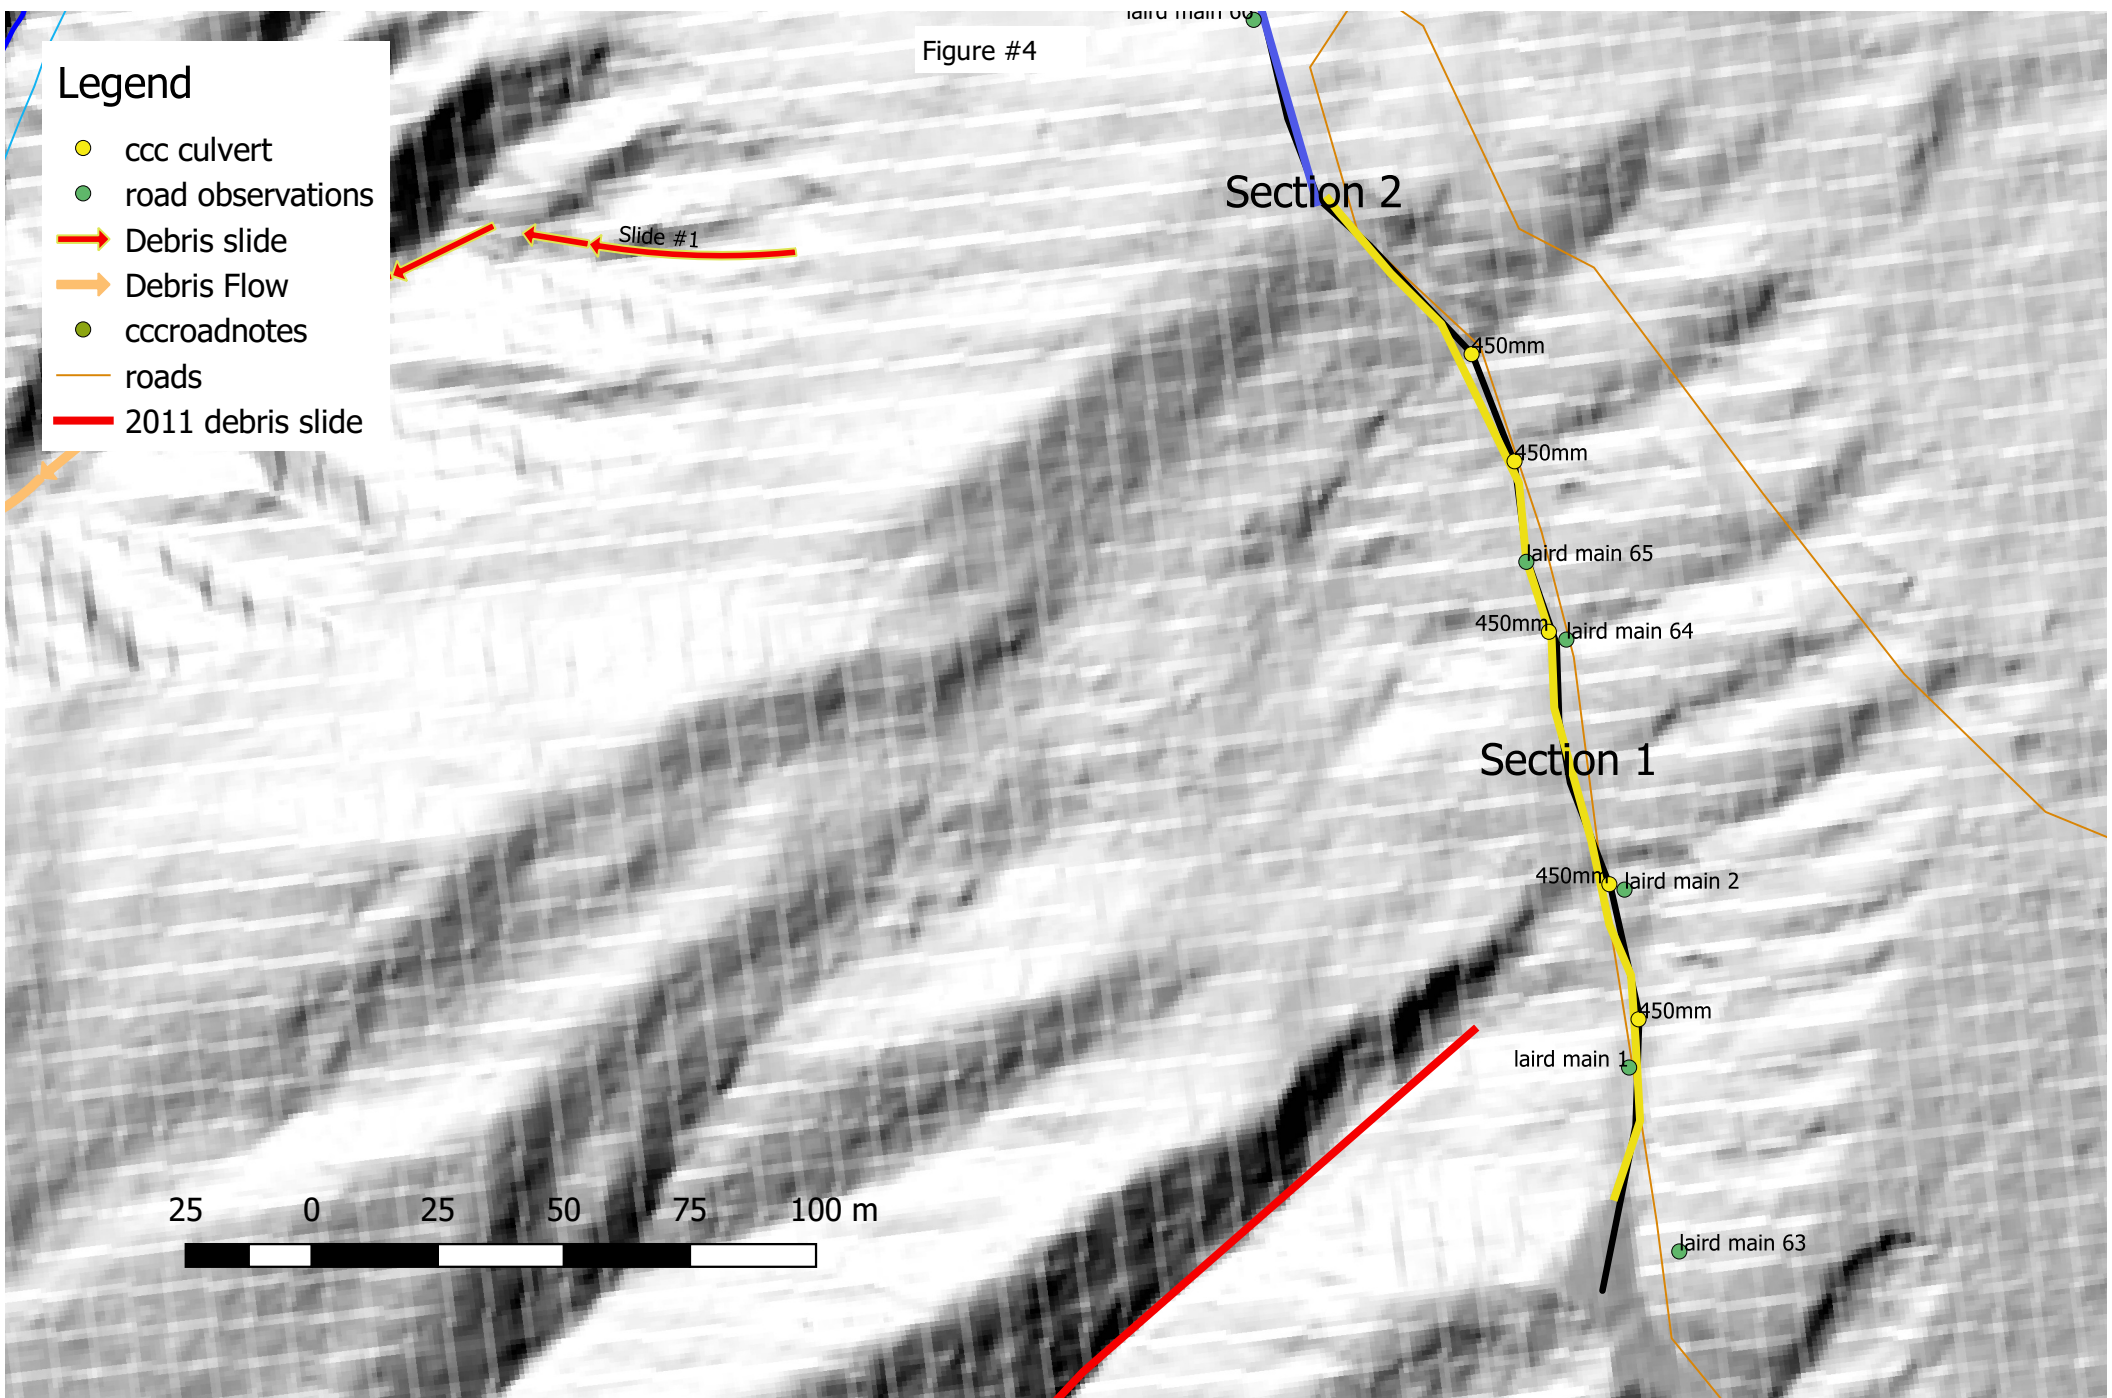
Figure #4

The recontoured road traverses and switches through a “swaled” ancient slump scarp. Currently there are cross-ditches at all swale locations, the cutslope has sloughed to 30 to 60% at swale locations. Cross-drain culverts locations are marked at all the cross-ditch locations (Figure 4).

Just before the road stream crossing (Section #3) there is a recent (~15 yrs old) shallow small debris slide (Slide #2), on an 80% gradient slope underlain by loose sandy gravel. The debris slide made it to the gully below. The proposed road at this location is set back from the slope break on a small flat.

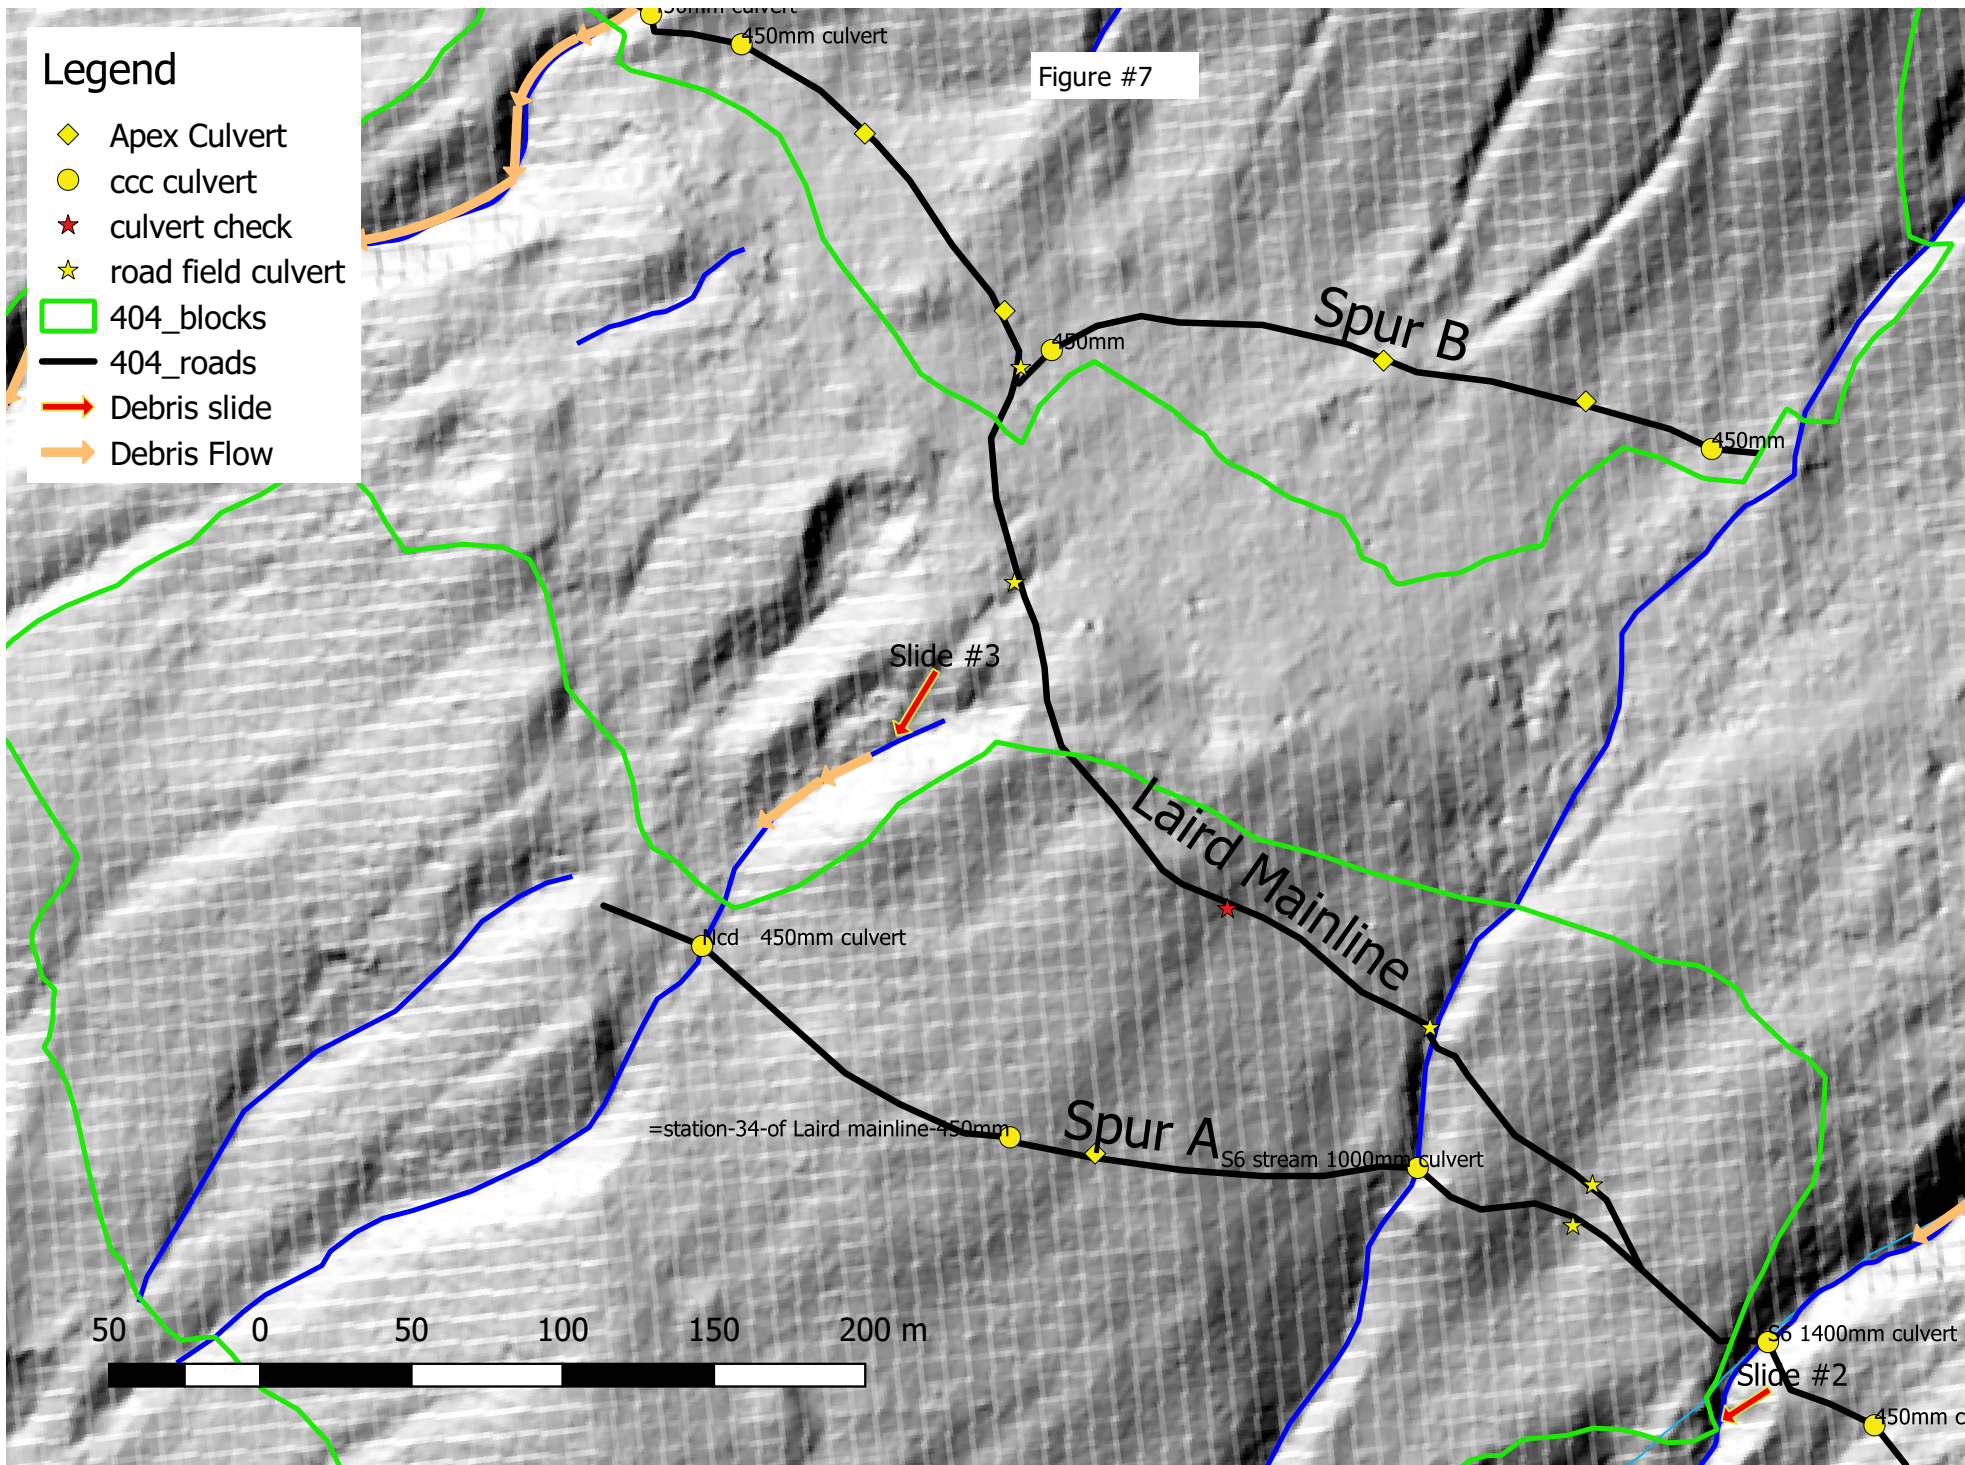
Figure #7

Spur A is located downslope of Proposed Laird Main (Figure #7), the slope (30 to 55%) is underlain by sandy gravel to boulder gravel. Just past the junction point of departure from Laird Main, the Spur crosses a creek confined by 2 to 3 m high 60% boulder sideslopes. There is no evidence of debris flows through here, there are old burnt stump in bottom. The channel gradient is 45%, with small woody debris and mossy cobbles.

Spur B leaves the proposed Laird Main extension on the wet flat, the spur then traverses Colluvial cones the base of two draws. The slope gradient does not exceed 45%. It is likely that water flows sub-surface through the cones (Figure #7).
