# Detailed Terrain Stability/Karst Field Review

Proposed Harvesting and Road Construction  
in the Argenta Face Area CP 416 blocks 1 – 9;  
12- 14: Bulmer Main Line and Spurs  
for  
Cooper Creek Cedar Ltd.

2022-03-10

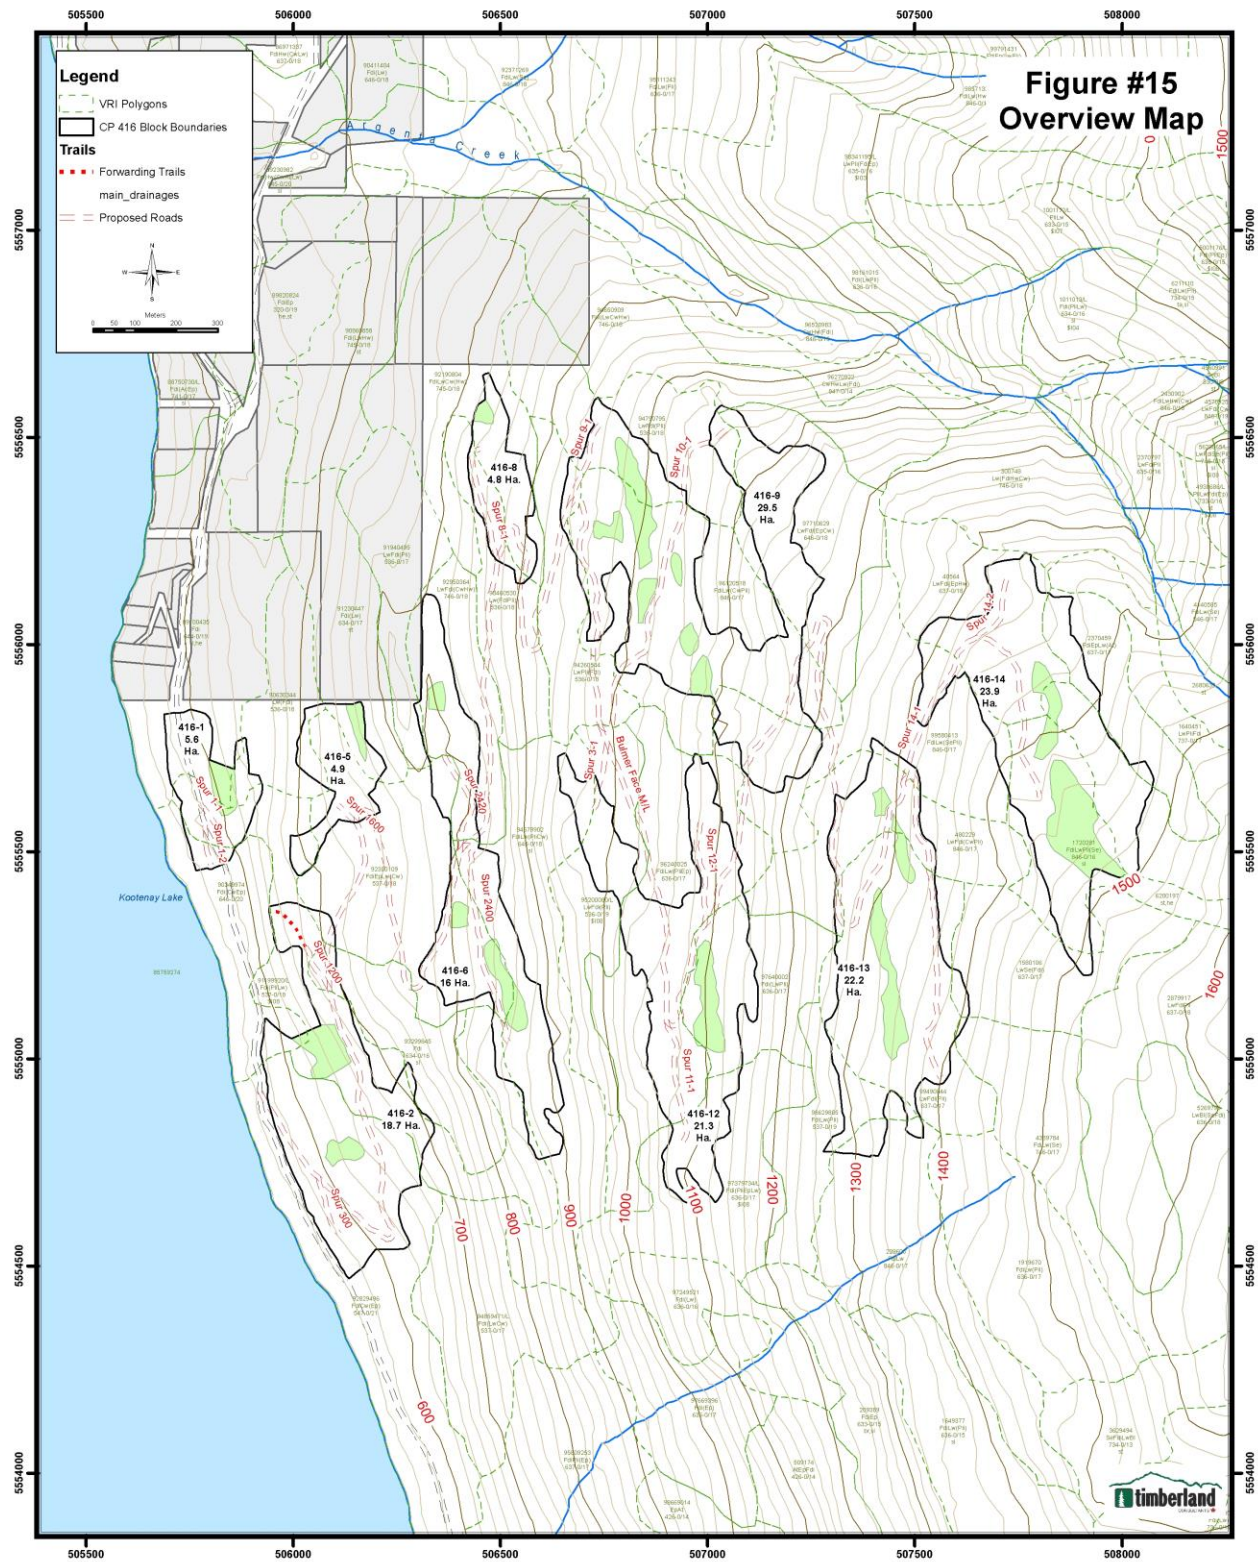
## Appendix I Final Layout 1

As seen on figure #14 only portions of Blocks 416-9 and 416-14 are within the Argenta Catchment. The end of Spur 10-1 just enters the mapped boundary within block 416-9 and the switch just upslope of this block is also just within the catchment. There is a low likelihood of landslides (the slope gradient within the block is  $>45\%$ ), the boundary is set back from the slope to the creek which is this location is  $\sim 55\%$ . The recommended excluded area in block 416-14 isolates the proposed harvesting from historic instability on the slope above Argenta Creek (visible on hillshade), the drainage within the block will not flow towards the noted instability. To the north, the block and in block spurs are separated from the slope to Argenta creek by a small rise. Both Blocks 416-9 and 416-14 are assessed as having a low likelihood of landslides, landslides that did initiated would not reach Argenta Creek, however due to the drainage patterns sediment may reach the stream.
